9.1 Demolition Asbestos Survey, Vezey Wing (2015)

Demolition Asbestos Survey

National Temperance Hospital (Vezey-Strong Wing)
London NW1

RSK Report Number: 415000-2 (00)

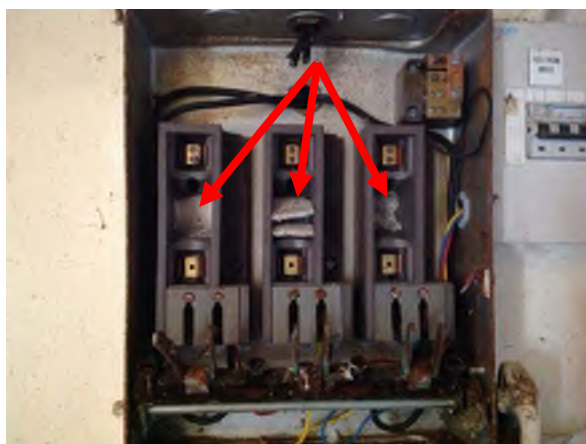
Building	Vezey-Strong wing
Floor	Third
Room	049
Item Description	Textile flash guard
Material Type	Textiles/Cloth
Sample Number	25258
Asbestos Type	Chrysotile

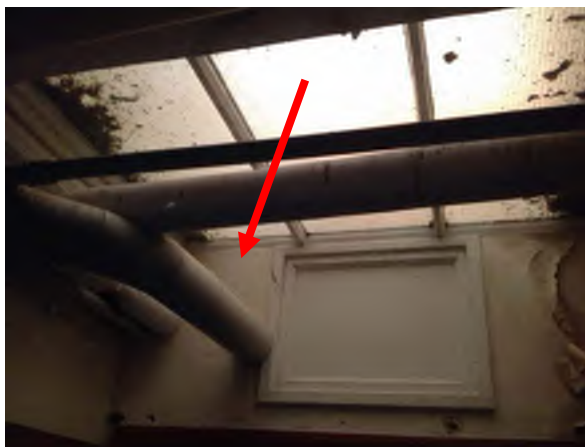
Building	Vezey-Strong wing
Floor	Third
Room	049
Item Description	Pipe insulation
Material Type	Thermal Insulation/Lagging
Sample Number	Similar to 25250
Asbestos Type	Sp Chrysotile

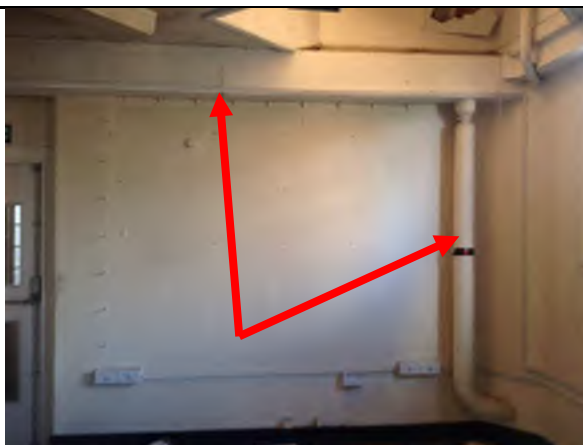
Building	Vezey-Strong wing
Floor	Third
Room	050
Item Description	Pipe insulation
Material Type	Thermal Insulation/Lagging
Sample Number	Similar to 25250
Asbestos Type	Sp Chrysotile

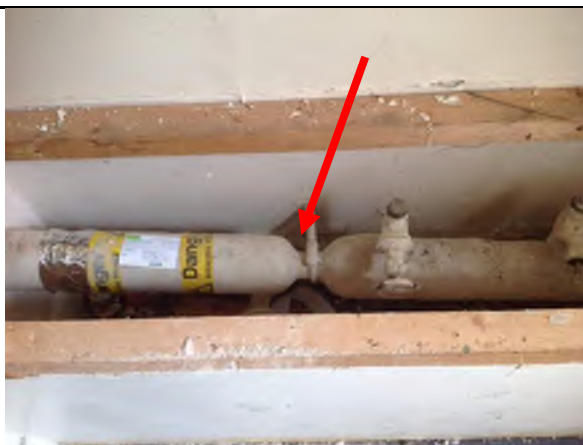
Building	Vezey-Strong wing
Floor	Third
Room	056
Item Description	Pipe insulation
Material Type	Thermal Insulation/Lagging
Sample Number	25260
Asbestos Type	Chrysotile

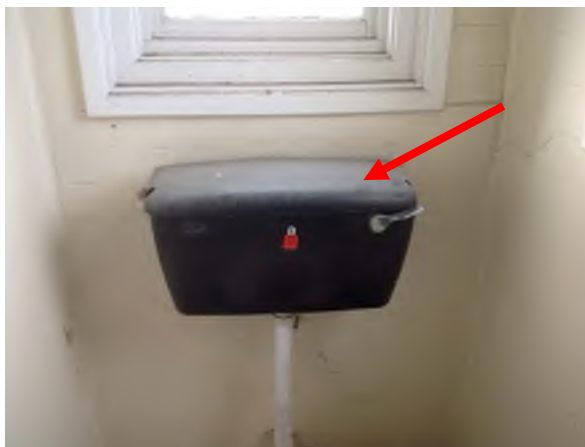
Building	Vezey-Strong wing
Floor	Third
Room	071
Item Description	Toilet cistern
Material Type	Composite
Sample Number	Similar to 25263
Asbestos Type	Sp Amosite

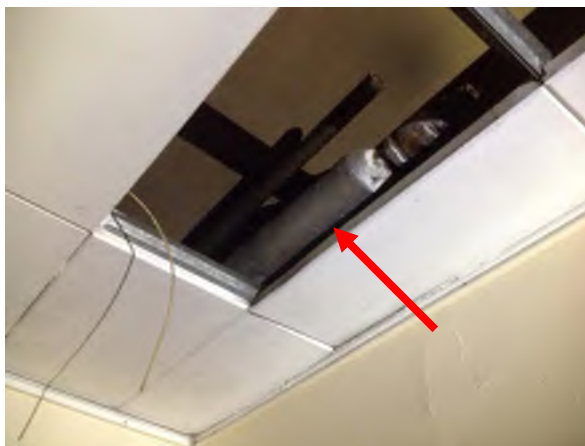
Building	Vezey-Strong wing
Floor	Third
Room	072
Item Description	Pipe insulation
Material Type	Thermal Insulation/Lagging
Sample Number	Similar to 25260
Asbestos Type	Sp Chrysotile

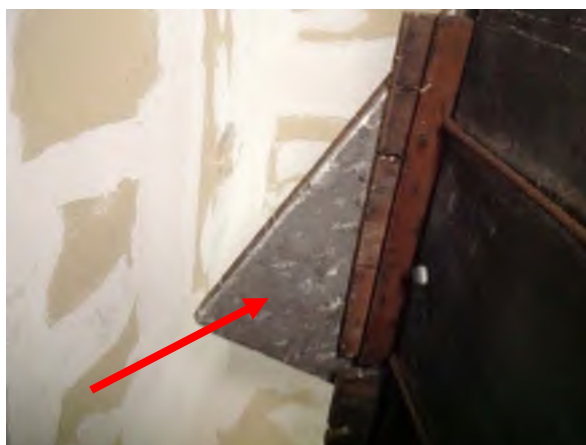
Building	Vezey-Strong wing
Floor	Third
Room	Loft area 10
Item Description	Insulating board panel
Material Type	Insulating Board
Sample Number	Similar to 25265
Asbestos Type	Sp Chrysotile / Amosite

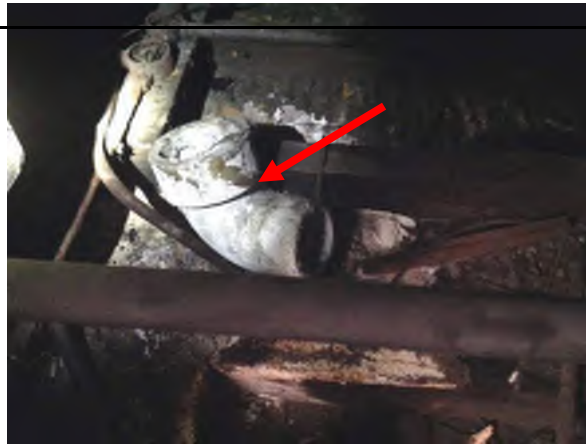
Building	Vezey-Strong wing
Floor	Third
Room	Loft space 6
Item Description	Redundant pipe bend
Material Type	Cement
Sample Number	25242
Asbestos Type	Amosite

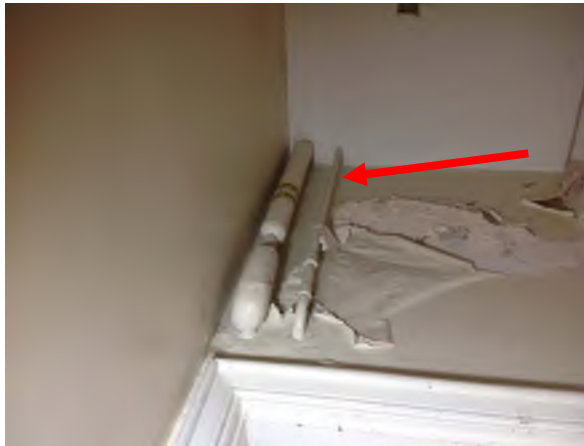
Building	Vezey-Strong wing
Floor	Stairwell
Room	Stairwell 2 between floors 1 and 2
Item Description	Pipe insulation
Material Type	Thermal Insulation/Lagging
Sample Number	Similar to 25260
Asbestos Type	Sp Chrysotile

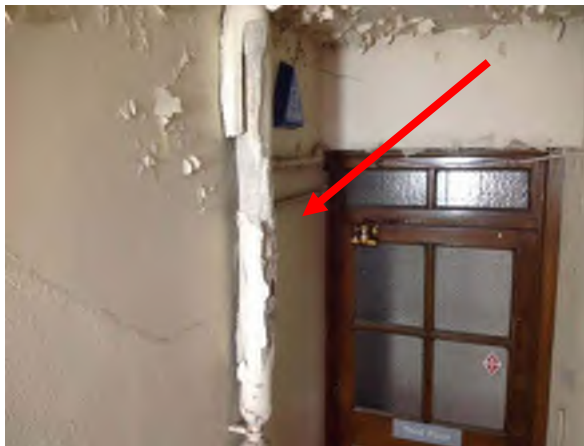
Building	Vezey-Strong wing
Floor	Stairwell
Room	Stairwell 3 - All floors
Item Description	Pipe insulation
Material Type	Thermal Insulation/Lagging
Sample Number	Similar to 25250
Asbestos Type	Sp Chrysotile

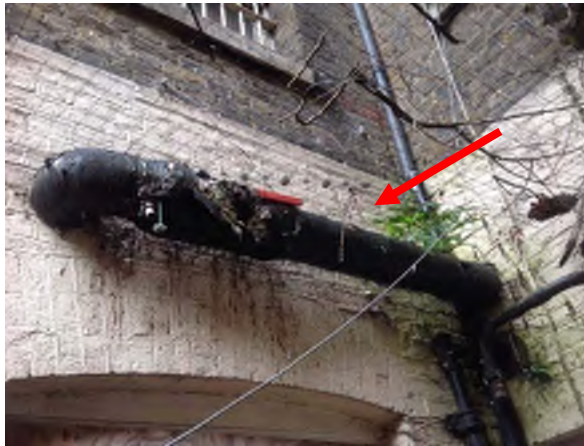
Building	Vezey-Strong wing
Floor	External
Room	External
Item Description	Paper insulation to exterior pipework
Material Type	Thermal Insulation/Lagging
Sample Number	Similar to 27103
Asbestos Type	Sp Chrysotile

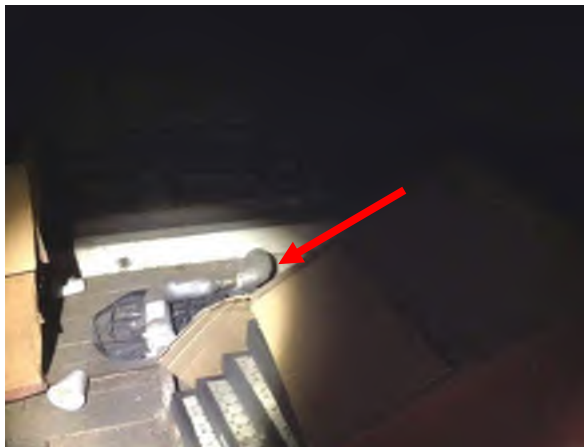
Building	Vezey-Strong wing
Floor	Lofts / Roof
Room	Loft area 11
Item Description	Pipe insulation
Material Type	Thermal Insulation/Lagging
Sample Number	25267
Asbestos Type	Chrysotile / Crocidolite

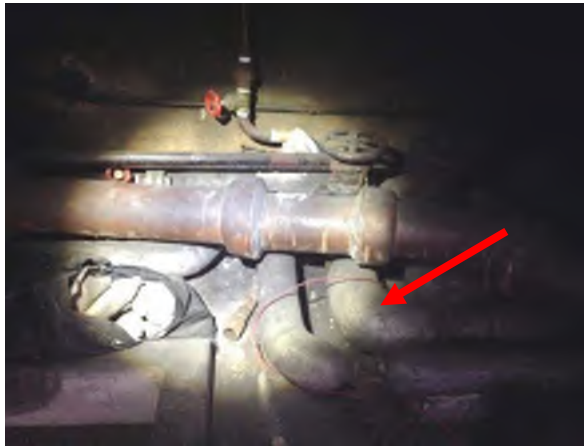
Building	Vezey-Strong wing
Floor	Lofts / Roof
Room	Loft area11
Item Description	Pipe insulation
Material Type	Thermal Insulation/Lagging
Sample Number	25268
Asbestos Type	Chrysotile / Crocidolite

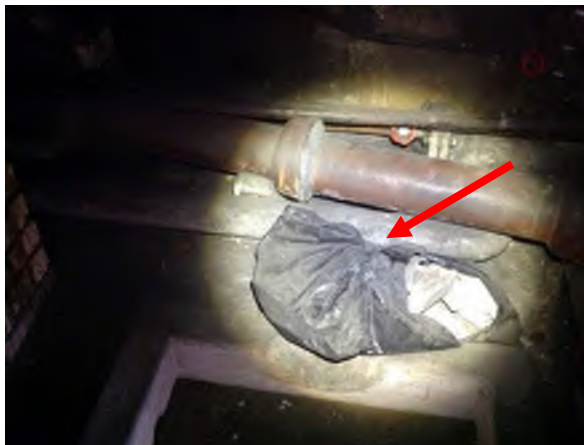
Building	Vezey-Strong wing
Floor	Lofts / Roof
Room	Loft space 11
Item Description	Lagging debris
Material Type	Thermal Insulation/Lagging
Sample Number	25269
Asbestos Type	Chrysotile / Crocidolite

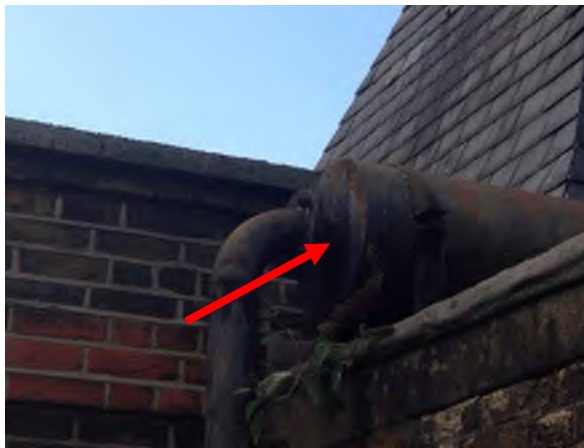
Building	Vezey-Strong wing
Floor	External
Room	Roof
Item Description	Gasket to cylinder and adjoining pipe work in light well
Material Type	Gaskets/Washers
Sample Number	25266
Asbestos Type	Chrysotile

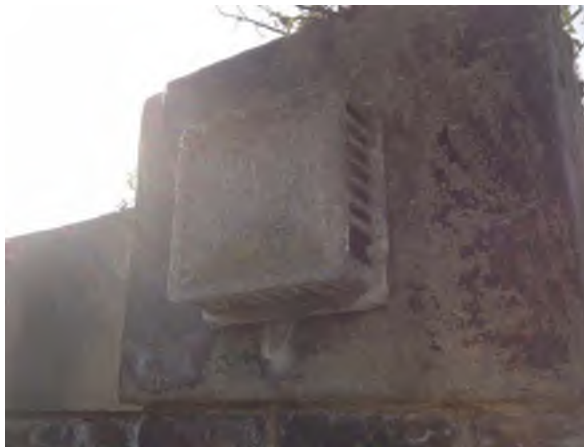
Building	Vezey-Strong wing
Floor	External
Room	Roof
Item Description	Cement cowl
Material Type	Cement
Sample Number	25270
Asbestos Type	Chrysotile / Crocidolite

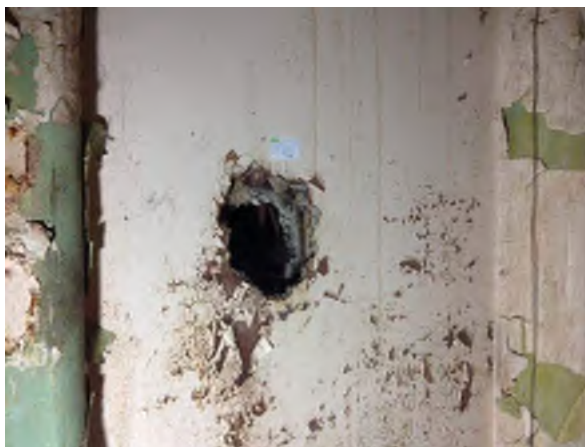
Building	Vezey-Strong wing
Floor	Basement
Room	331
Item Description	Insulation board to wall
Material Type	Insulating Board
Sample Number	27088
Asbestos Type	Asbestos Not Detected

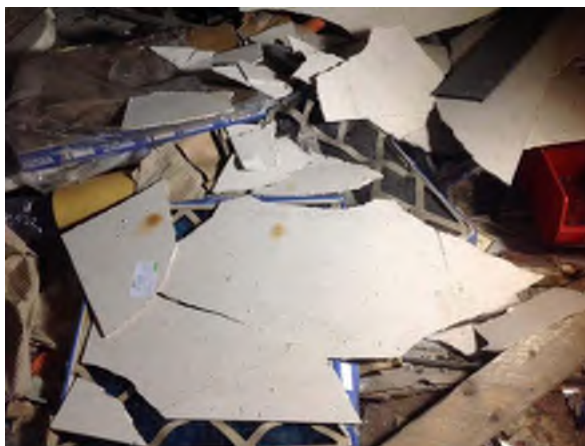
Building	Vezey-Strong wing
Floor	Basement
Room	340
Item Description	Board panel debris to floor
Material Type	Insulating Board
Sample Number	27089
Asbestos Type	Asbestos Not Detected

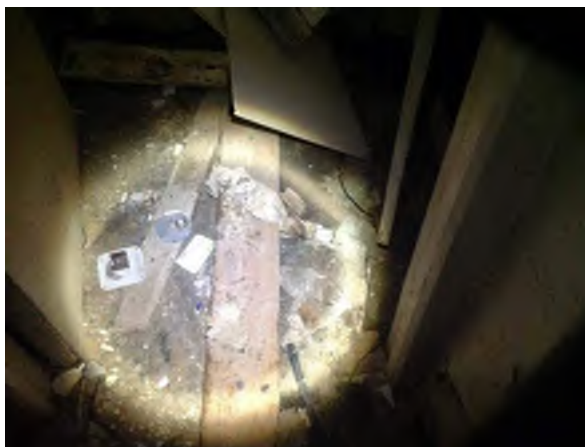
Building	Vezey-Strong wing
Floor	Basement
Room	340
Item Description	Lino to floor
Material Type	Floor Tile / Vinyl
Sample Number	27090
Asbestos Type	Asbestos Not Detected

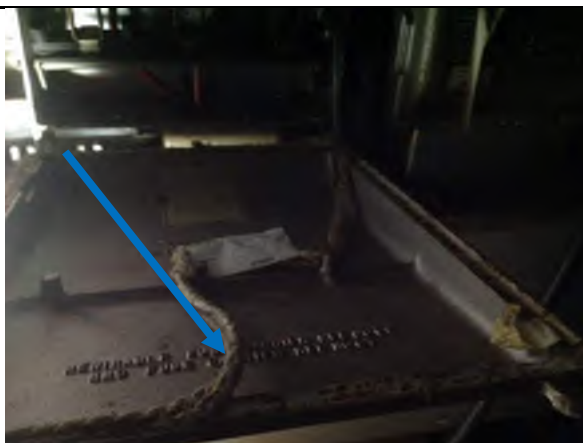
Building	Vezey-Strong wing
Floor	Basement
Room	342
Item Description	Rope seal to large fuse box
Material Type	Rope/String
Sample Number	27092
Asbestos Type	Asbestos Not Detected

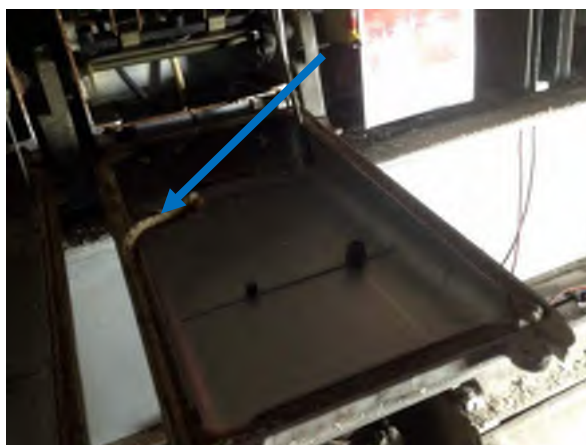
Building	Vezey-Strong wing
Floor	Basement
Room	342
Item Description	Rope seal to small fuse box
Material Type	Rope/String
Sample Number	27094
Asbestos Type	Asbestos Not Detected

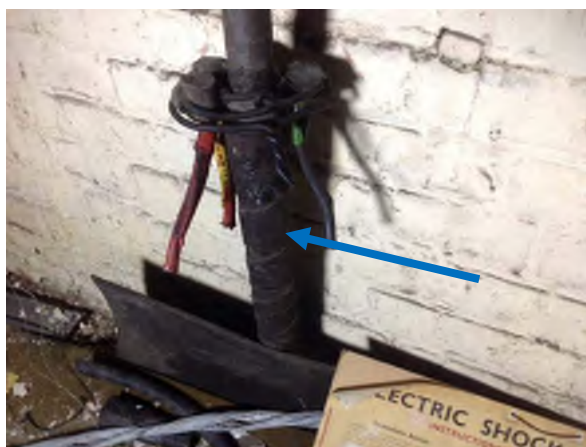
Building	Vezey-Strong wing
Floor	Basement
Room	342
Item Description	Cable wrap
Material Type	Bitumen
Sample Number	27096
Asbestos Type	Asbestos Not Detected

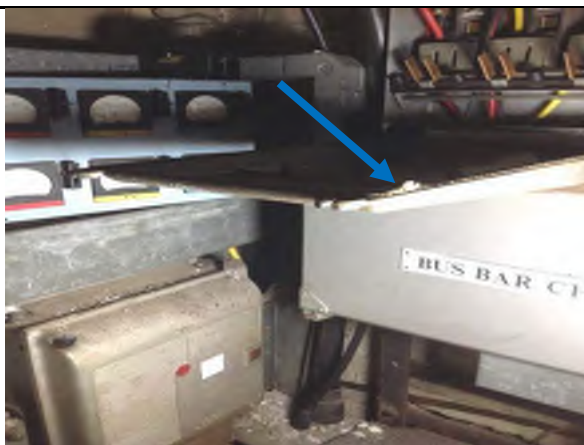
Building	Vezey-Strong wing
Floor	Basement
Room	342
Item Description	Rope seal to large fuse box
Material Type	Rope/String
Sample Number	Similar to 27092
Asbestos Type	Pr No Asbestos

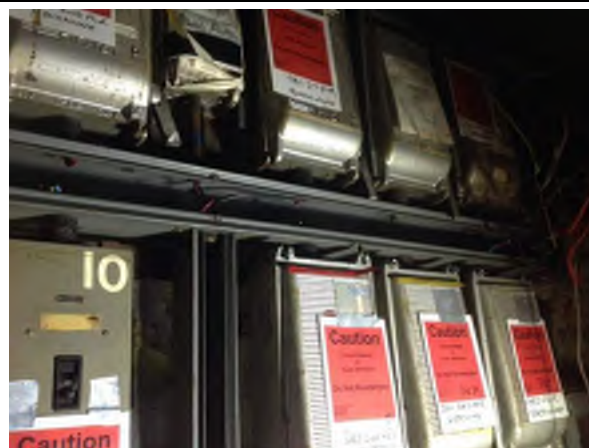
Building	Vezey-Strong wing
Floor	Basement
Room	342
Item Description	Rope seal to small fuse box
Material Type	Rope/String
Sample Number	Similar to 27094
Asbestos Type	Pr No Asbestos

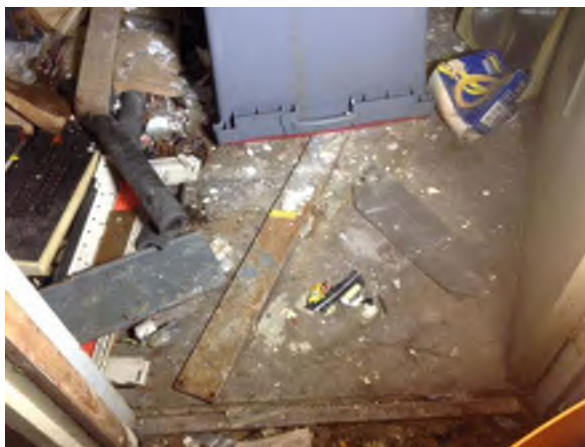
Building	Vezey-Strong wing
Floor	Basement
Room	343
Item Description	Lino to floor
Material Type	Floor Tile / Vinyl
Sample Number	Similar to 27090
Asbestos Type	Pr No Asbestos

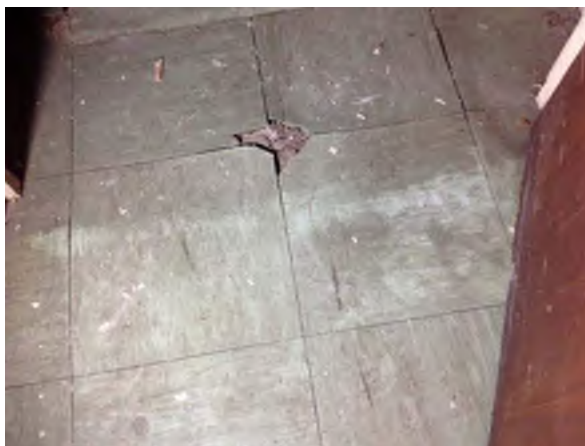
Building	Vezey-Strong wing
Floor	Ground
Room	246
Item Description	Green floor tile
Material Type	Floor Tile / Vinyl
Sample Number	27065
Asbestos Type	Asbestos Not Detected

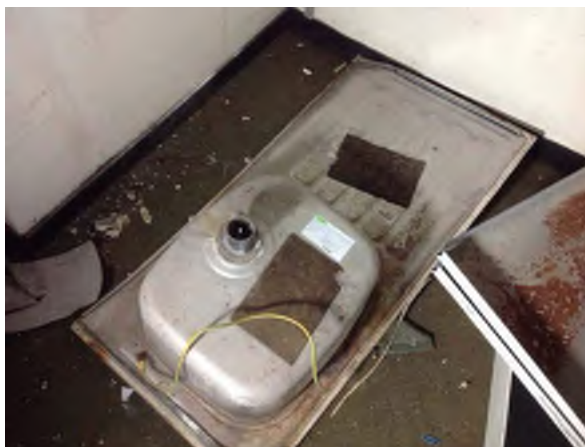
Building	Vezey-Strong wing
Floor	Ground
Room	253
Item Description	Sink pad
Material Type	Bitumen
Sample Number	27066
Asbestos Type	Asbestos Not Detected

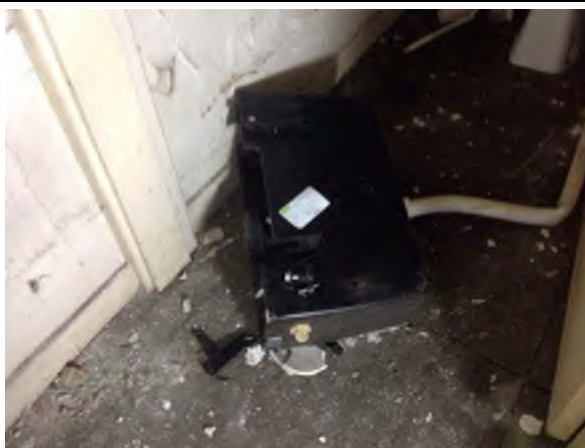
Building	Vezey-Strong wing
Floor	Ground
Room	261
Item Description	Toilet cistern
Material Type	Composite
Sample Number	27067
Asbestos Type	Asbestos Not Detected

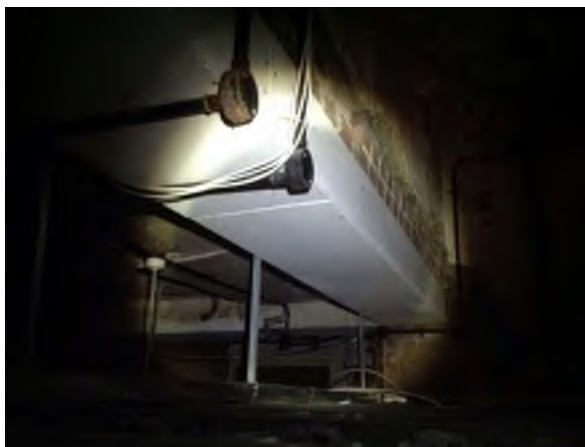
Building	Vezey-Strong wing
Floor	Ground
Room	264
Item Description	Insulation board to boxing
Material Type	Insulating Board
Sample Number	27069
Asbestos Type	Asbestos Not Detected

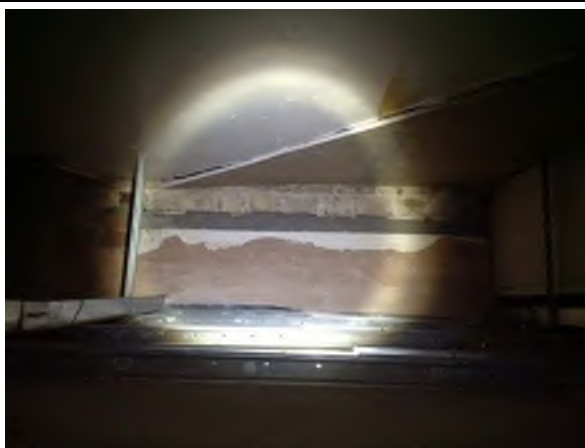
Building	Vezey-Strong wing
Floor	Ground
Room	266
Item Description	Insulation board to boxing
Material Type	Insulating Board
Sample Number	Similar to 27069
Asbestos Type	Pr No Asbestos

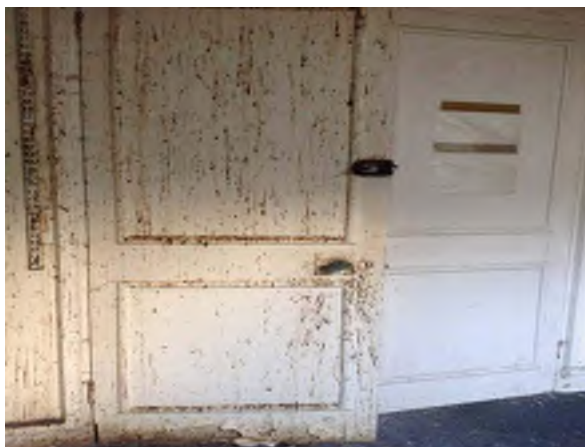
Building	Vezey-Strong wing
Floor	Ground
Room	273
Item Description	Panel to door
Material Type	Insulating Board
Sample Number	27072
Asbestos Type	Asbestos Not Detected

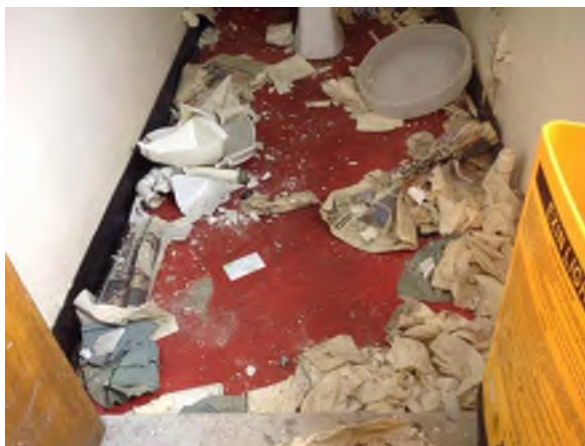
Building	Vezey-Strong wing
Floor	Ground
Room	281
Item Description	Vinyl flooring
Material Type	Floor Tile / Vinyl
Sample Number	27075
Asbestos Type	Asbestos Not Detected

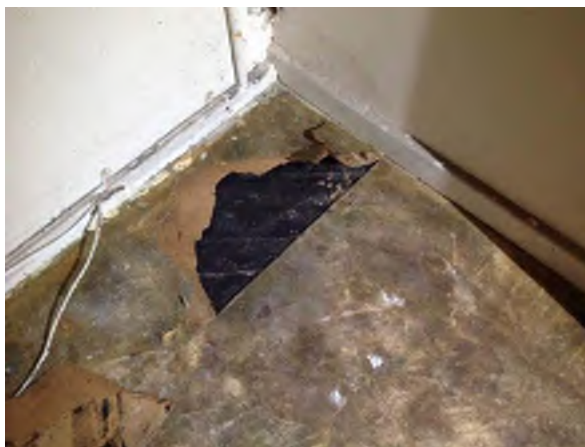
Building	Vezey-Strong wing
Floor	First
Room	119
Item Description	Bitumen to parquet floor
Material Type	Bitumen
Sample Number	Similar to 27050
Asbestos Type	Pr No Asbestos

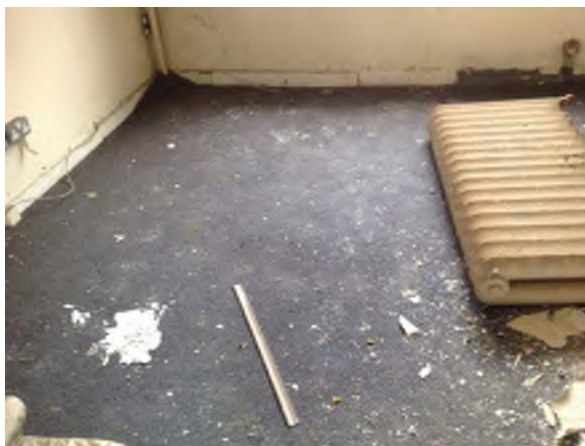
Building	Vezey-Strong wing
Floor	First
Room	120
Item Description	Bitumen to parquet floor
Material Type	Bitumen
Sample Number	Similar to 27050
Asbestos Type	Pr No Asbestos

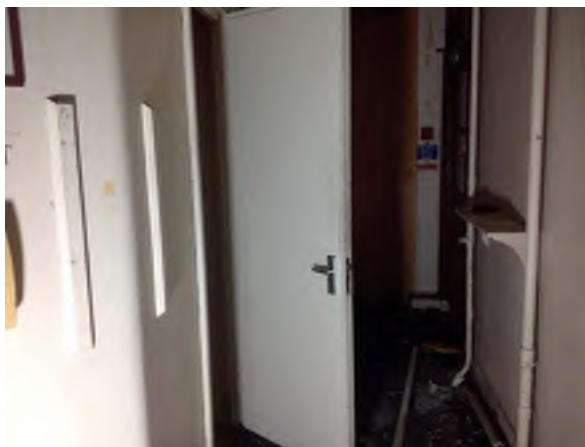
Building	Vezey-Strong wing
Floor	First
Room	
Item Description	Panel lining to door
Material Type	Insulating Board
Sample Number	Similar to 27059
Asbestos Type	Pr No Asbestos

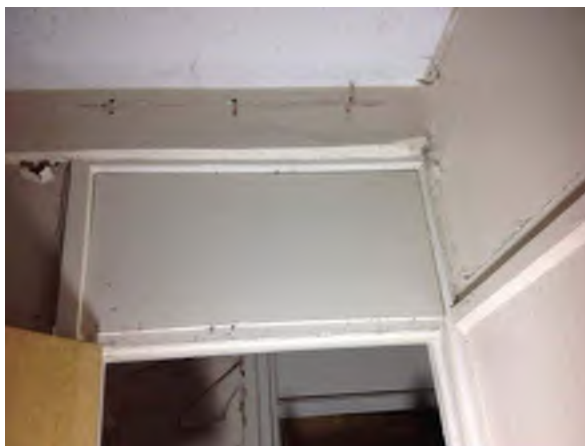
Building	Vezey-Strong wing
Floor	First
Room	173
Item Description	Interior door header
Material Type	Insulating Board
Sample Number	27055
Asbestos Type	Asbestos Not Detected

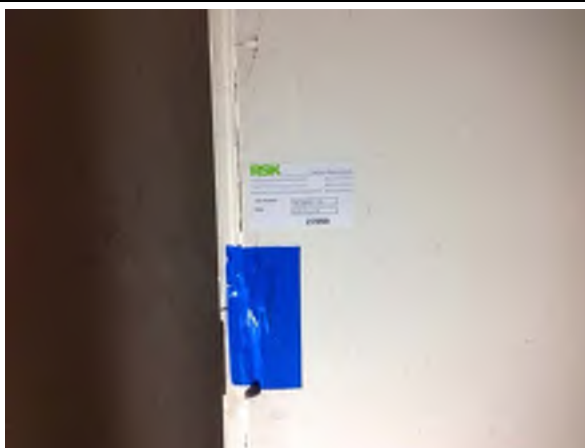
Building	Vezey-Strong wing
Floor	First
Room	174-181 & 183-189
Item Description	Interior door headers
Material Type	Insulating Board
Sample Number	Similar to 27055
Asbestos Type	Pr No Asbestos

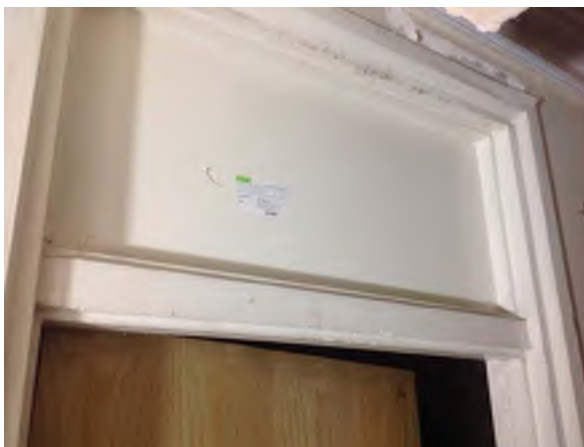
Building	Vezey-Strong wing
Floor	First
Room	180
Item Description	Panel lining to cupboard door
Material Type	Insulating Board
Sample Number	27059
Asbestos Type	Asbestos Not Detected

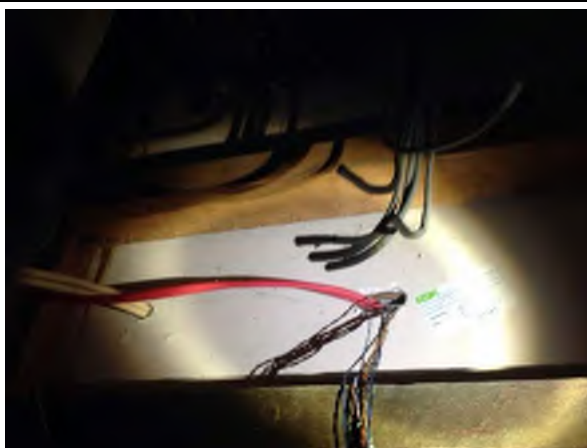
Building	Vezey-Strong wing
Floor	First
Room	157
Item Description	Insulation board
Material Type	Insulating Board
Sample Number	27046
Asbestos Type	Asbestos Not Detected

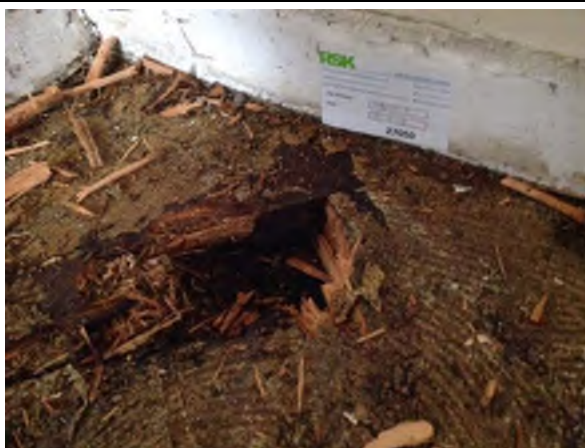
Building	Vezey-Strong wing
Floor	First
Room	163
Item Description	Bitumen to parquet floor
Material Type	Bitumen
Sample Number	Similar to 27050
Asbestos Type	Pr No Asbestos

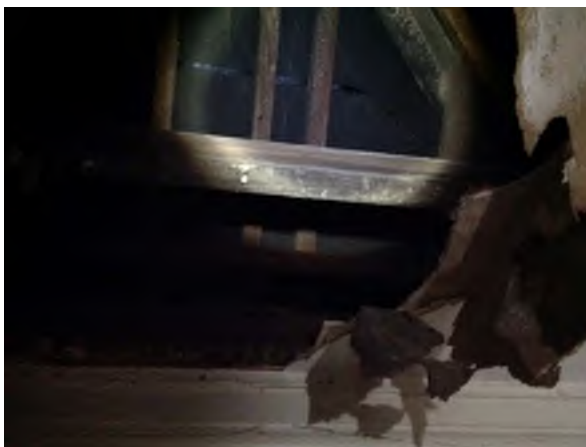
Building	Vezey-Strong wing
Floor	First
Room	164
Item Description	Bitumen to parquet floor
Material Type	Bitumen
Sample Number	27050
Asbestos Type	Asbestos Not Detected

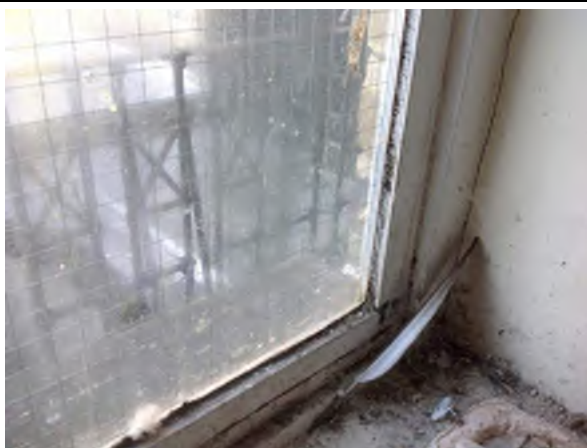
Building	Vezey-Strong wing
Floor	Second
Room	081
Item Description	Window putty
Material Type	Putty
Sample Number	25275
Asbestos Type	Asbestos Not Detected

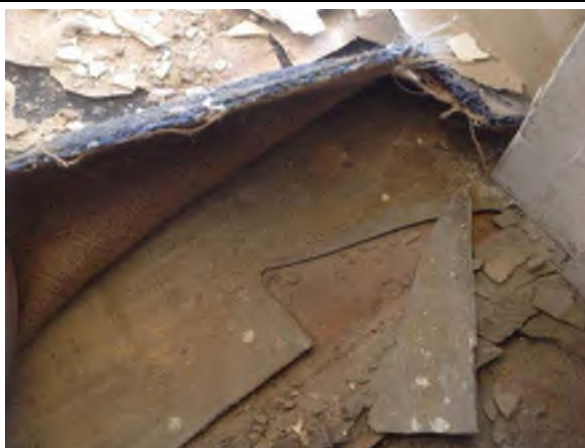
Building	Vezey-Strong wing
Floor	Second
Room	082
Item Description	Vinyl flooring beneath carpet
Material Type	Floor Tile / Vinyl
Sample Number	Similar to 25276
Asbestos Type	Pr No Asbestos

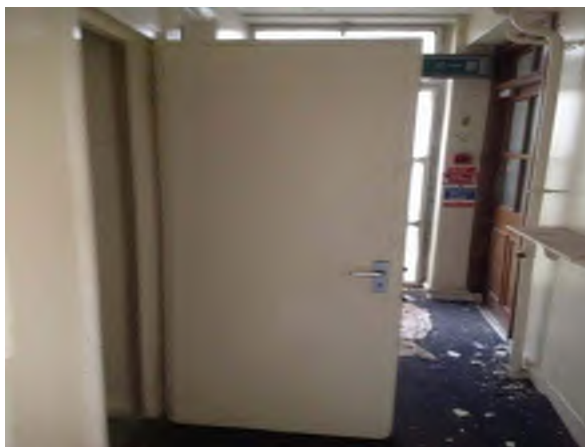
Building	Vezey-Strong wing
Floor	Second
Room	107
Item Description	Panel to rear of door
Material Type	Insulating Board
Sample Number	25282
Asbestos Type	Asbestos Not Detected

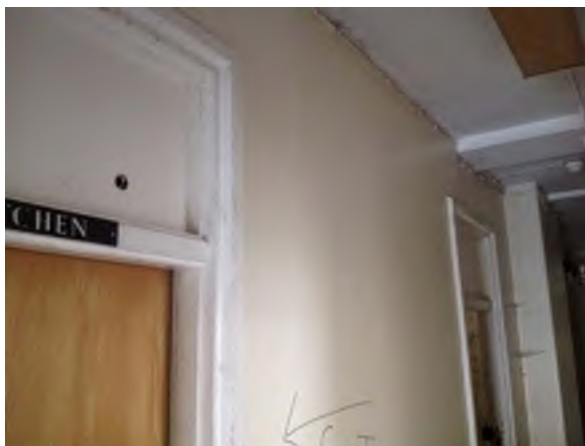
Building	Vezey-Strong wing
Floor	Second
Room	109
Item Description	Panel to rear of door
Material Type	Insulating Board
Sample Number	Similar to 25282
Asbestos Type	Pr No Asbestos

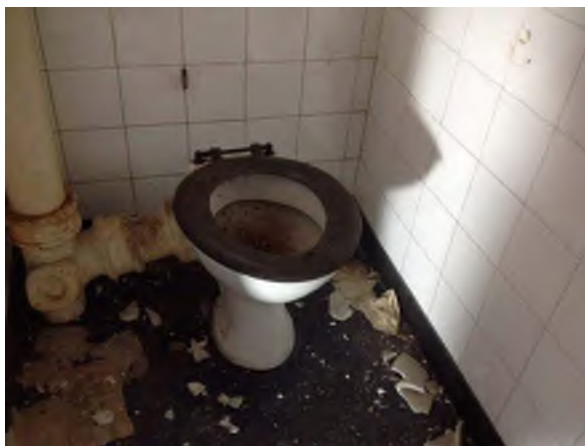
Building	Vezey-Strong wing
Floor	Second
Room	134
Item Description	Toilet seat
Material Type	Composite
Sample Number	Similar to 25262
Asbestos Type	Pr No Asbestos

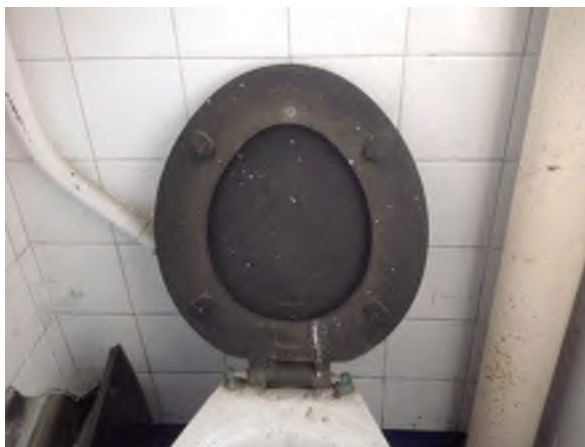
Building	Vezey-Strong wing
Floor	Second
Room	136
Item Description	Toilet seat
Material Type	Composite
Sample Number	Similar to 25262
Asbestos Type	Pr No Asbestos

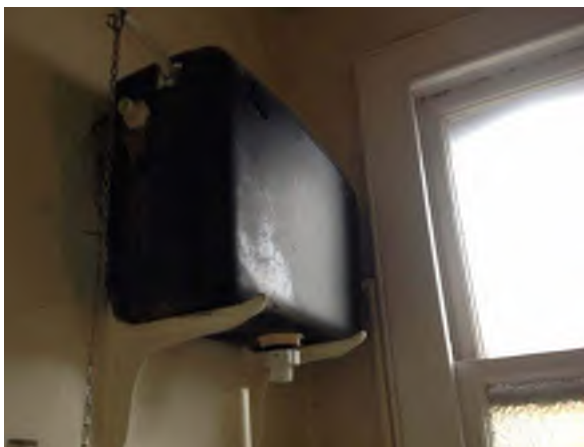
Building	Vases wing
Floor	Third
Room	002
Item Description	Black toilet cistern
Material Type	Composite
Sample Number	25229
Asbestos Type	Asbestos Not Detected

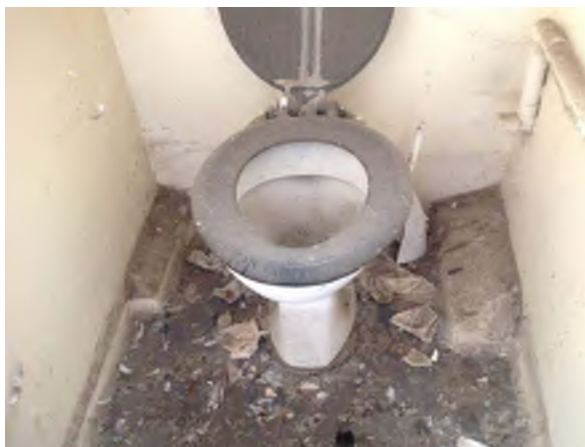
Building	Vezey-Strong wing
Floor	Third
Room	004
Item Description	Toilet seat
Material Type	Composite
Sample Number	Similar to 25243
Asbestos Type	Pr No Asbestos

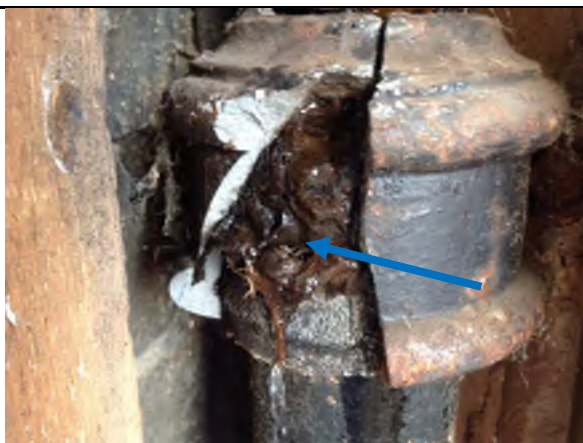
Building	Vezey-Strong wing
Floor	Third
Room	024
Item Description	Small Downpipe collar textile
Material Type	Textiles/Cloth
Sample Number	25244
Asbestos Type	Asbestos Not Detected

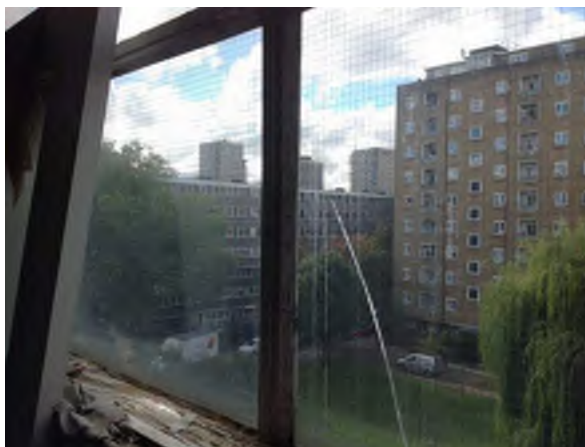
Building	Vezey-Strong wing
Floor	Third
Room	024
Item Description	Window putty
Material Type	Putty
Sample Number	25245
Asbestos Type	Asbestos Not Detected

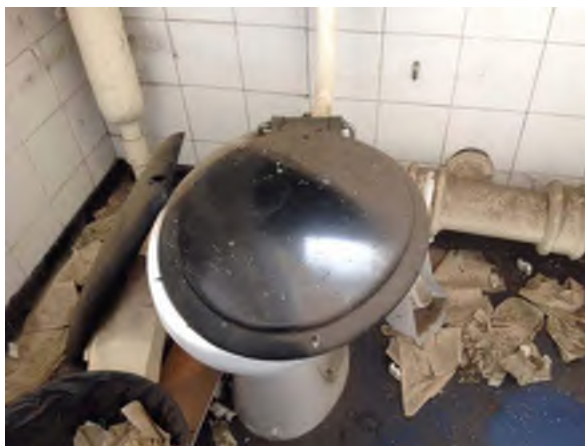
Building	Vezey-Strong wing
Floor	Third
Room	025
Item Description	Toilet seat
Material Type	Composite
Sample Number	Similar to 25243
Asbestos Type	Pr No Asbestos

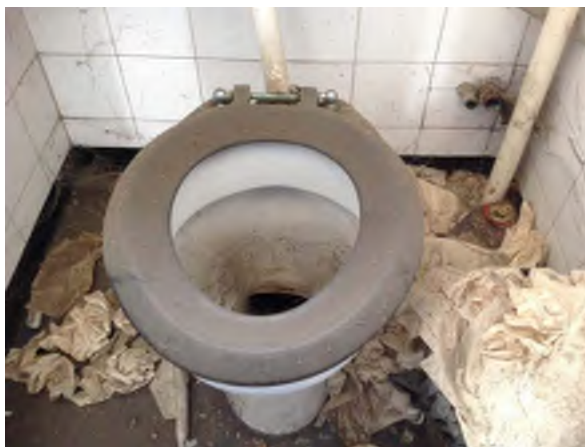
Building	Vezey-Strong wing
Floor	Third
Room	027
Item Description	Toilet seat
Material Type	Composite
Sample Number	25243
Asbestos Type	Asbestos Not Detected

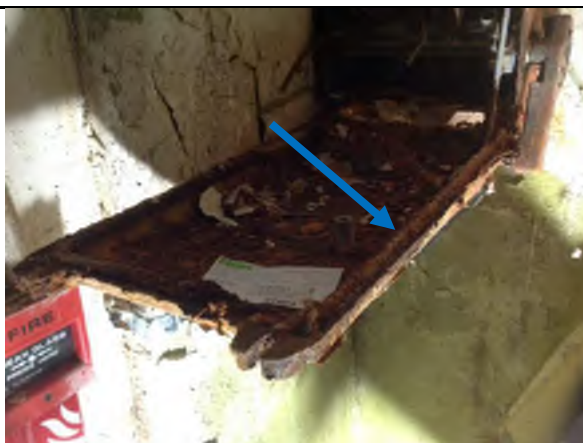
Building	Vezey-Strong wing
Floor	Basement
Room	314
Item Description	Rope seal to fuse box
Material Type	Rope/String
Sample Number	27084
Asbestos Type	Asbestos Not Detected

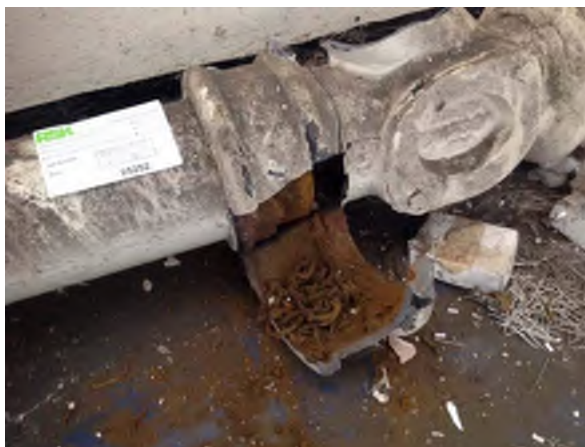
Building	Vezey-Strong wing
Floor	Third
Room	026
Item Description	Large pipe collar textile
Material Type	Textiles/Cloth
Sample Number	25252
Asbestos Type	Asbestos Not Detected

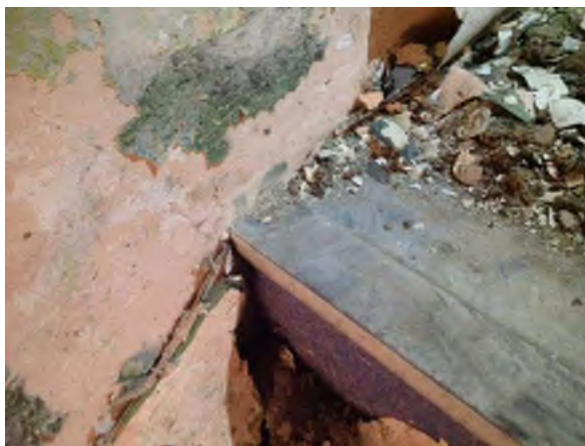
Building	Vezey-Strong wing
Floor	Third
Room	036
Item Description	Stair nosing
Material Type	Composite
Sample Number	25253
Asbestos Type	Asbestos Not Detected

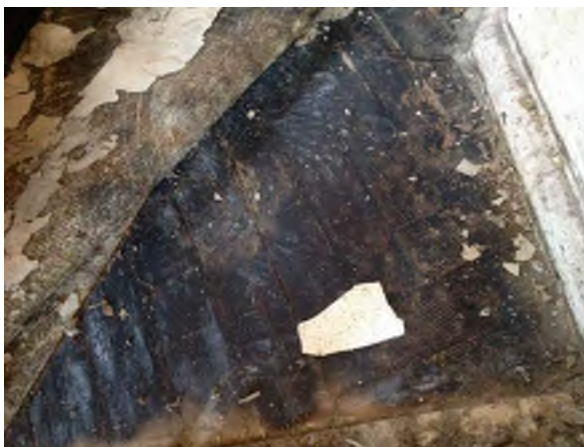
Building	Vezey-Strong wing
Floor	Third
Room	037
Item Description	Bitumen to parquet floor
Material Type	Bitumen
Sample Number	Similar to 25255
Asbestos Type	Pr No Asbestos

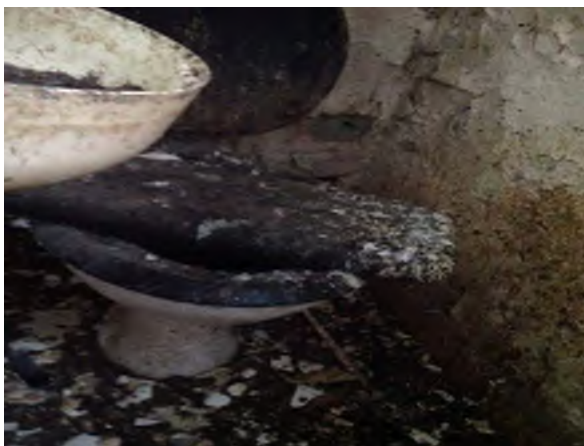
Building	Vezey-Strong wing
Floor	Third
Room	038
Item Description	Toilet seat
Material Type	Composite
Sample Number	Similar to 25243
Asbestos Type	Pr No Asbestos

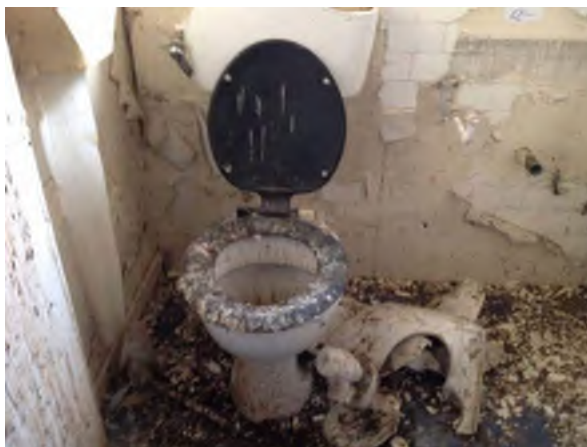
Building	Vezey-Strong wing
Floor	Third
Room	039
Item Description	Toilet seat
Material Type	Composite
Sample Number	Similar to 25243
Asbestos Type	Pr No Asbestos

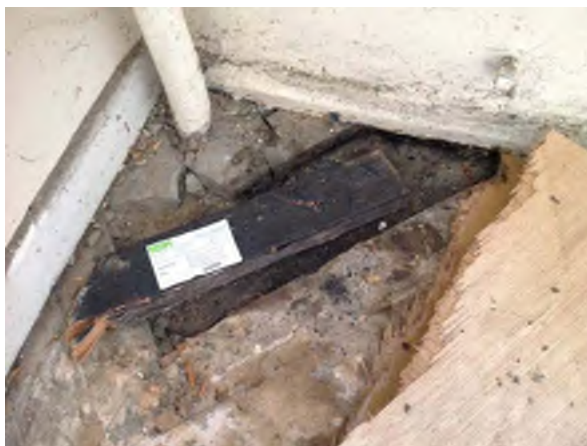
Building	Vezey-Strong wing
Floor	Third
Room	040
Item Description	Bitumen to parquet floor
Material Type	Bitumen
Sample Number	25255
Asbestos Type	Asbestos Not Detected

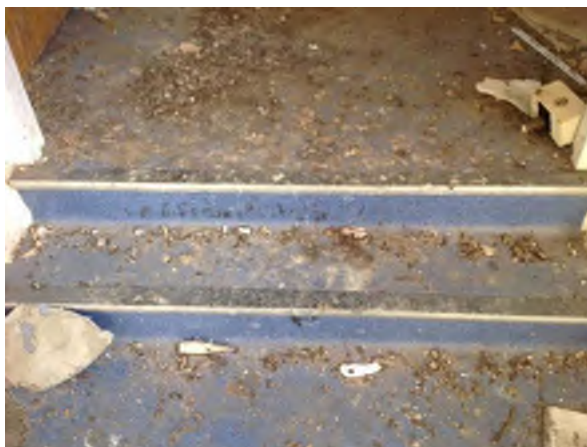
Building	Vezey-Strong wing
Floor	Third
Room	041
Item Description	Stair nosing
Material Type	Composite
Sample Number	Similar to 25253
Asbestos Type	Pr No Asbestos

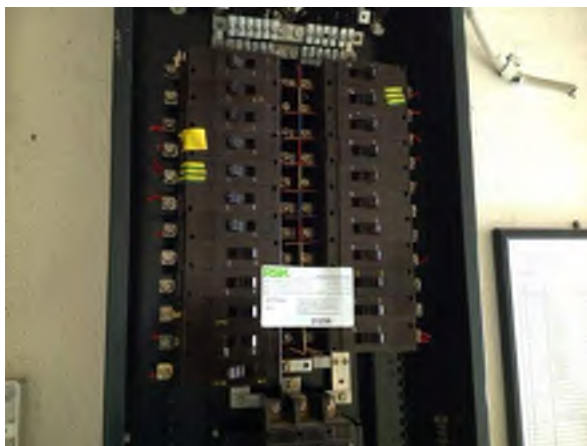
Building	Vezey-Strong wing
Floor	Third
Room	042
Item Description	Switch and baffle plate
Material Type	Composite
Sample Number	25256
Asbestos Type	Asbestos Not Detected

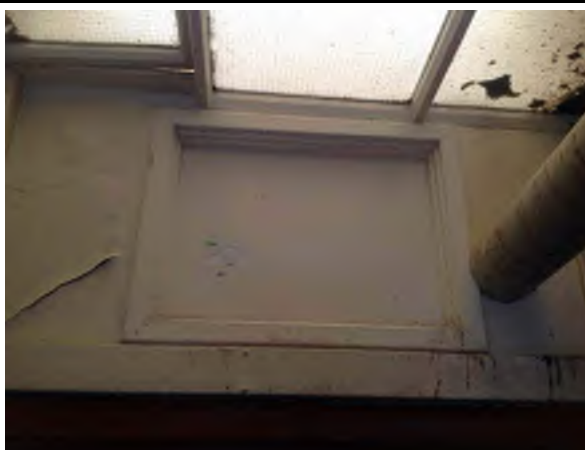
Building	Vezey-Strong wing
Floor	Third
Room	042
Item Description	Insulation board above door
Material Type	Insulating Board
Sample Number	25257
Asbestos Type	Asbestos Not Detected

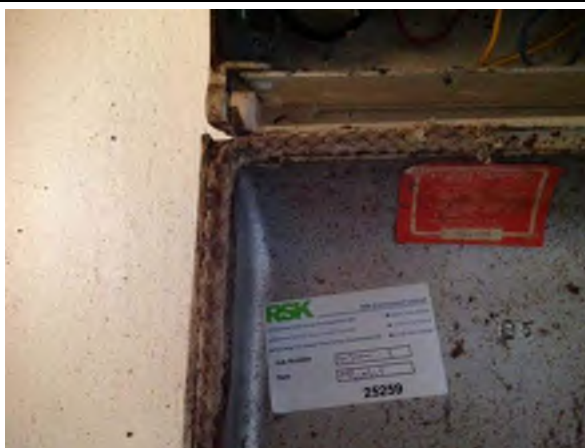
Building	Vezey-Strong wing
Floor	Third
Room	049
Item Description	Textile gasket to fuse board
Material Type	Rope/String
Sample Number	25259
Asbestos Type	Asbestos Not Detected

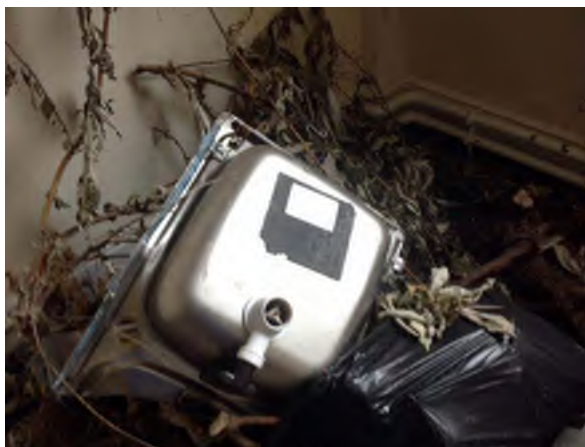
Building	Vezey-Strong wing
Floor	Third
Room	061
Item Description	Sink pad
Material Type	Bitumen
Sample Number	25261
Asbestos Type	Asbestos Not Detected

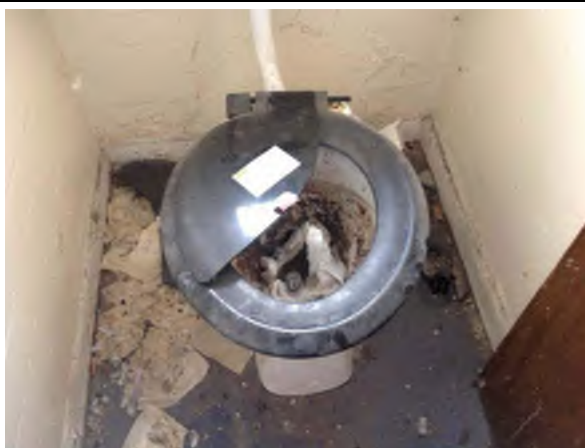
Building	Vezey-Strong wing
Floor	Third
Room	071
Item Description	Toilet seat
Material Type	Composite
Sample Number	25262
Asbestos Type	Asbestos Not Detected

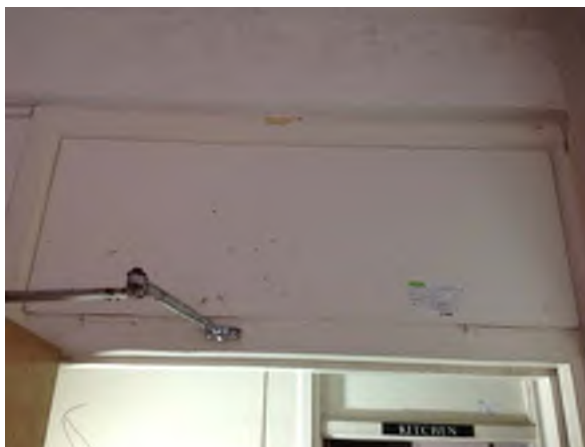
Building	Vezey-Strong wing
Floor	2 nd floor Mezzanine
Room	210
Item Description	Interior door header
Material Type	Insulating Board
Sample Number	27060
Asbestos Type	Asbestos Not Detected

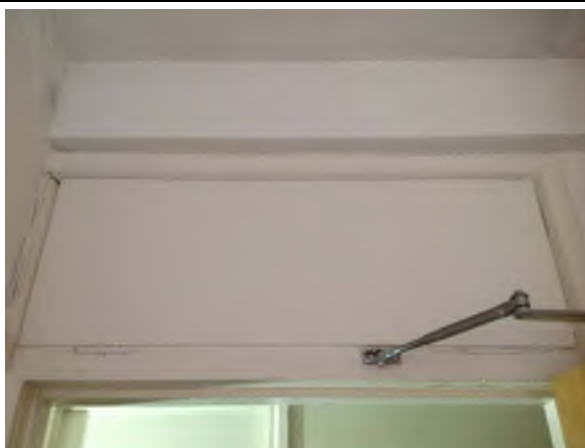
Building	Vezey-Strong wing
Floor	2 nd floor Mezzanine
Room	211-216, 218, 220-226
Item Description	Interior door header
Material Type	Insulating Board
Sample Number	Similar to 27060
Asbestos Type	Pr No Asbestos

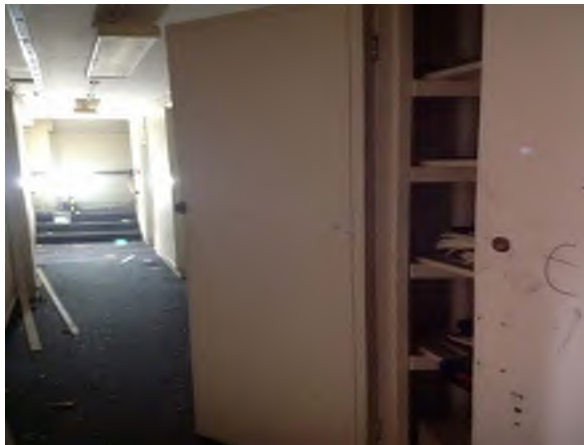
Building	Vezey-Strong wing
Floor	2 nd floor Mezzanine
Room	217
Item Description	Panel to door
Material Type	Insulating Board
Sample Number	27062
Asbestos Type	Asbestos Not Detected

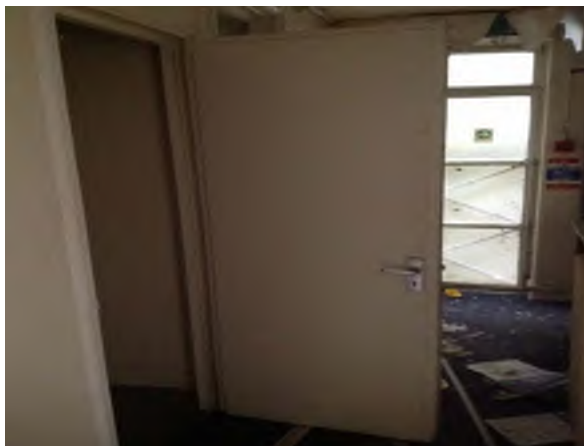
Building	Vezey-Strong wing
Floor	2 nd floor Mezzanine
Room	218
Item Description	Panel to door
Material Type	Insulating Board
Sample Number	Similar to 27062
Asbestos Type	Pr No Asbestos

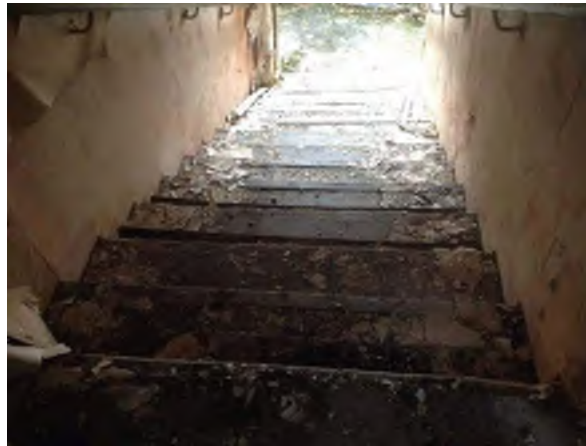
Building	Vezey-Strong wing
Floor	Stairwell
Room	Stairwell 1
Item Description	Stair nosing
Material Type	Composite
Sample Number	Similar to 25253
Asbestos Type	Pr No Asbestos

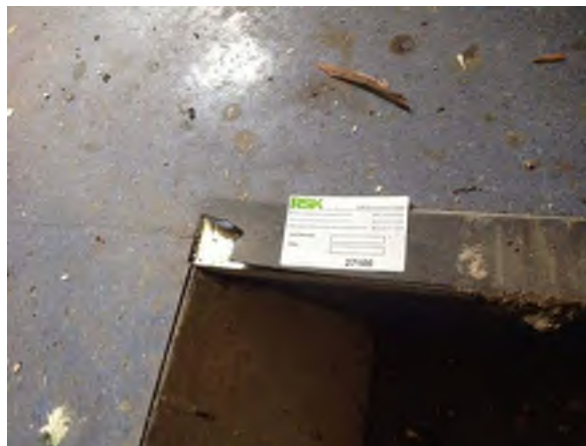
Building	Vezey-Strong wing
Floor	Stairwell
Room	Stairwell 2
Item Description	Stair nosing
Material Type	Composite
Sample Number	27100
Asbestos Type	Asbestos Not Detected

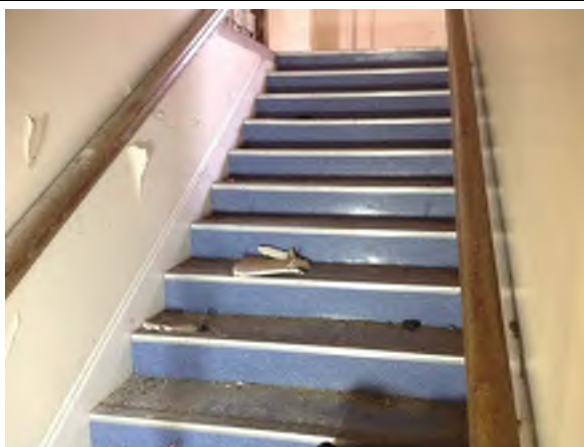
Building	Vezey-Strong wing
Floor	Stairwell
Room	Stairwell 2 between floors 1 and 2
Item Description	Stair nosing
Material Type	Composite
Sample Number	Similar to 27100
Asbestos Type	Pr No Asbestos

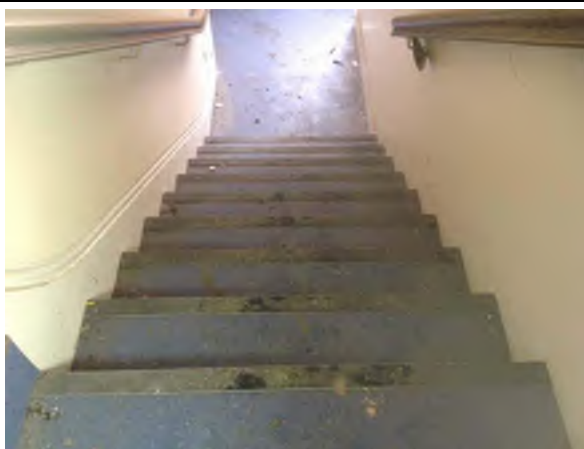
Building	Vezey-Strong wing
Floor	Stairwell
Room	Stairwell 2 between floors 2 and 3
Item Description	Stair nosing
Material Type	Composite
Sample Number	Similar to 27100
Asbestos Type	Pr No Asbestos
