9.1 Demolition Asbestos Survey, Vezey Wing (2015)

Demolition Asbestos Survey

National Temperance Hospital (Vezey-Strong Wing)
London NW1

RSK Report Number: 415000-2 (00)

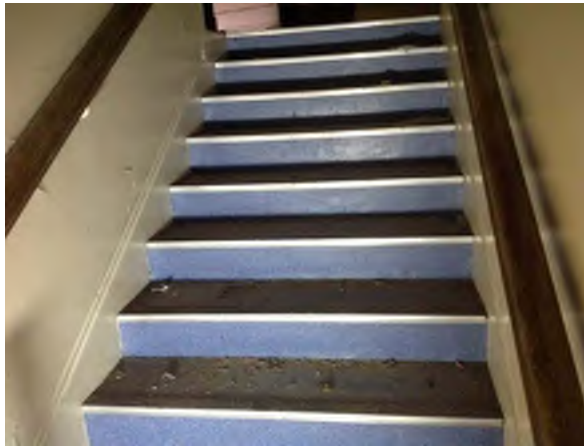
Building	Vezey-Strong wing
Floor	Stairwell
Room	Stairwell 2 between floors G and 1
Item Description	Stair nosing
Material Type	Composite
Sample Number	Similar to 27100
Asbestos Type	Pr No Asbestos

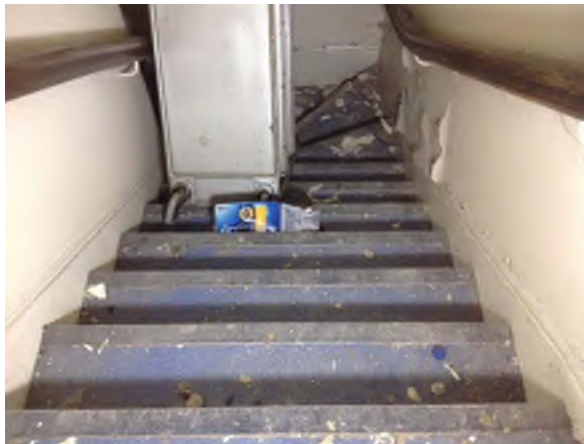
Building	Vezey-Strong wing
Floor	Stairwell
Room	Stairwell 2 between G and B floors
Item Description	Stair nosing
Material Type	Composite
Sample Number	Similar to 27100
Asbestos Type	Pr No Asbestos

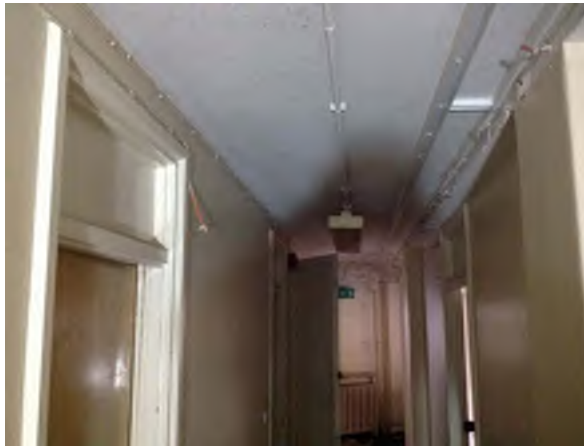
Building	Vezey-Strong wing
Floor	2 nd floor Mezzanine
Room	Throughout 209
Item Description	Corridor door header
Material Type	Insulating Board
Sample Number	Similar to 27061
Asbestos Type	Pr No Asbestos

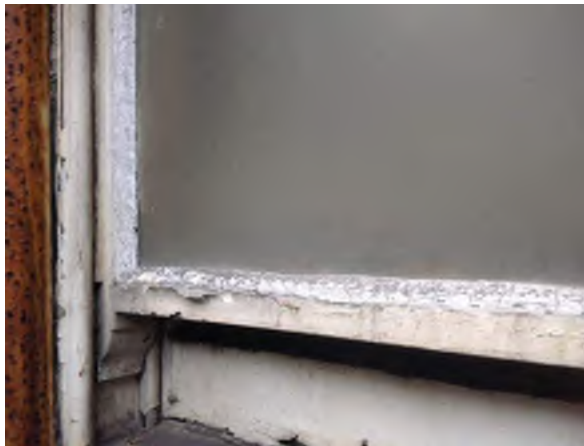
Building	Vezey-Strong wing
Floor	External
Room	Exterior
Item Description	Window putty
Material Type	Putty
Sample Number	27104
Asbestos Type	Asbestos Not Detected

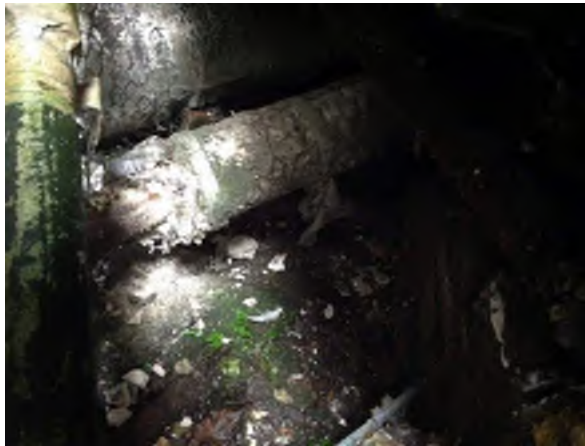
Building	Vezey-Strong wing
Floor	External
Room	Exterior
Item Description	Pipe insulation
Material Type	Thermal Insulation/Lagging
Sample Number	27106
Asbestos Type	Asbestos Not Detected

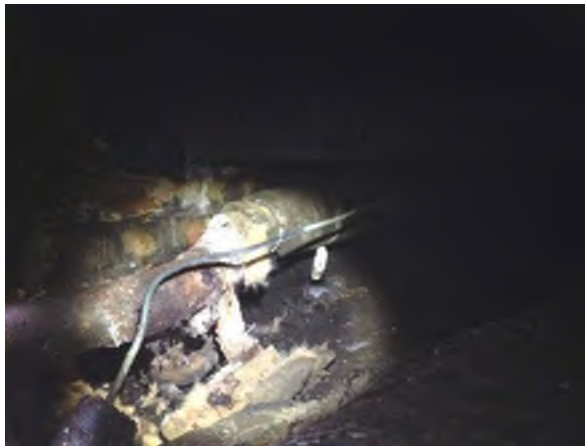
Building	Vezey-Strong wing
Floor	External
Room	Exterior
Item Description	Pipe insulation
Material Type	Thermal Insulation/Lagging
Sample Number	27107
Asbestos Type	Asbestos Not Detected

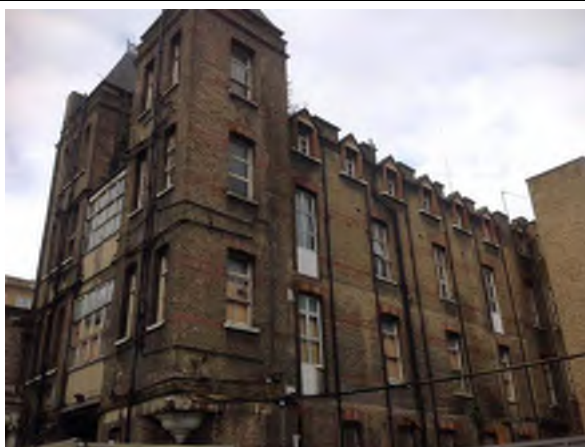
Building	Vezey-Strong wing
Floor	External
Room	Exterior
Item Description	Window putty
Material Type	Putty
Sample Number	Similar to 27104
Asbestos Type	Pr No Asbestos

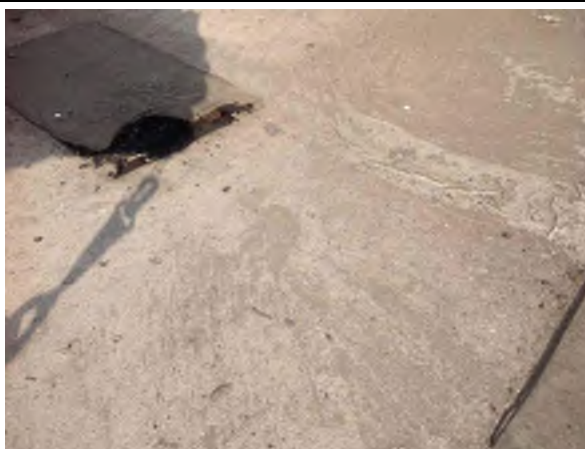
Building	Vezey-Strong wing
Floor	External
Room	Roof
Item Description	Asphalt roof
Material Type	Bitumen
Sample Number	25271
Asbestos Type	Asbestos Not Detected

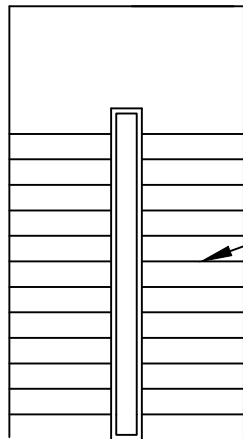
STAIRWELL 1

SIMILAR TO 25253
STAIR NOSING
PRESUMED NON ASBESTOS
(THROUGHOUT ENTIRE STAIRWELL)

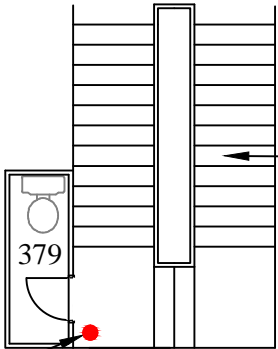
BETWEEN FLOORS
1 & 2

SIMILAR TO 27100
STAIR NOSING
(THROUGHOUT)
PRESUMED NON ASBESTOS

SIMILAR TO 25260
PIPE INSULATION
STRONGLY PRESUMED CHRYSOTILE

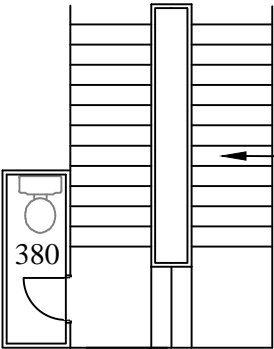
BETWEEN FLOORS
GROUND & 1

SIMILAR TO 27100
STAIR NOSING
(THROUGHOUT)
PRESUMED NON ASBESTOS

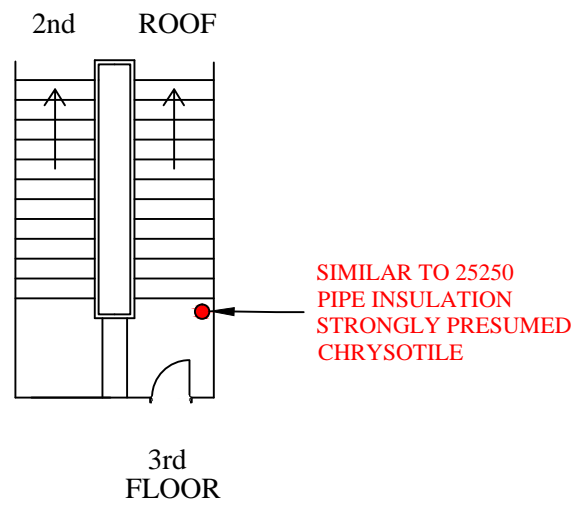
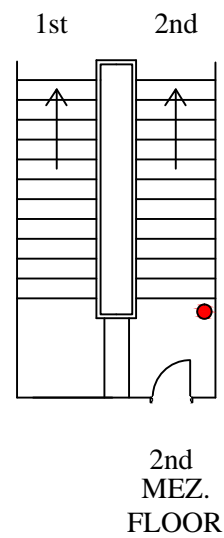
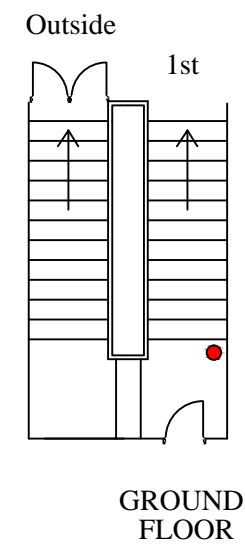
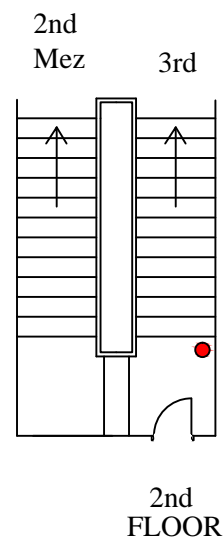
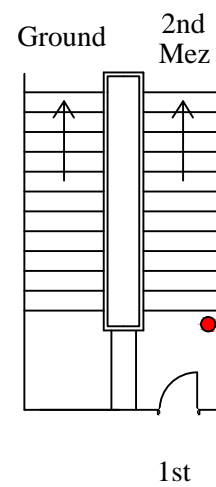
STAIRWELL 3

● SIMILAR TO 25250
PIPE INSULATION
STRONGLY PRESUMED
CHRYSOTILE
