Demolition Asbestos Survey

National Temperance Hospital
Insull Wing

RSK Report Number: 415000-1(00)

16 March 2015

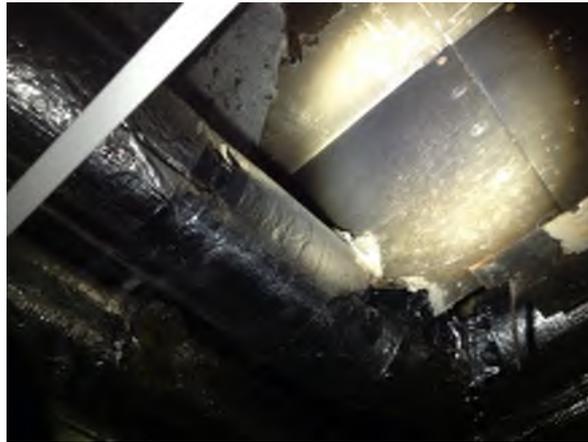
Building	Insull wing
Floor	Basement
Room	015
Item Description	Lagging to pipes and hangers
Material Type	Thermal Insulation/Lagging
Sample Number	21752
Asbestos Type	Chrysotile

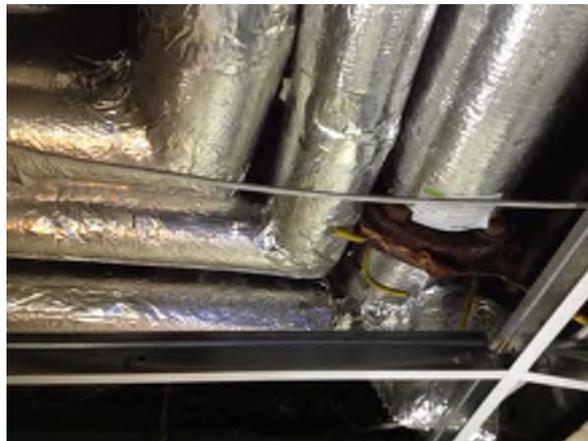
Building	Insull wing
Floor	Basement
Room	015
Item Description	Pipe gasket
Material Type	Gaskets/Washers
Sample Number	21755
Asbestos Type	Chrysotile

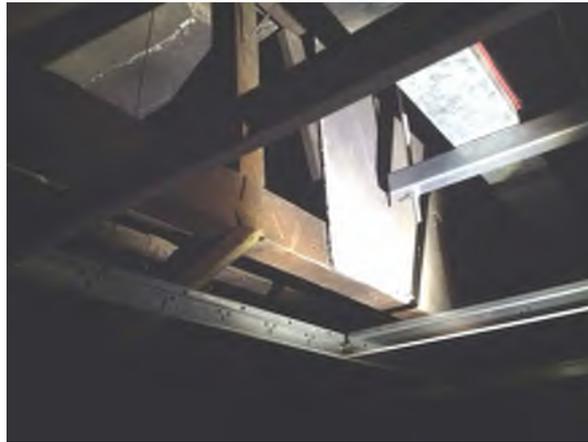
Building	Insull wing
Floor	Basement
Room	016
Item Description	Cement panel above ceiling
Material Type	Cement
Sample Number	21756
Asbestos Type	Chrysotile / Crocidolite

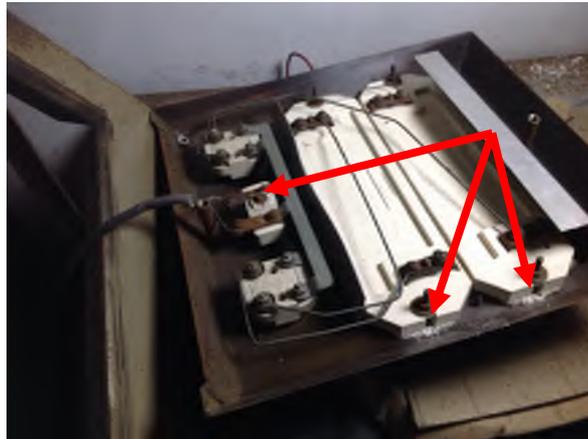
Building	Insull wing
Floor	Basement
Room	019
Item Description	Gasket to electric heater
Material Type	Paper
Sample Number	21757
Asbestos Type	Chrysotile

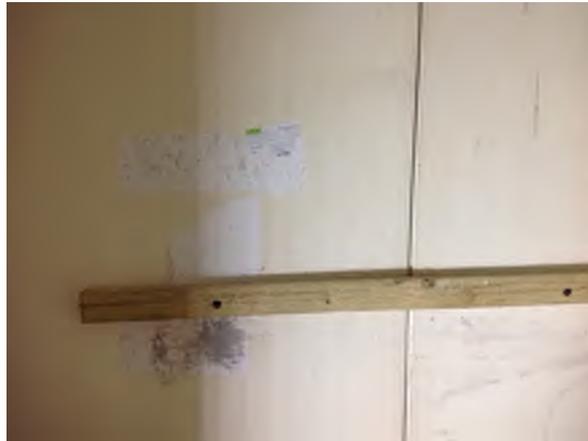
Building	Insull wing
Floor	Basement
Room	022
Item Description	Panels to double doors
Material Type	Insulating Board
Sample Number	21760
Asbestos Type	Chrysotile / Amosite

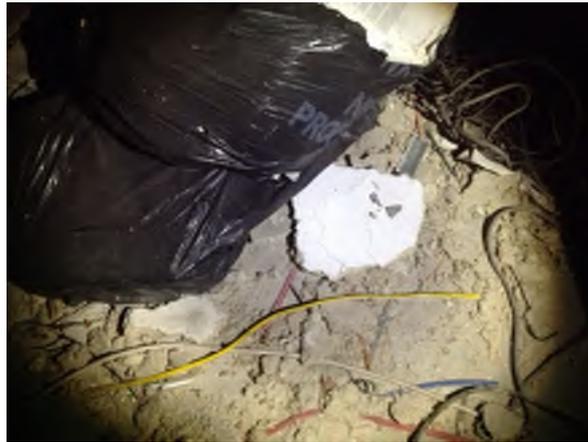
Building	Insull wing
Floor	Second
Room	016
Item Description	Cement panel debris on floor
Material Type	Cement
Sample Number	Similar to 21756
Asbestos Type	Chrysotile / Crocidolite

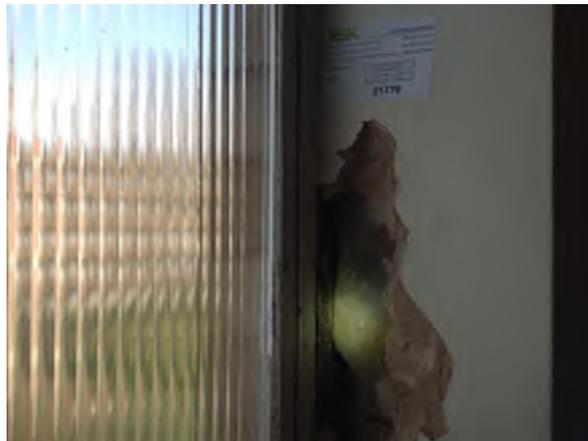
Building	Insull Wing
Floor	Second
Room	092
Item Description	Bitumen lining to window in wall cavity
Material Type	Bitumen
Sample Number	21776
Asbestos Type	Chrysotile

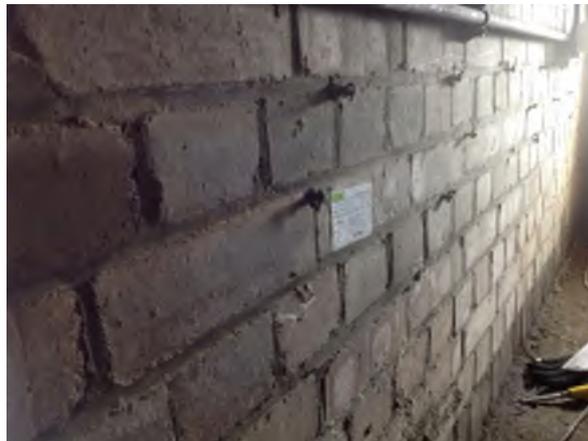
Building	Insull Wing
Floor	Basement
Room	Underground duct
Item Description	Wall residue
Material Type	Dust/Debris
Sample Number	21768
Asbestos Type	Chrysotile

Access to the duct tunnel should be prohibited until the duct has been fully environmentally cleaned by a licensed asbestos removal contractor (see recommendations for further details)

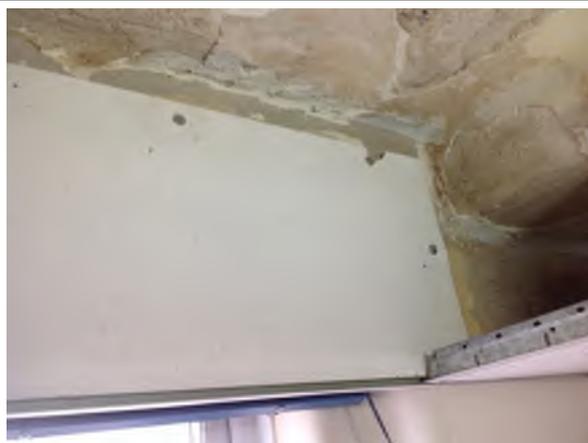
Building	Insull wing
Floor	Fifth
Room	146
Item Description	Upstand above false ceiling
Material Type	Insulation Board
Sample Number	Similar to 21785
Asbestos Type	Pr No Asbestos

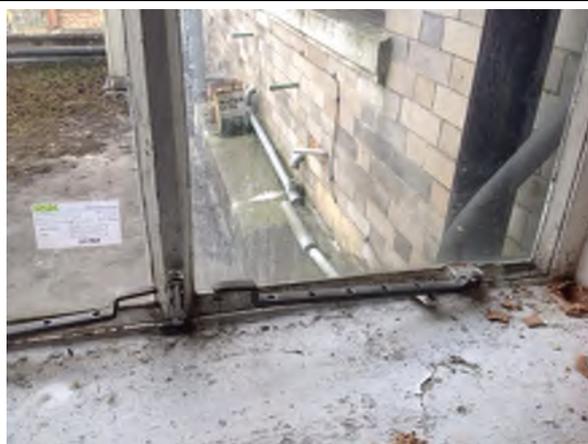
Building	Insull wing
Floor	Fifth
Room	147
Item Description	Wide section putty to metal window
Material Type	Composite
Sample Number	21784
Asbestos Type	Asbestos Not Detected

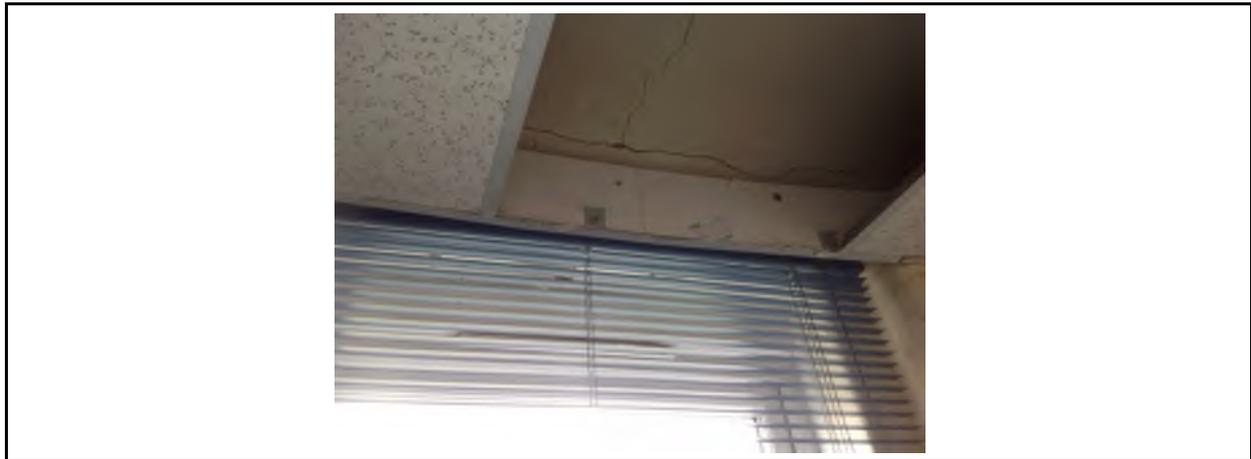
Building	Insull wing
Floor	Fifth
Room	158
Item Description	Upstand above false ceiling
Material Type	Insulation Board
Sample Number	21785
Asbestos Type	Asbestos Not Detected

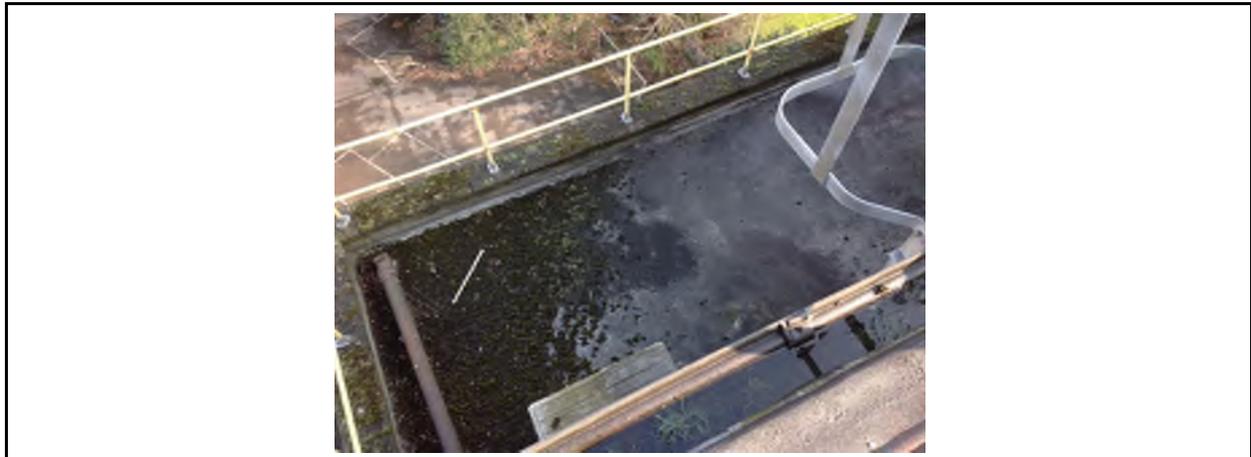
Building	Insull wing
Floor	Fifth
Room	Balcony 1
Item Description	Asphalt roof
Material Type	Composite
Sample Number	Similar to 21788
Asbestos Type	Pr No Asbestos

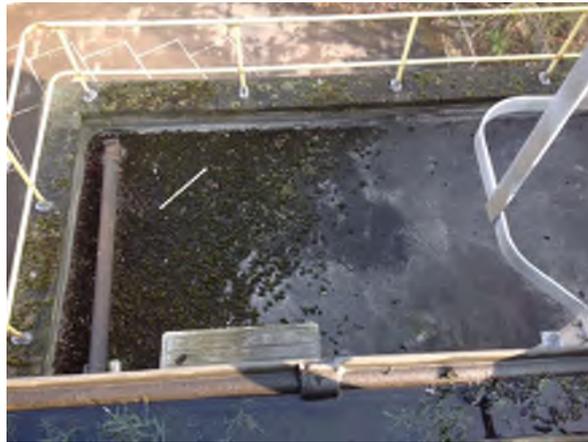
Building	Insull wing
Floor	Fifth
Room	Balcony 1
Item Description	Bitumen lining below asphalt roof
Material Type	Bitumen
Sample Number	Similar to 21789
Asbestos Type	Pr No Asbestos

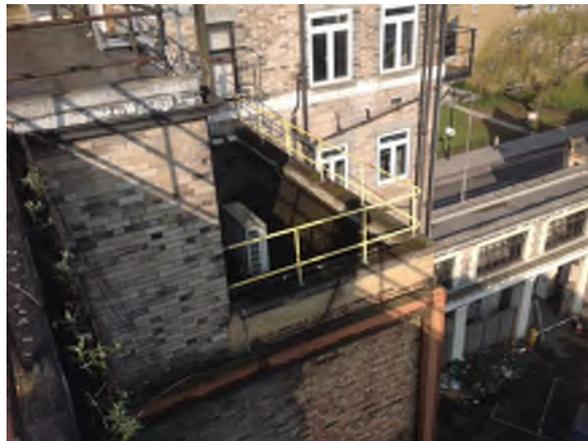
Building	Insull wing
Floor	Fifth
Room	Balcony 2
Item Description	Asphalt roof
Material Type	Composite
Sample Number	Similar to 21788
Asbestos Type	Pr No Asbestos

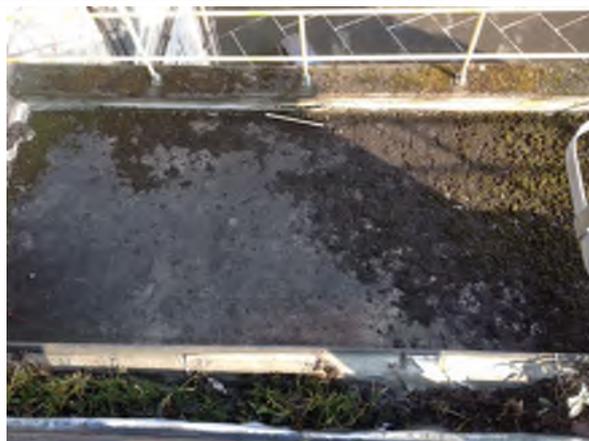
Building	Insull wing
Floor	Fifth
Room	Balcony 2
Item Description	Bitumen lining below asphalt roof
Material Type	Bitumen
Sample Number	Similar to 21789
Asbestos Type	Pr No Asbestos

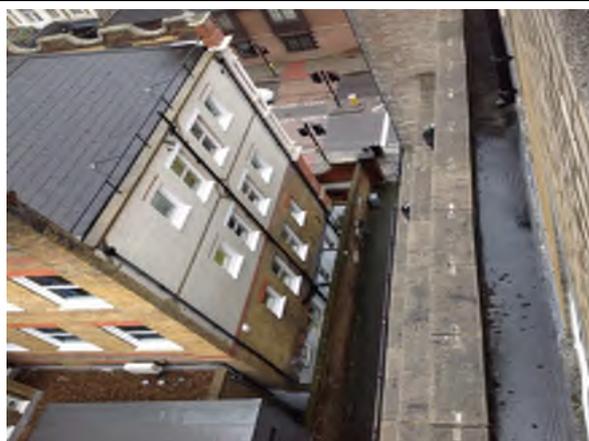
Building	Insull wing
Floor	Fifth
Room	External walkway (see plan)
Item Description	Bitumen floor to external walkway
Material Type	Bitumen
Sample Number	21798
Asbestos Type	Asbestos Not Detected

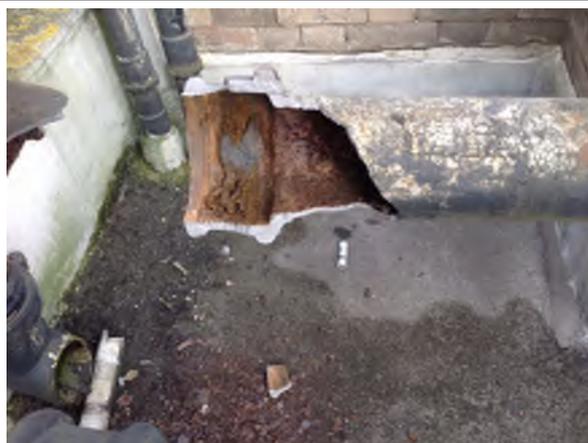
Building	Insull wing
Floor	Roof
Room	External flat roof
Item Description	Textile lining to metal pipe collar
Material Type	Textiles/Cloth
Sample Number	21791
Asbestos Type	Asbestos Not Detected

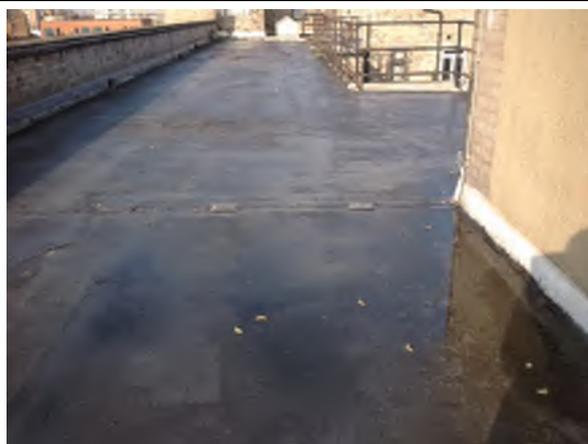
Building	Insull wing
Floor	Roof
Room	Flat roof
Item Description	Asphalt roof
Material Type	Composite
Sample Number	21788
Asbestos Type	Asbestos Not Detected

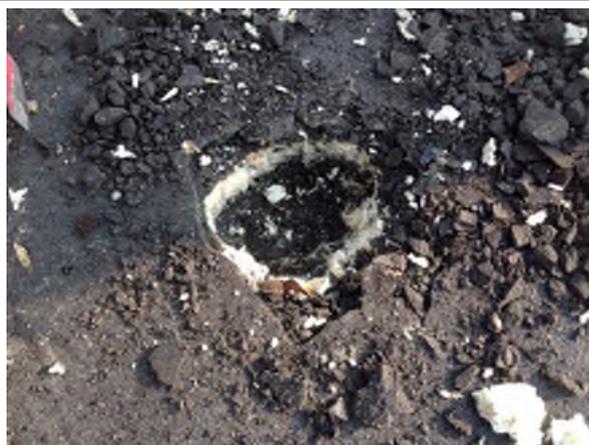
Building	Insull wing
Floor	Roof
Room	Flat roof
Item Description	Bitumen lining below asphalt roof
Material Type	Bitumen
Sample Number	21789
Asbestos Type	Asbestos Not Detected

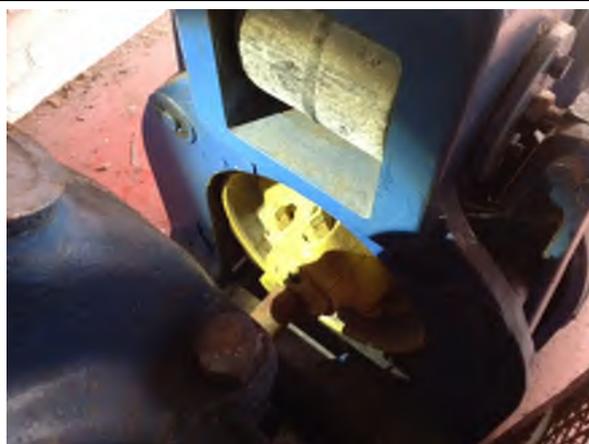
Building	Insull wing
Floor	Roof
Room	Lift machinery room
Item Description	Brake pad
Material Type	Textiles/Cloth
Sample Number	21793
Asbestos Type	Asbestos Not Detected

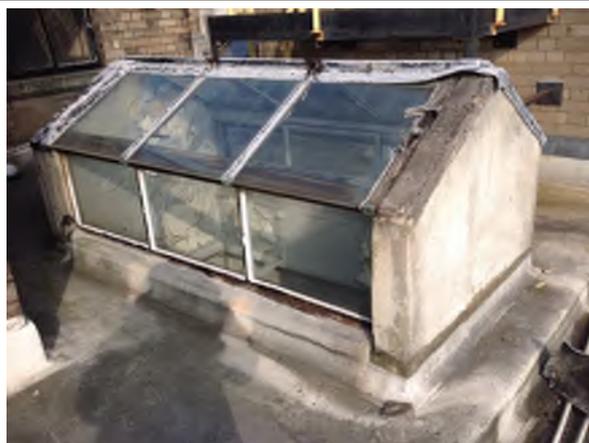
Building	Insull wing
Floor	Roof
Room	Roof
Item Description	Thick window putty to skylights
Material Type	Putty
Sample Number	Similar to 21787
Asbestos Type	Pr No Asbestos

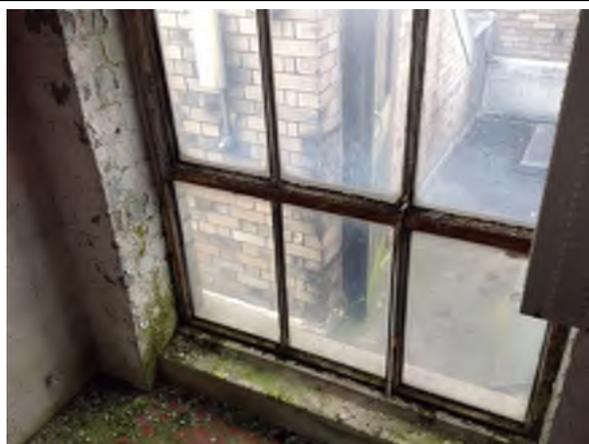
Building	Insull wing
Floor	Roof
Room	Roof lift machinery room
Item Description	Thick window putty
Material Type	Putty
Sample Number	Similar to 21787
Asbestos Type	Pr No Asbestos

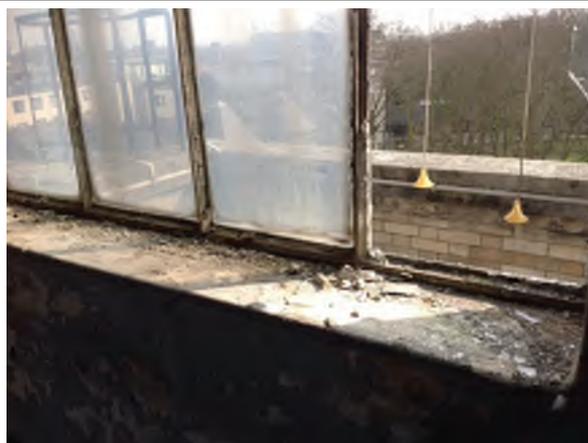
Building	Insull wing
Floor	Roof
Room	Roof plant room
Item Description	Thick window putty
Material Type	Putty
Sample Number	Similar to 21787
Asbestos Type	Pr No Asbestos

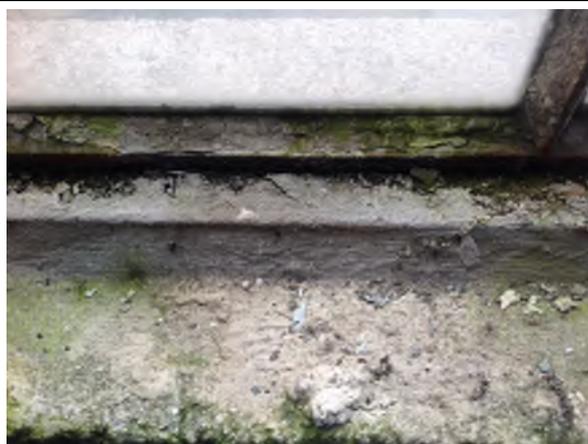
Building	Insull wing
Floor	Roof
Room	Tank room
Item Description	Thick window putty
Material Type	Putty
Sample Number	Similar to 21787
Asbestos Type	Pr No Asbestos

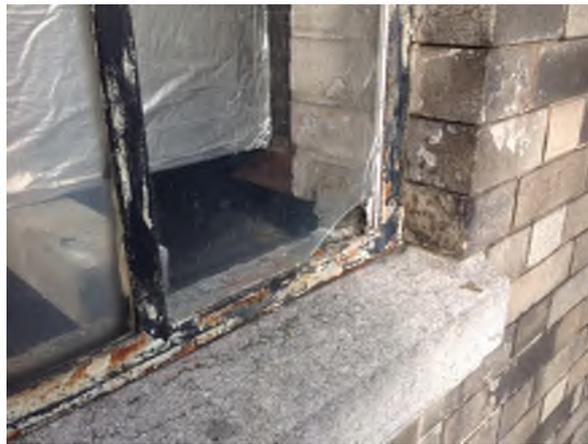
Building	Insull wing
Floor	Roof
Room	Tank room, lift machinery room and plant room
Item Description	Thin window putty
Material Type	Putty
Sample Number	21790
Asbestos Type	Asbestos Not Detected

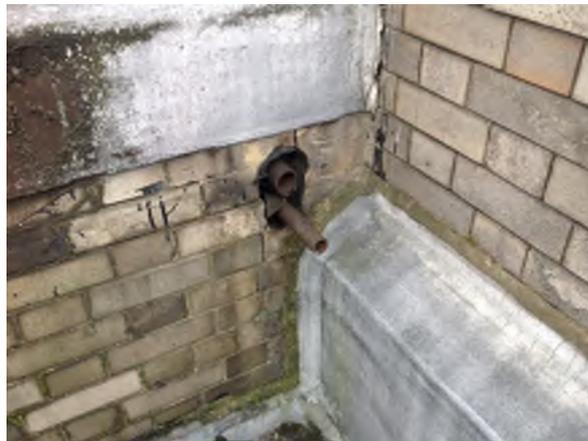
Building	Insull wing
Floor	Roof
Room	Wall to stairwell 2
Item Description	Bitumen lining where pipe enters wall
Material Type	Bitumen
Sample Number	21792
Asbestos Type	Asbestos Not Detected

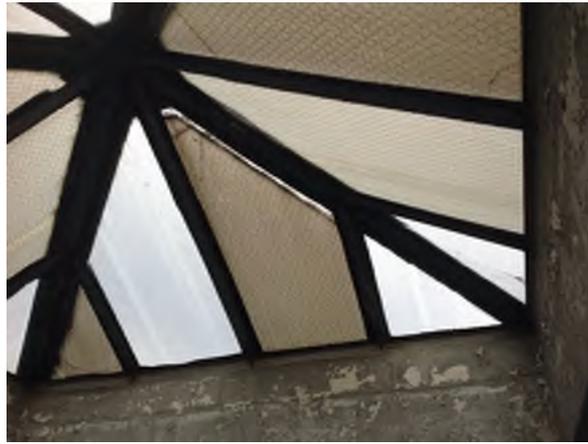
Building	Insull wing
Floor	Other
Room	Roof plant room
Item Description	Thick window putty to skylight
Material Type	Putty
Sample Number	Similar to 21787
Asbestos Type	Pr No Asbestos

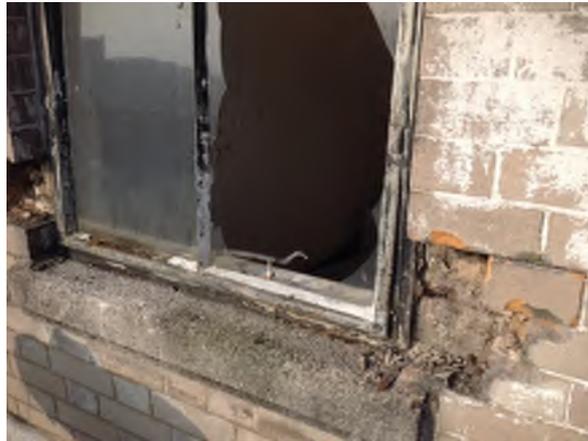
Building	Insull wing
Floor	Other
Room	Stairwell 1
Item Description	Thick window putty
Material Type	Putty
Sample Number	21787
Asbestos Type	Asbestos Not Detected

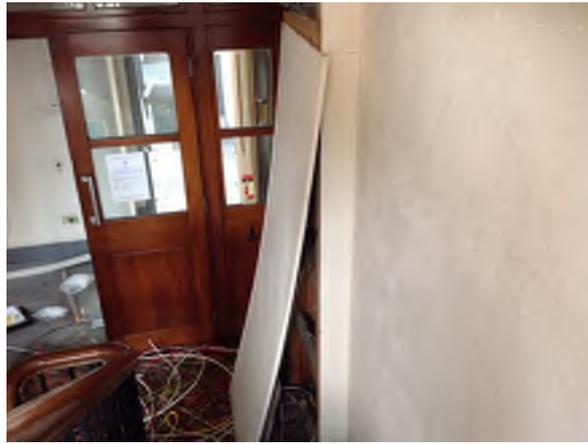
Building	Insull wing
Floor	Other
Room	Stairwell 2
Item Description	Belgian board
Material Type	Insulation Board
Sample Number	21794
Asbestos Type	Asbestos Not Detected

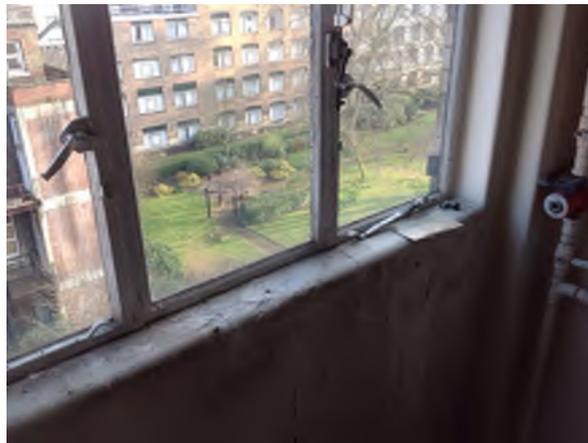
Building	Insull wing
Floor	Other
Room	Stairwells 1 and 2
Item Description	Thick window putty
Material Type	Putty
Sample Number	21786
Asbestos Type	Asbestos Not Detected

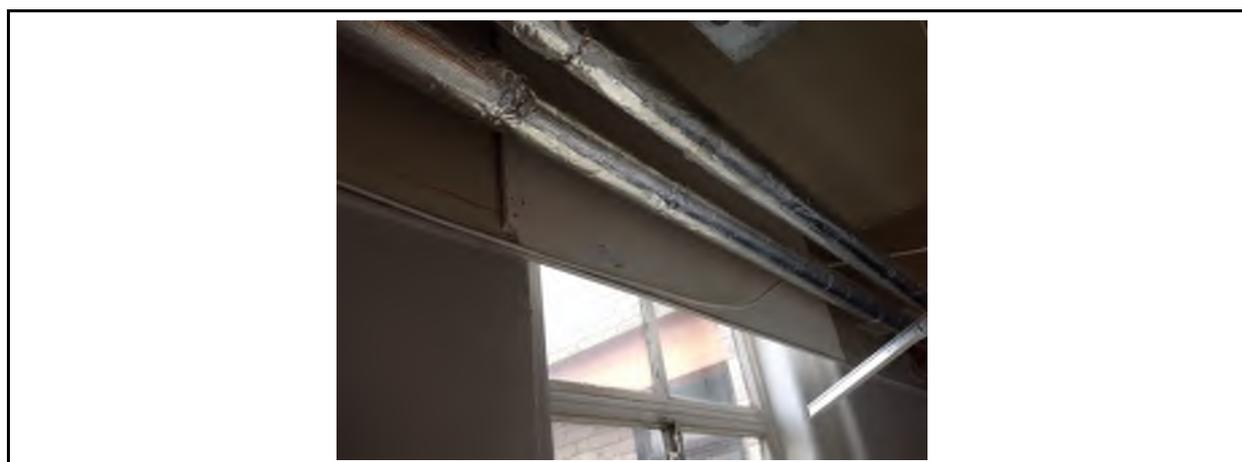
Building	Insull Wingse
Floor	Second
Room	099
Item Description	Upstands to ceiling edge
Material Type	Insulation Board
Sample Number	21777
Asbestos Type	Asbestos Not Detected

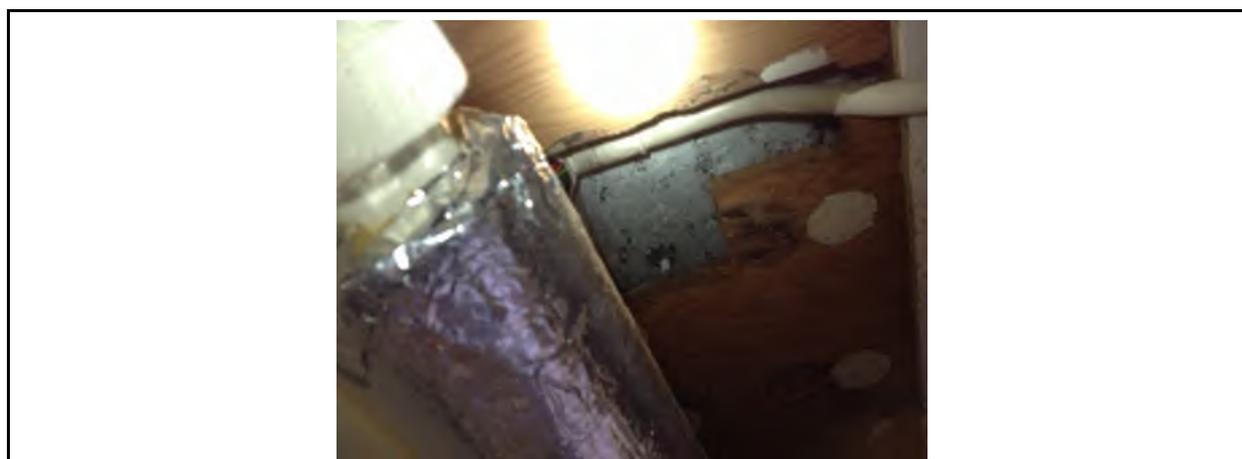
Building	Insult building
Floor	Basement
Room	001
Item Description	Debris to ceiling
Material Type	Composite
Sample Number	21742
Asbestos Type	Asbestos Not Detected

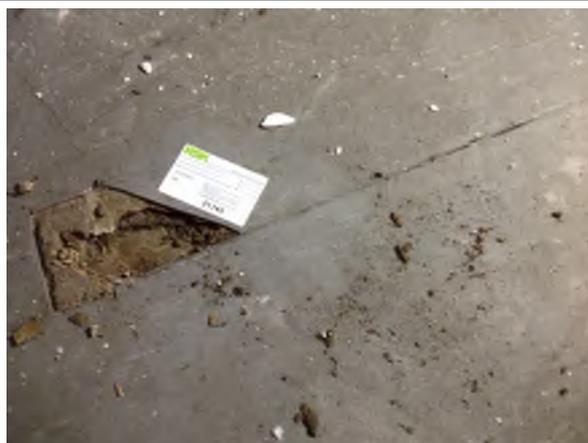
Building	Insult wing basement
Floor	Basement
Room	002
Item Description	Bitumen under mvfr
Material Type	Bitumen
Sample Number	21743
Asbestos Type	Asbestos Not Detected

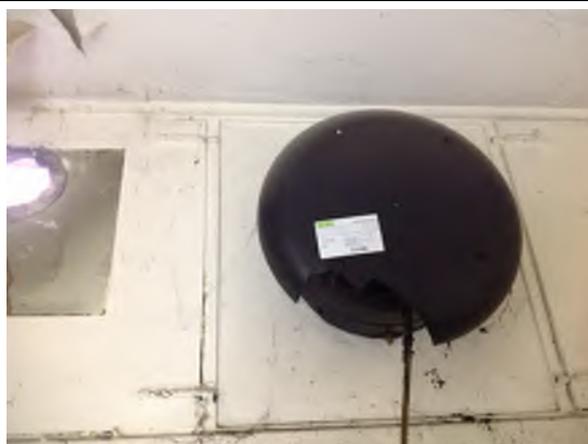
Building	Insult wing basement
Floor	Basement
Room	003
Item Description	Extractor fan cover
Material Type	Composite
Sample Number	21744
Asbestos Type	Asbestos Not Detected

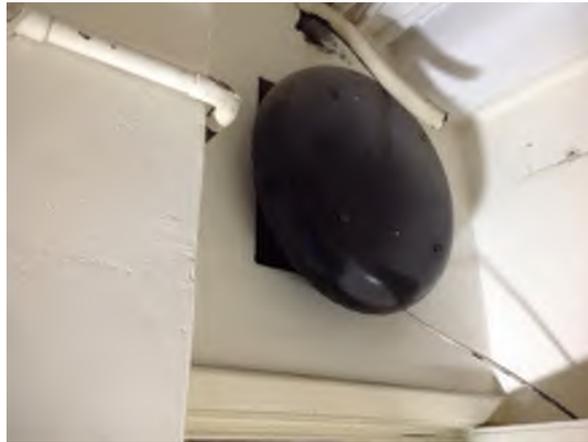
Building	Insull wing basement
Floor	Basement
Room	003
Item Description	Extractor fan cover
Material Type	Composite
Sample Number	Similar to 21744
Asbestos Type	Asbestos Not Detected

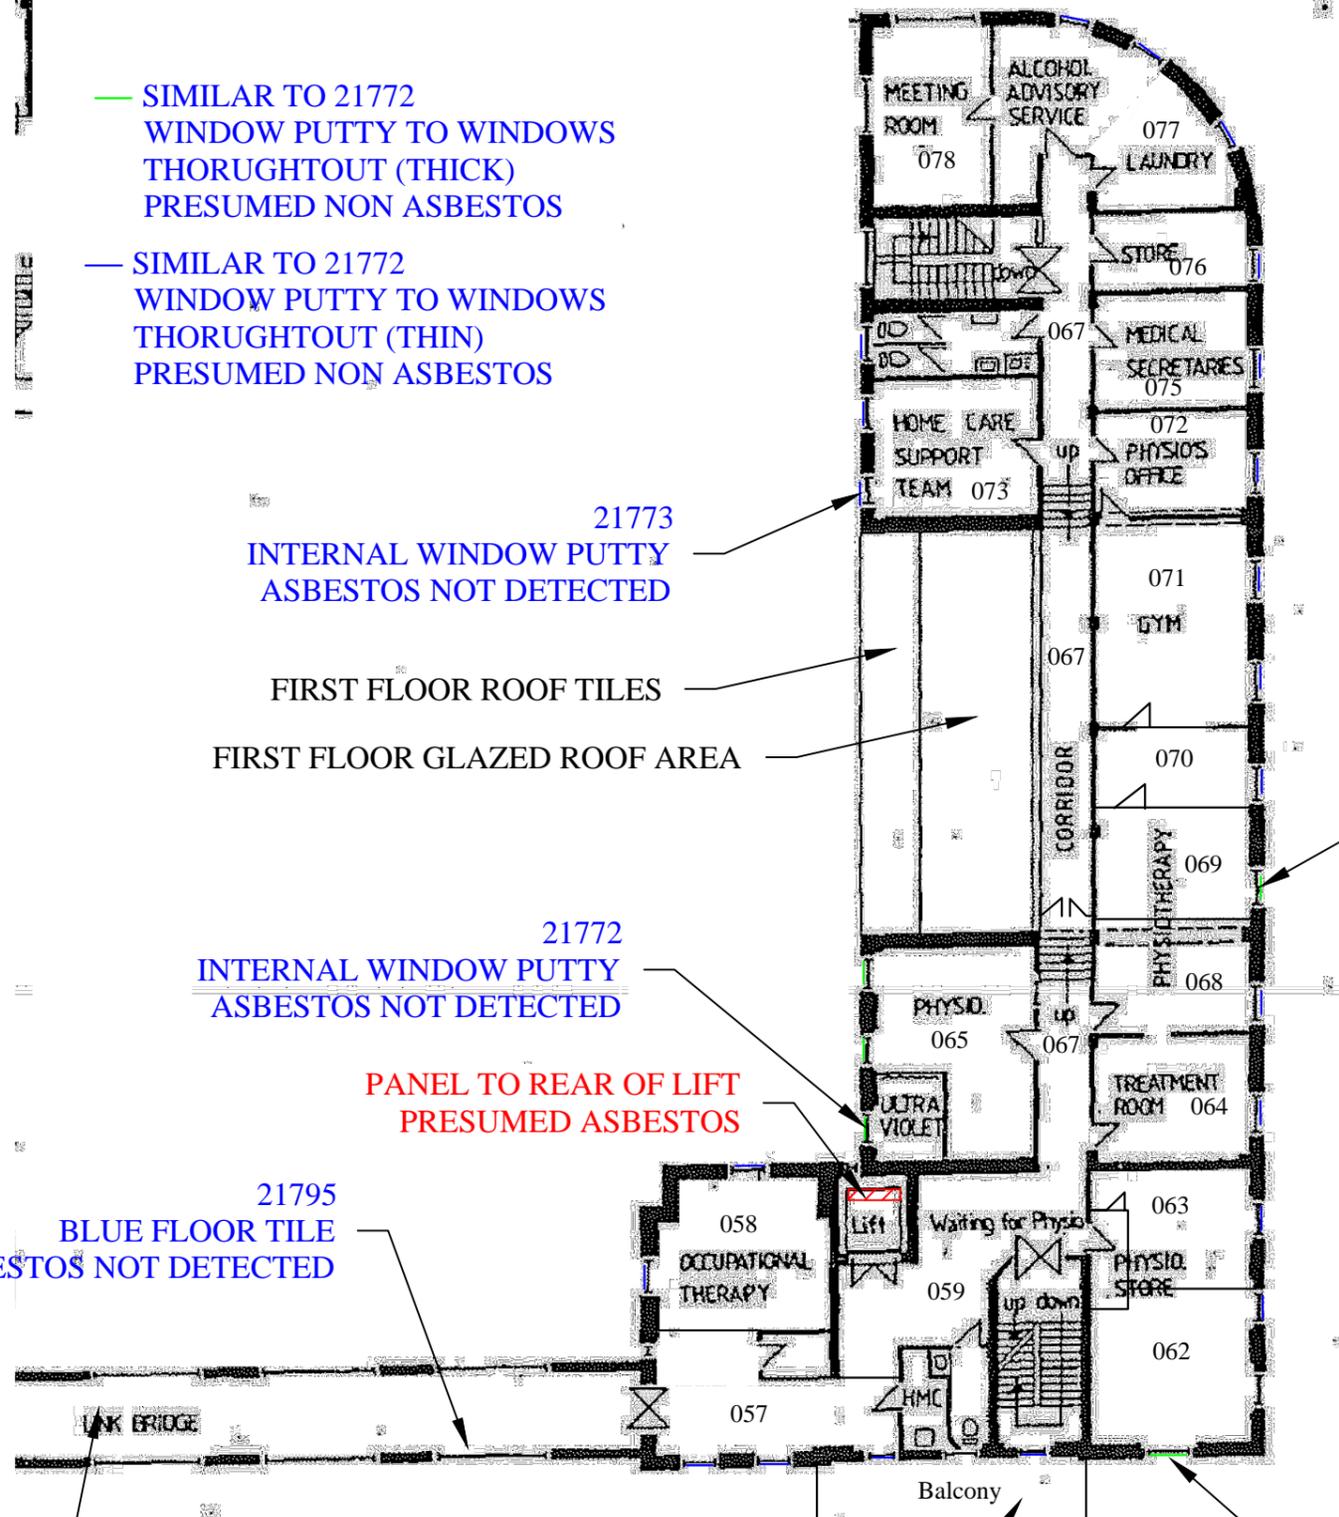
SIMILAR TO 21772
WINDOW PUTTY
PRESUMED NON ASBESTOS
