ARBORICULTURAL IMPACT ASSESSMENT REPORT:

Maryon House
115 - 119 Goldhurst Terrace
London
NW6 3EY

Ref: HV1/1MRN/AIA/01c

Date: 21st June 2016

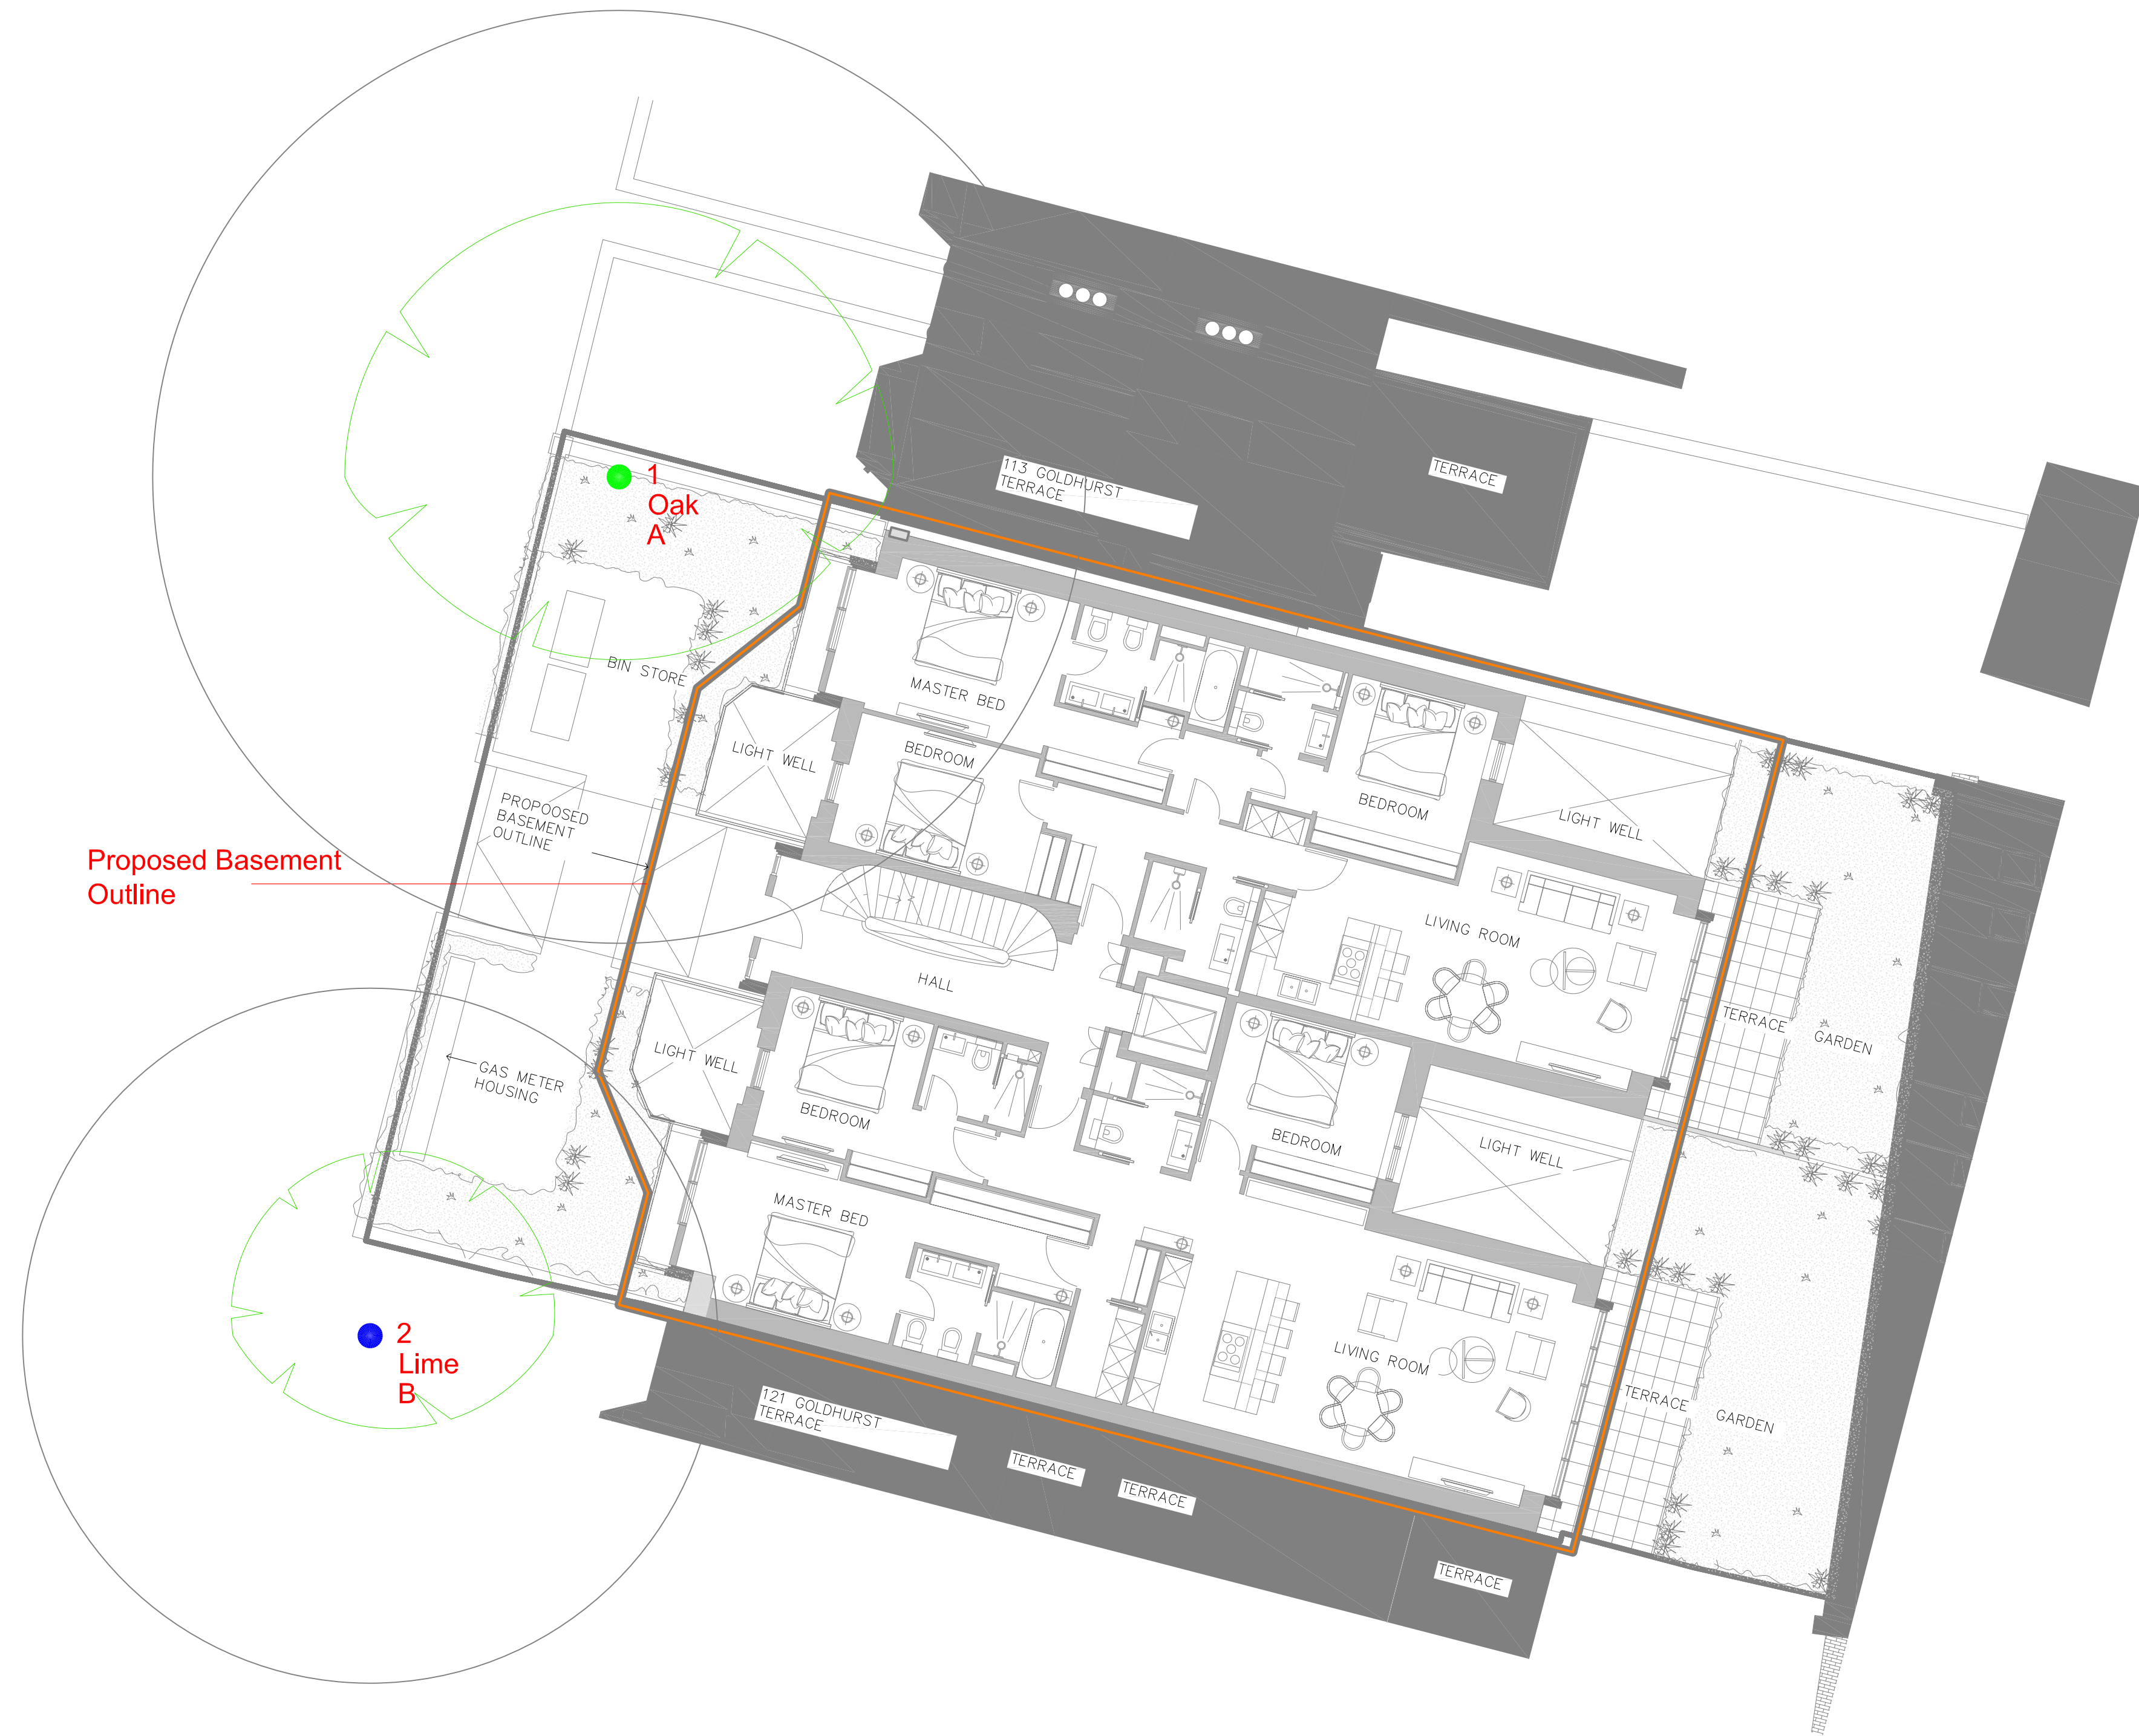
ARBORICULTURAL IMPACT ASSESSMENT PLAN

6.1.2 Further theoretical impacts arise from the encroachment of the proposed gas meter housing and associated hard surfacing within the RPA of T2 by 7.2%. Whilst this impact is assessed as very low, proposed mitigation of no-dig construction and low-invasive foundations for any structure requiring such support will reduce this potential impact to negligible levels. The location of these meters within the RPA of T2 means that any new gas pipes necessary will need to be installed using the provisions described in BS5837 and NJUG Volume 4 i.e. mole trenching / direct drilling to avoid further potential impacts.

- 6.3.2 The path of foundations through RPAs will be manually excavated to 750mm depth under arboricultural supervision; any roots encountered within the trenches / pits will be cleanly pruned back to an appropriate junction with a sharp pruning saw or secateurs back to a junction. Roots larger than 25mm diameter may only be cut in consultation with an arboriculturalist.

- 6.3.4 The replacement paving/hard landscaping will require a no-dig construction technique, either using a cellular confinement system with no fines aggregate for the sub-base or simply building upon the existing sub-base without disturbing the ground below. Choice of construction method will initially depend upon root penetration within the existing sub-grade. The key principle is not to excavate in the presence of roots and to provide a porous surface to promote healthy soil water relations for future root growth. A further consideration in the use of a more expensive cellular confinement system or similar, may be the claimed reduction in risk of possible future slab / surface displacement by roots of trees growing in paved areas.
