Branch Hill Estate

Spedan Close Type 5P

Design & Access Statement

Jan 2016

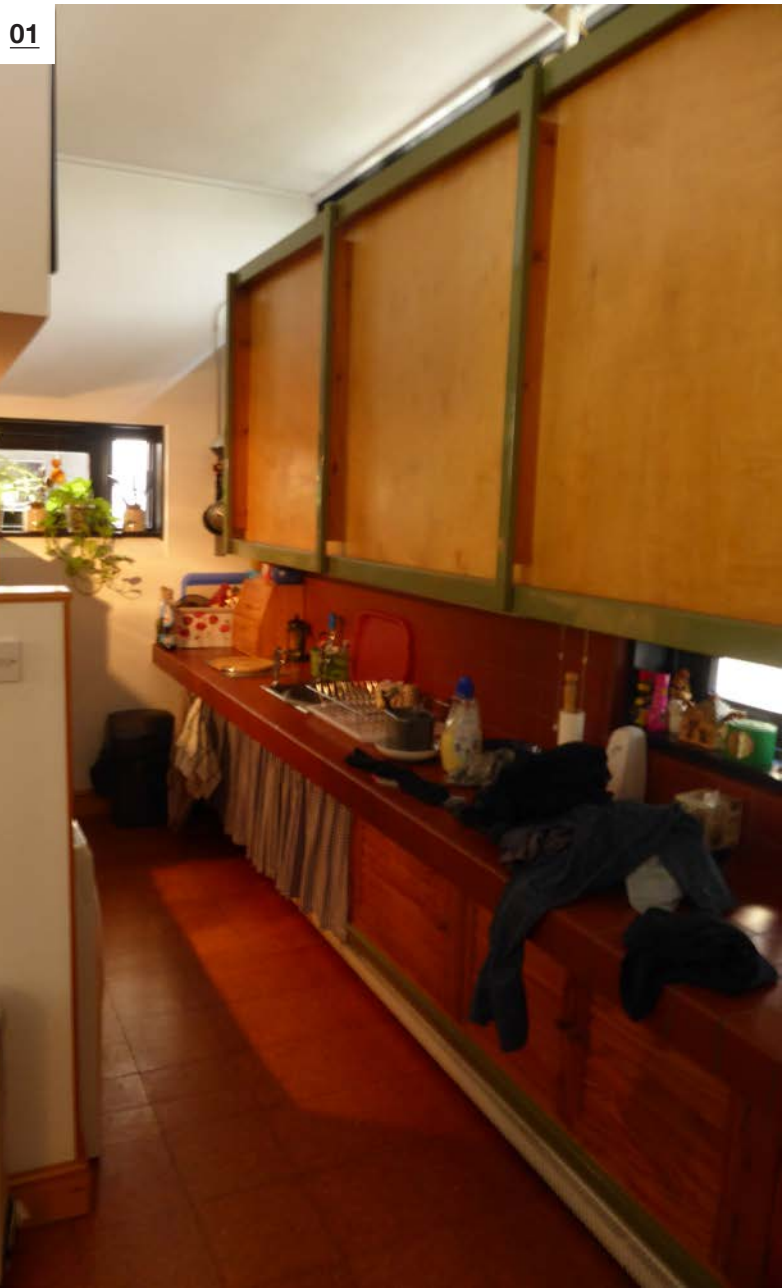
- 01 Kitchen with original worktop and wall mounted cupboards. (Green paint original)
- 02 Original sliding cupboard doors
- 03 Original loft access doors
- 04 Original Timber stairs and handrail

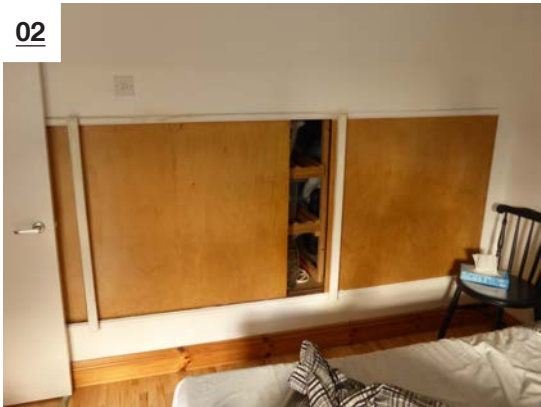
02

It has become clear through conducting the surveys and discussion with the tenants that several of the bespoke features have, over time, presented maintenance issues. Plywood cupboards featuring sliding doors are prone to stick and fail and tiled surfaces over time become damaged and hard to maintain are two examples of this.

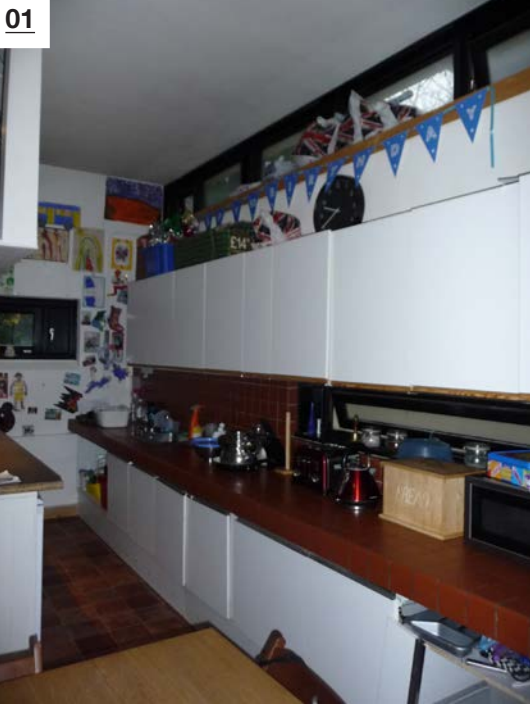
No. 23 Spedan Close

- Original concrete worktop and tiling retained. [01+03+05+06]
- Original tiled splashback retained. [01+03+05]
- Original wall mounted cupboards removed including carcass. [01+02+03]
- Original below-counter cupboards removed, including carcass. [01+06]
- Island unit walls modified and worktop installed to top. [02+03+04]
- Timber panelling applied to island walls. [03]
- Loft doors replaced. [07]
- Full height cupboard doors replaced and worktop installed. [08]

Proposed Schedule of Works		Condition	Works	Listing sensitive feature
Feature				
KITCHEN				
1.0	Worktop			
1.1	Tiled worktop	Tiles retained and generally good condition, some leaking around the sink	Replace damaged tiles and renew all grout	Y

1.2	Stainless steel sink	In poor condition	Replace with new stainless steel sink	N
2.0	Tiled splashback			
2.1	Tiled splashback	Retained and in good condition	Tiles retained and grout to be renewed	Y

4.1	Solid walls	Height modified, panelling applied and worktop fitted	Height to be reinstated, panelling removed and wall made good	Y
4.2	Shelves	Original shelves removed. Non-original worktop installed	Worktop to be removed and solid hardwood worktop replacement installed with tiled splashback, to match original tiles	Y

5.0	Flooring and walls			
5.1	Sheet lino flooring	In poor condition	Sheet lino replacement to be laid	N
5.2	Walls	In good condition	To be repainted	N
6.0	Loft door

6.1	Sliding timber doors	Doors missing	Doors to be replaced to match original	Y
WC				
NO WORKS				
BATHROOM				
NO WORKS

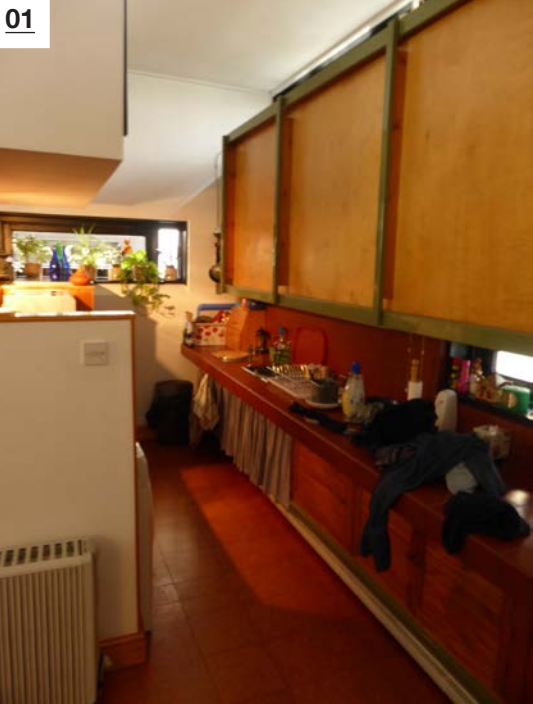
No. 25 Spedan Close

- Original concrete worktop and tiles retained. [01+02+03]
- Original tiled splashback retained. [01+02+03]
- Original wall mounted cupboard carcass and doors retained. [01+02+03]
- Original below counter cupboard carcass retained and doors replaced. [01+02+03]
- Island retained and clad internally with timber panelling. [04]
- Worktop and fitted drawers installed to island. [04]
- Loft door retained. [06]

Proposed Schedule of Works				
	Feature	Condition	Works	Listing sensitive feature
KITCHEN				
1.0	Worktop			
1.1	Tiled worktop	Tiles retained and generally good condition	Replace any damaged tiles and renew all grout	Y

1.2	Stainless steel sink	In poor condition	Replace with new stainless steel sink	N
2.0	Tiled splashback			
2.1	Tiled splashback	Retained and in good condition	Replace any damaged tiles and renew all grout	Y

3.0	Cupboards			
3.1	Below worktop cupboards	Original carcass retained and doors replaced	Replica doors to be birch plywood facing with solid timber replica handle	Y

3.2	Wall mounted cupboards	Original carcass retained and doors replaced	Replica doors to be birch plywood facing with solid timber replica handle	Y
4.0	Half-height kitchen island

4.1	Solid walls	Panelling applied to internal face	Panelling to be replaced with tiles to match original, external face of island to be painted	Y
4.2	Shelves	Original shelves removed. Non-original worktop installed	Worktop to be removed and solid hardwood worktop replacement installed with tiled splashback, to match original tiles	Y

5.0	Flooring and walls			
5.1	Lino tiled flooring	In poor condition	Sheet lino replacement to be laid	N
5.2	Walls	In good condition	To be repainted	N
6.0	Loft door

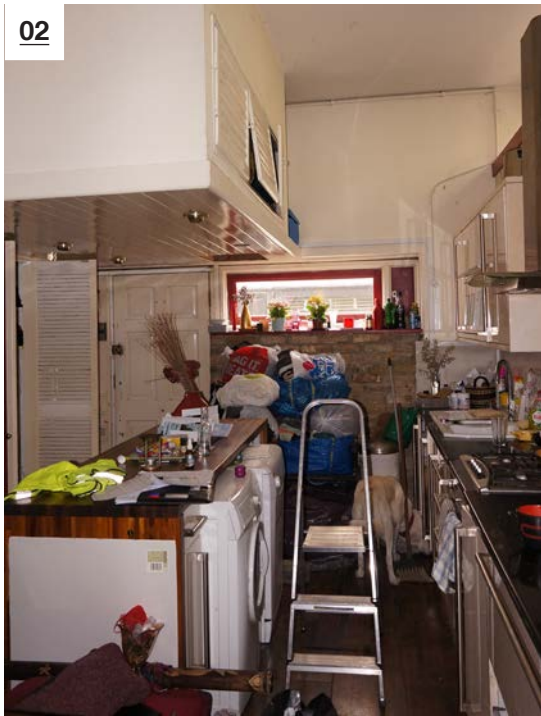
02

- Original concrete tiled worktop replaced. [01+02+05]
- Original tiled splashback retiled. [01+02+05]
- Original wall mounted cupboards replaced. [01+05]
- Original below counter cupboards replaced. [01+02]
- Ceiling lowered and glass ceiling tiles fitted. [01+04]
- Arches formed above island and above high level windows. [01+03+06]
- Island return infilled to ceiling.[01]
- Island wallpapered to external face and tiled to internal face. [04]
- Textured wallpaper applied to all walls. [ALL]

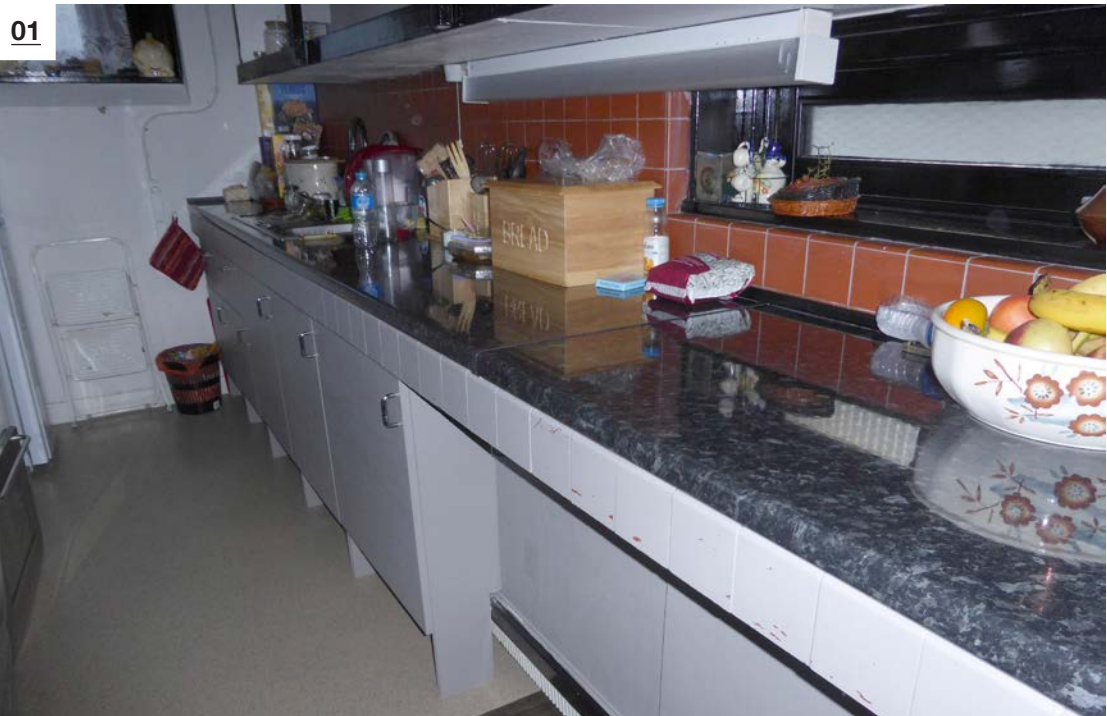
01

- Original concrete worktop and tile retained and new worktop fitted over the top. [01+03]
- Original tiled splashback retained and in good condition. [01+02]
- Original wall mounted cupboard carcass and doors retained and painted. [02+04]
- Original below counter worktop cupboards replaced. [03]
- Original island retained and all wall faces tiled. [05]

Proposed Schedule of Works		Condition	Works	Listing sensitive feature
Element				
KITCHEN				
1.0	Worktop			
1.1	Tiled worktop	Retained and clad over	Some tiles painted, all damaged tiles to be replaced and grout renewed	Y

1.2	Stainless steel sink	Non-original	Replace with new stainless steel sink	N
2.0	Tiled splashback			
2.1	Tiled splashback	Tiles retained and in good condition	Any damaged tiles to be replaced and all grout to be renewed	Y

3.0	Cupboards			
3.1	Below worktop cupboards	Original carcass and doors replaced	Replica carcass and doors to be fitted, doors to be birch plywood facing with solid timber replica handle	Y

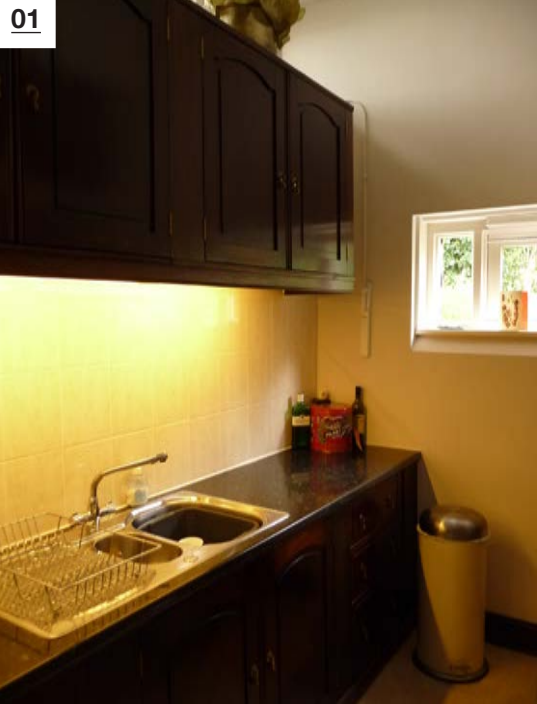
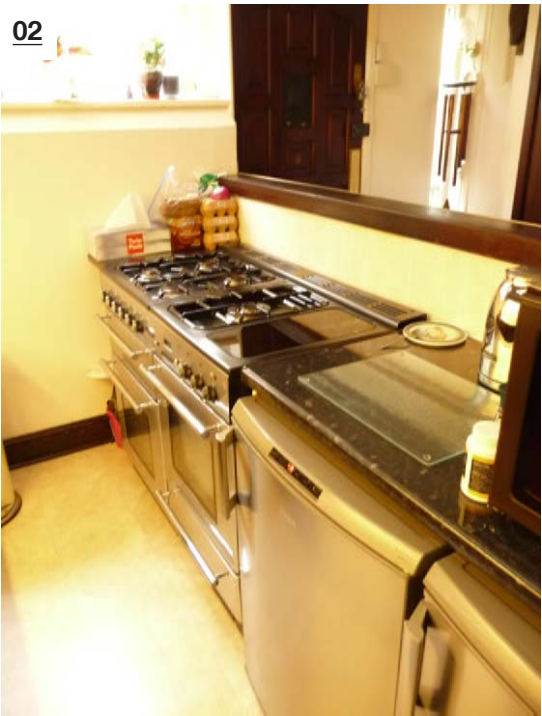
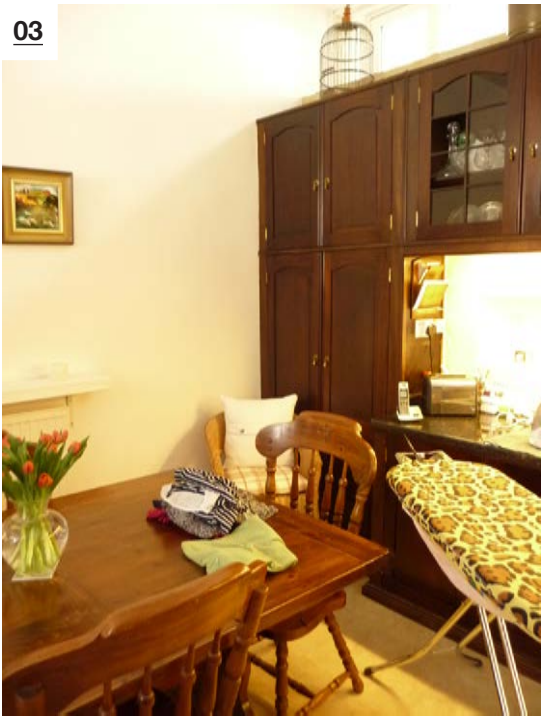
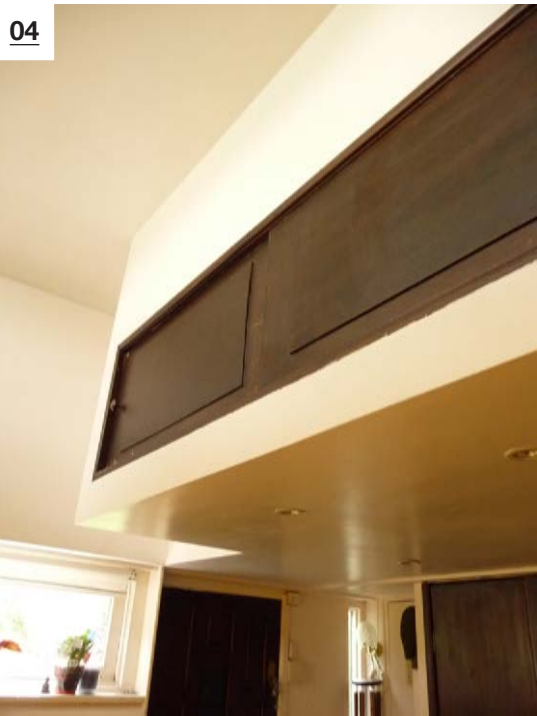
No. 36 Spedan Close

- Original concrete worktop and tiles replaced. [01 + 03]
- Original tiled splashback replaced. [01]
- Original below worktop cupboards replaced. [01 + 03]
- Original wall mounted cupboards replaced. [01 + 03]
- Original island modified. [02]
- Original racked shelving to island replaced with worktop and fitted appliances. [02]
- Original high-level cupboard doors replaced. [04]

Proposed Schedule of Works		Condition	Works	Listing sensitive feature
Element				
KITCHEN				
1.0	Worktop			
1.1	Tiled worktop	Tiles and worktop completely removed	Worktop to be replaced with solid timber	Y

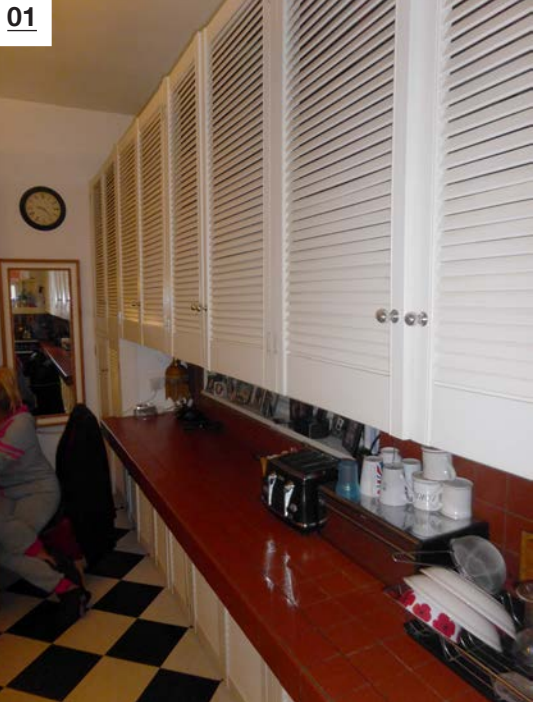
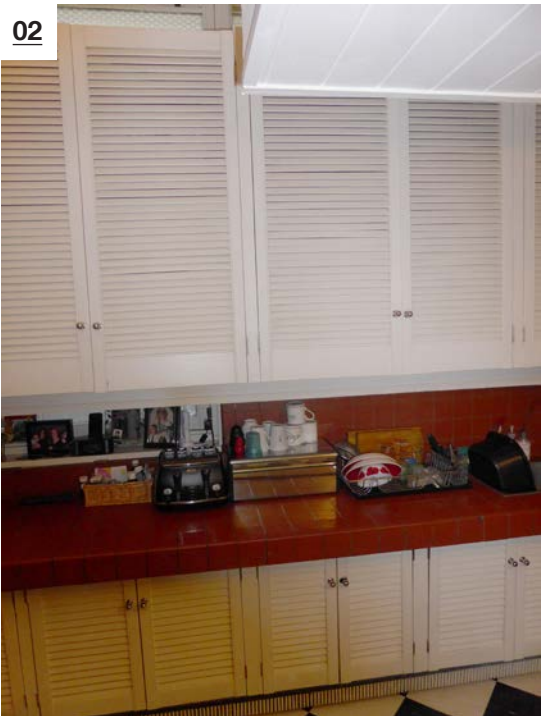
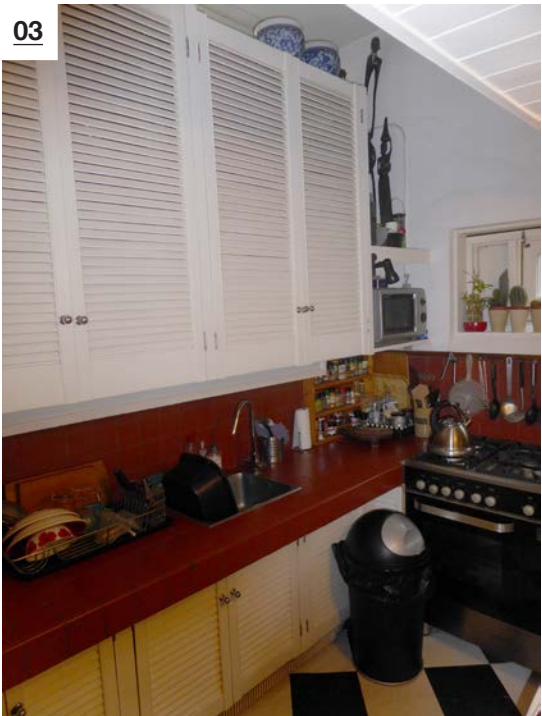
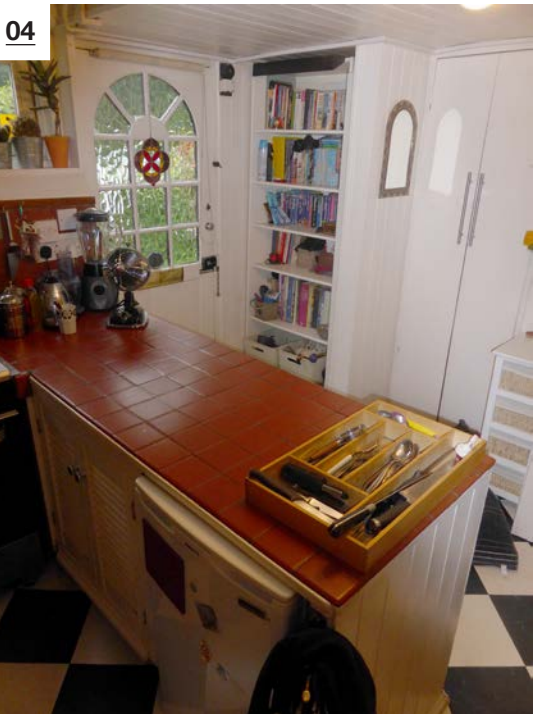
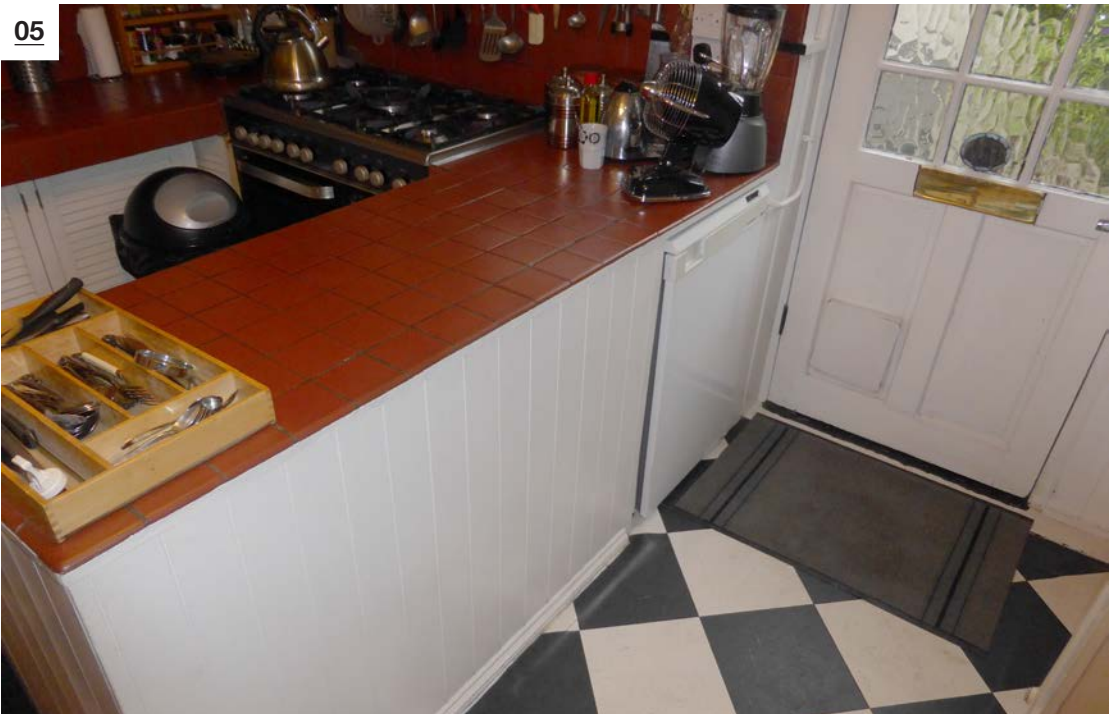
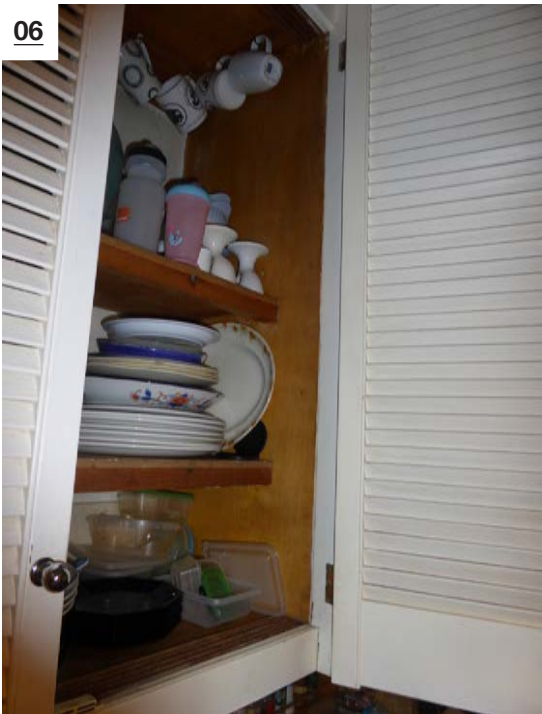
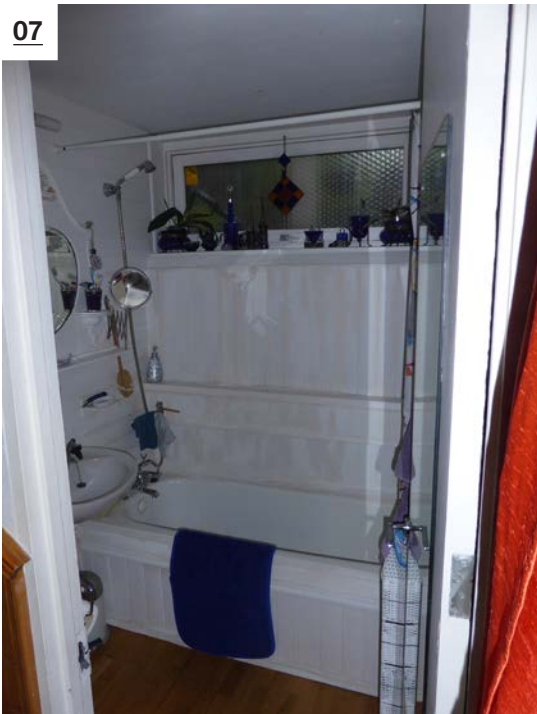
- Tiled bath panel replaced with timber panelling. [07]
- Tiled wall replaced with timber panelling. [07]

Proposed Schedule of Works		Condition	Works	Listing sensitive feature
Element				
KITCHEN				
1.0	Worktop			
1.1	Tiled worktop	Original concrete worktop and tiles retained, tiles sealed	Damaged tiles to be replaced and grout renewed	Y
