ARBORICULTURAL IMPACT ASSESSMENT REPORT  
BS 5837:2012 'Trees in relation to design, demolition and construction.  
Recommendations'

145 - 147 Camden Road,  
London  
NW1 9HA

**DATE: 16.03.16**

**OUR REF: SHA 153**

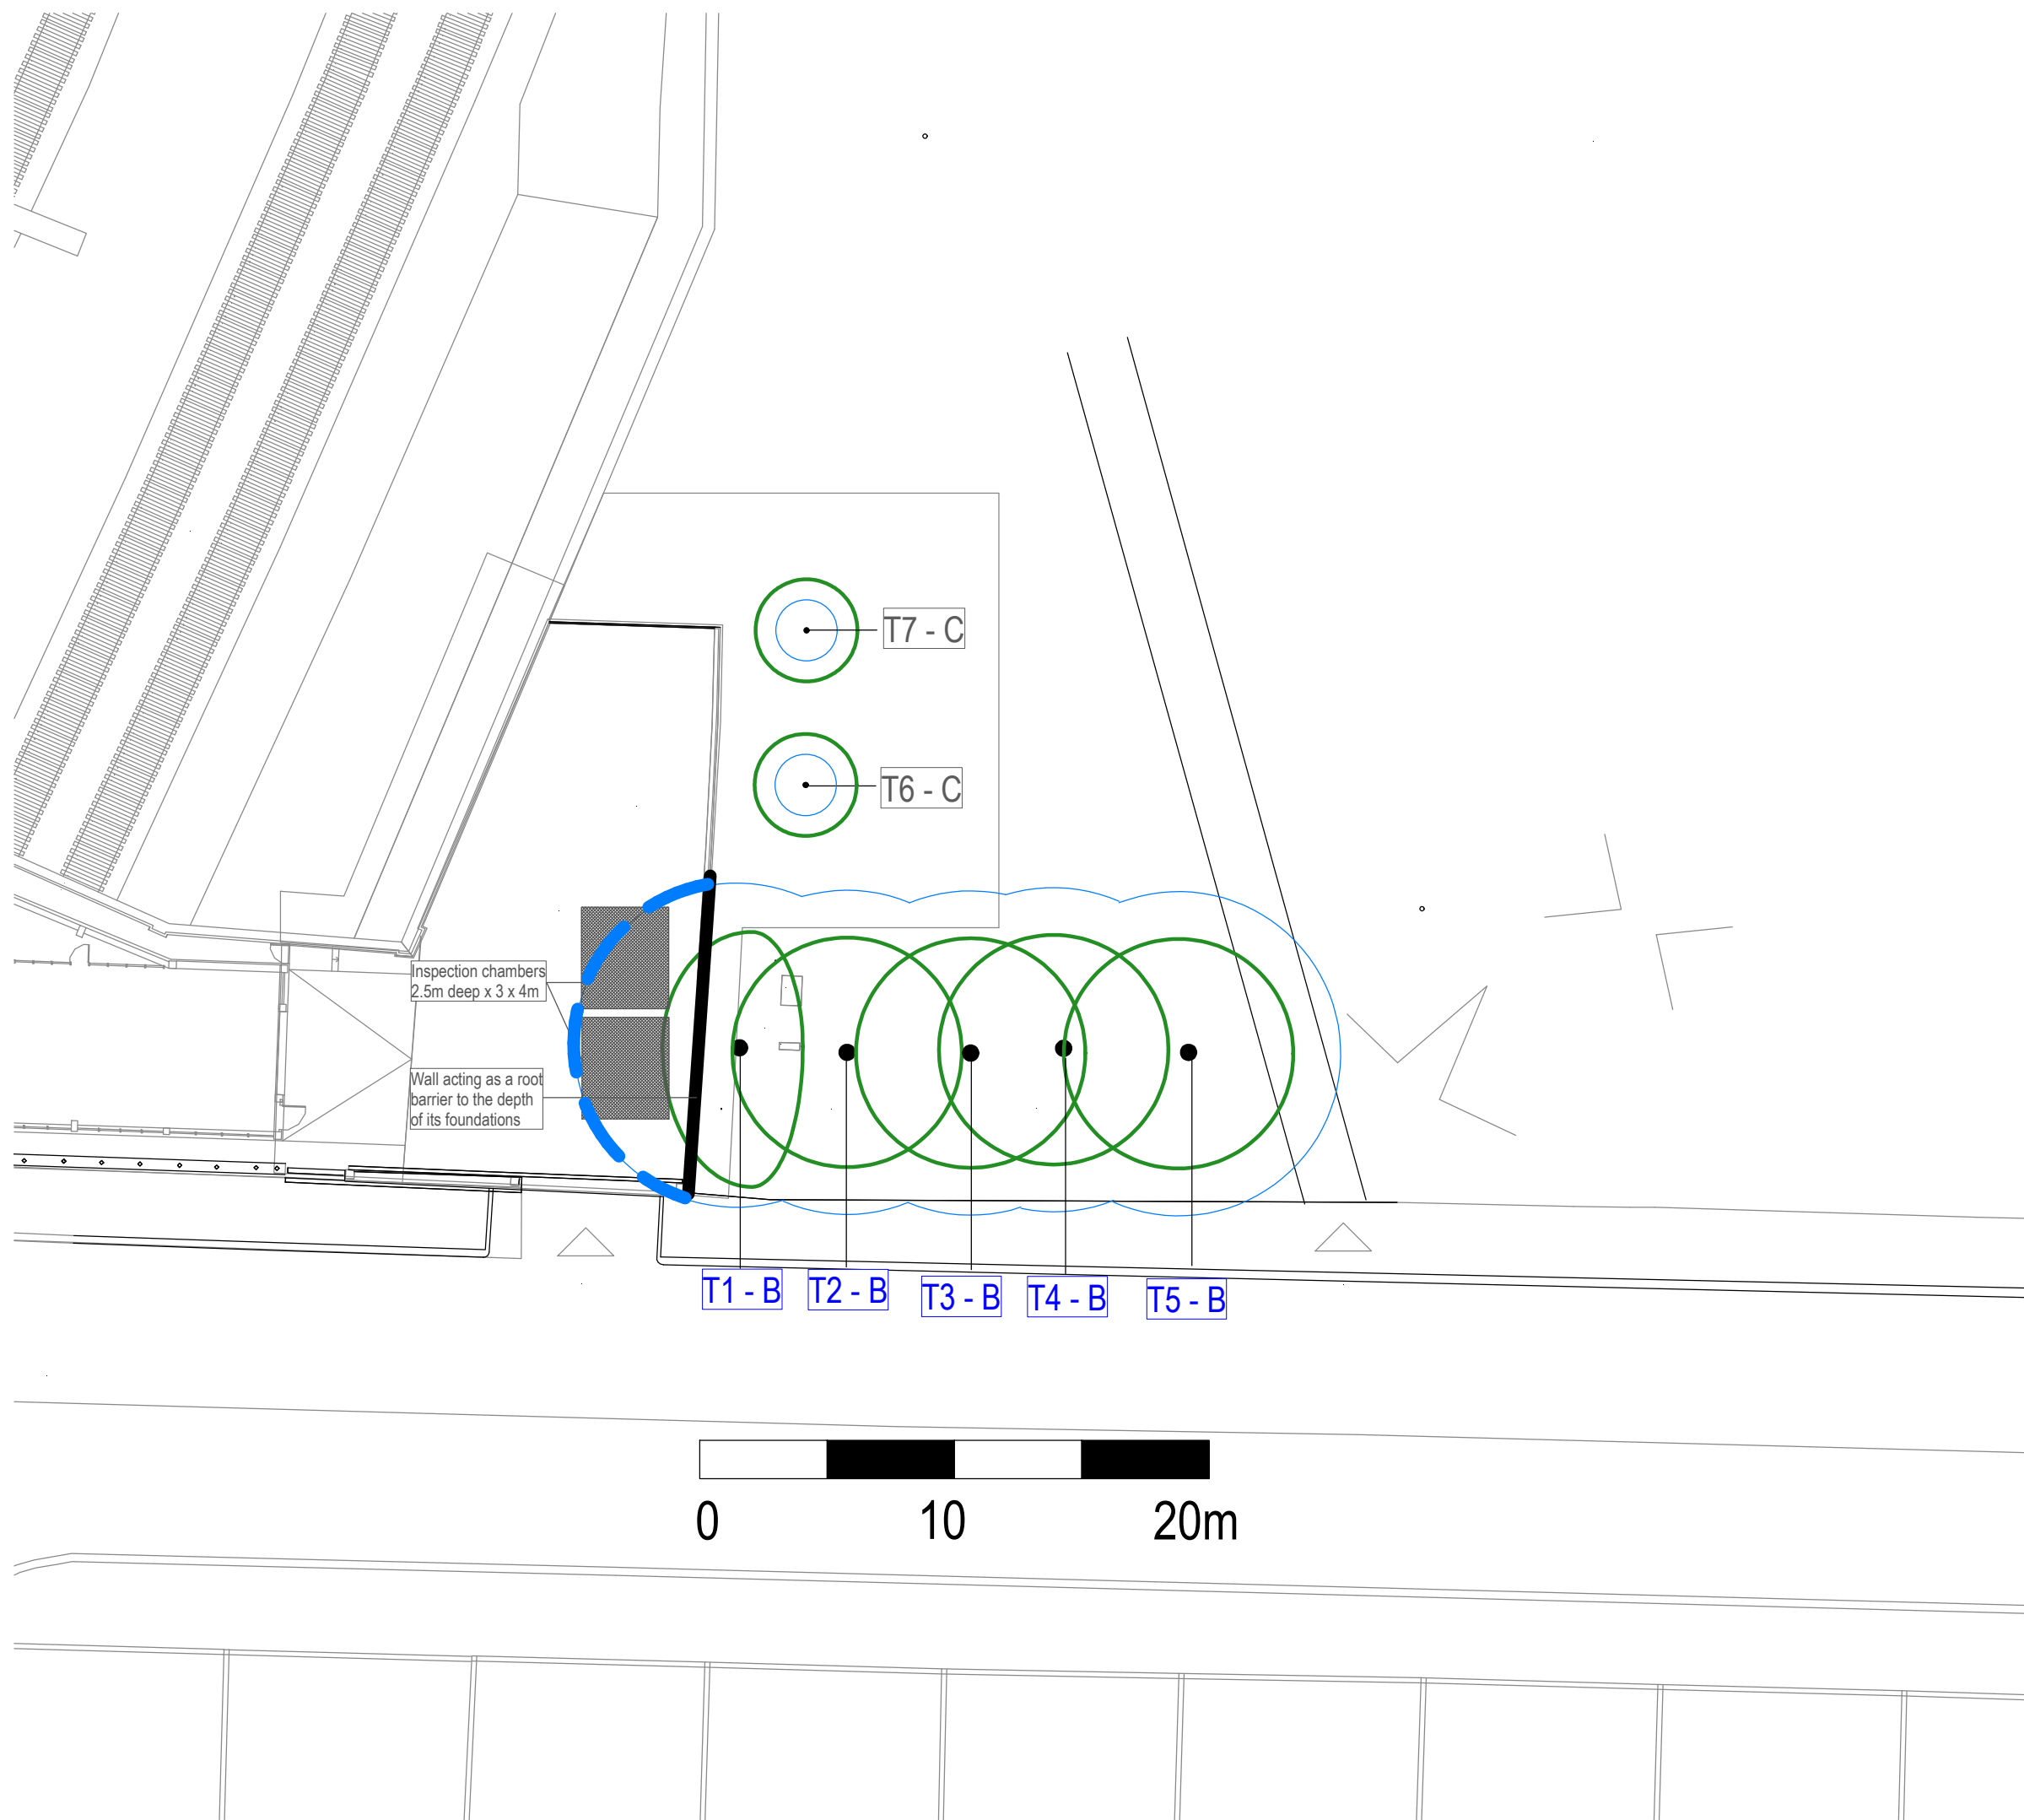
### Tree survey plan SHA 153 TSP

- T1-B Category B - moderate quality and value
- T1-C Category C - low quality and value
- Crown spread
- RPA - root protection area as defined by Table 2 BS 5837:2012
- Although this is in the root protection area, there are unlikely to be any roots due to the chambers, wall and concrete

Please note this is not based on a topographical drawing, and therefore tree locations need to be checked on site
