Athlone House Hampstead London N6 4RU

Structural Inspection

Date:- **May 2016**

MW Document Reference No: 7503Rja_3

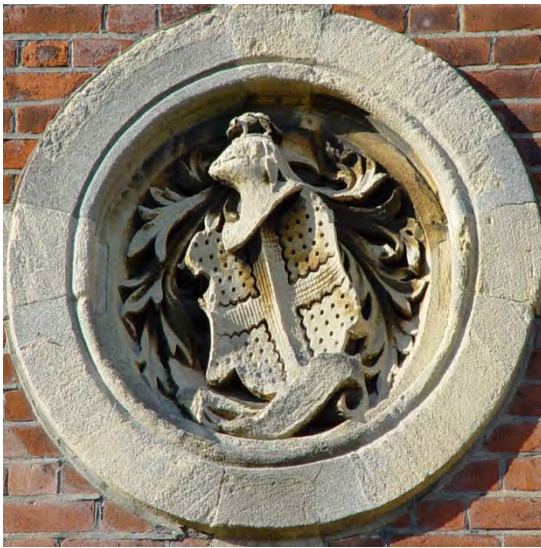
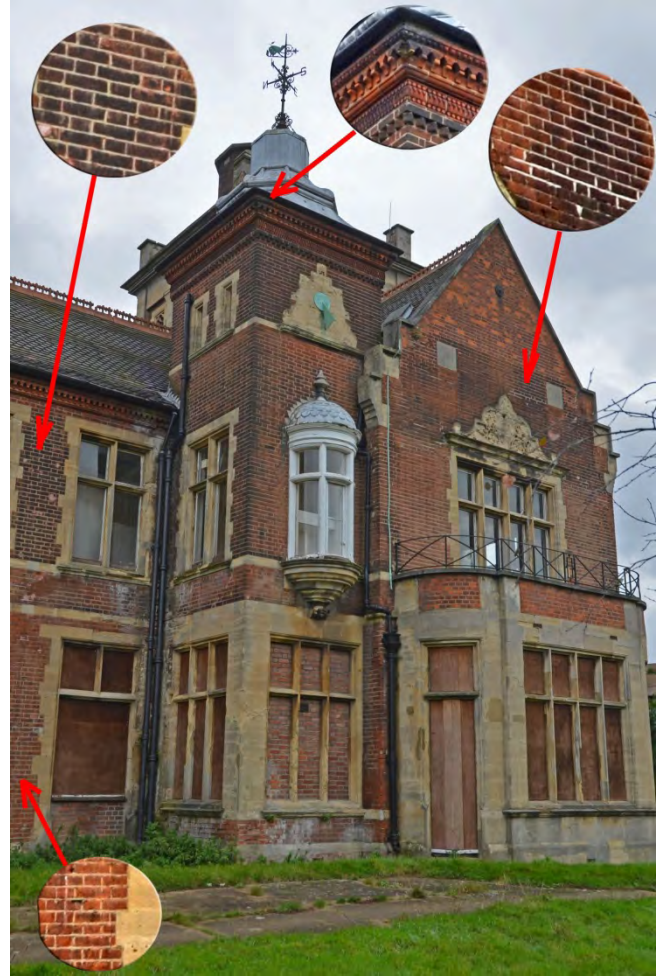
2.15 Similar situations exist around the full perimeter of the property, however despite evidence of spalled brickwork and decay to stone details there is also considerable and significant areas of serviceable masonry, and in particular a significant quantity of fine historic detailing in both stone and brick which is illustrated in the images opposite and below.

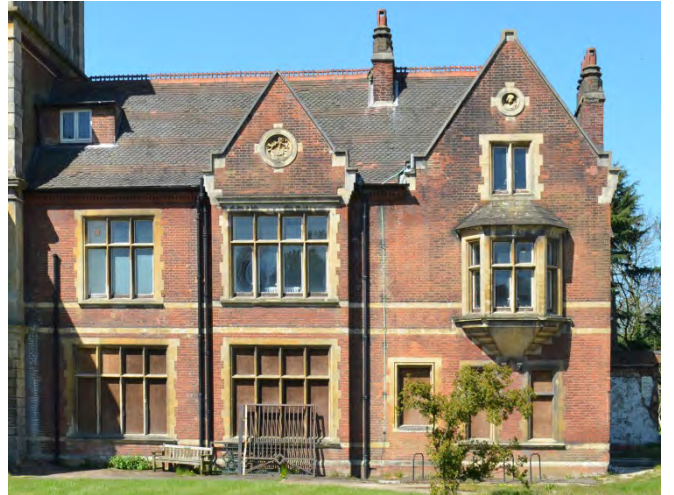
2.16 The photograph opposite shows the north end of the east elevation. The masonry is generally structurally sound, with only localised repairs required.

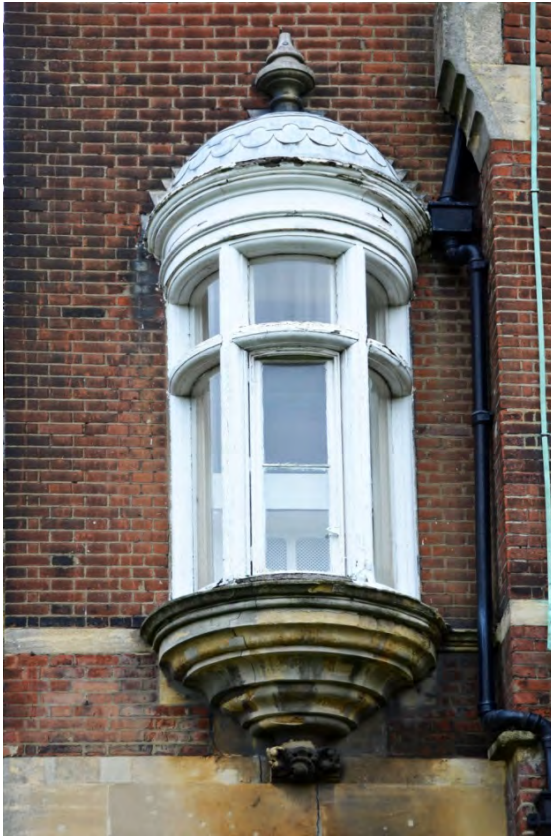
The image opposite shows a smaller Oriel window on the south elevation and is a further example of the detail present around the perimeter of the building. The window requires some cosmetic repairs, but appears to be structurally in serviceable condition.

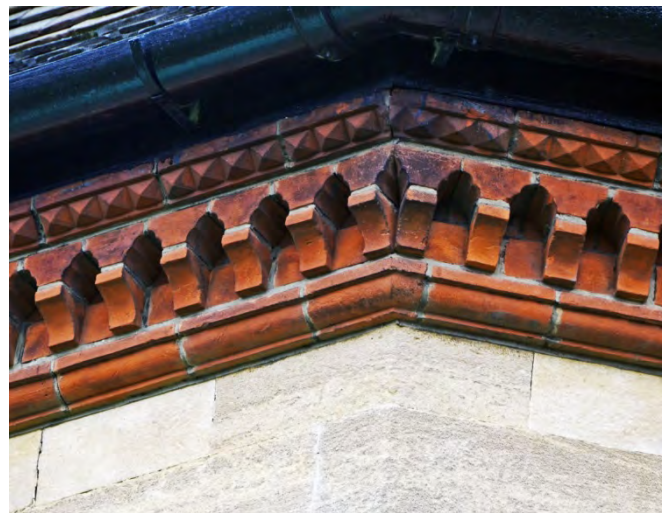
2.18 The image opposite illustrates elements of brick detailing to be found around the building. These are reasonably extensive and in predominantly serviceable condition. They are a key feature of the building and retention and careful cleaning and refurbishment is considered to be a practical option.

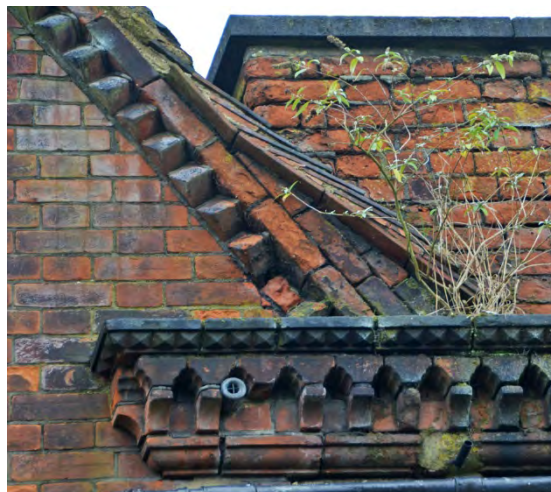
Further brick detailing is illustrated in the photograph opposite. Although some vegetation has established around gutter areas through poor maintenance the brickwork remains in serviceable condition. It is, however, important that all gutters are kept clear of vegetation and all drains running freely.

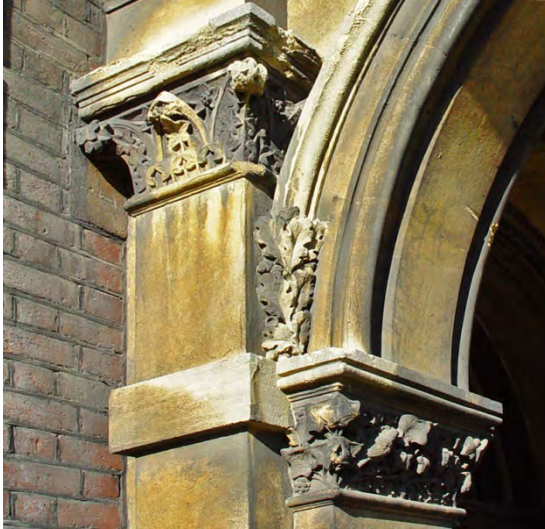
- 2.20 The principal entrance to the east elevation is in the form of a porte-cochère as illustrated in the photograph opposite. The structure contains a range of original features. Although areas of cosmetic decay and cement patch mortar repair was noted the overall entrance area appears generally structurally sound.

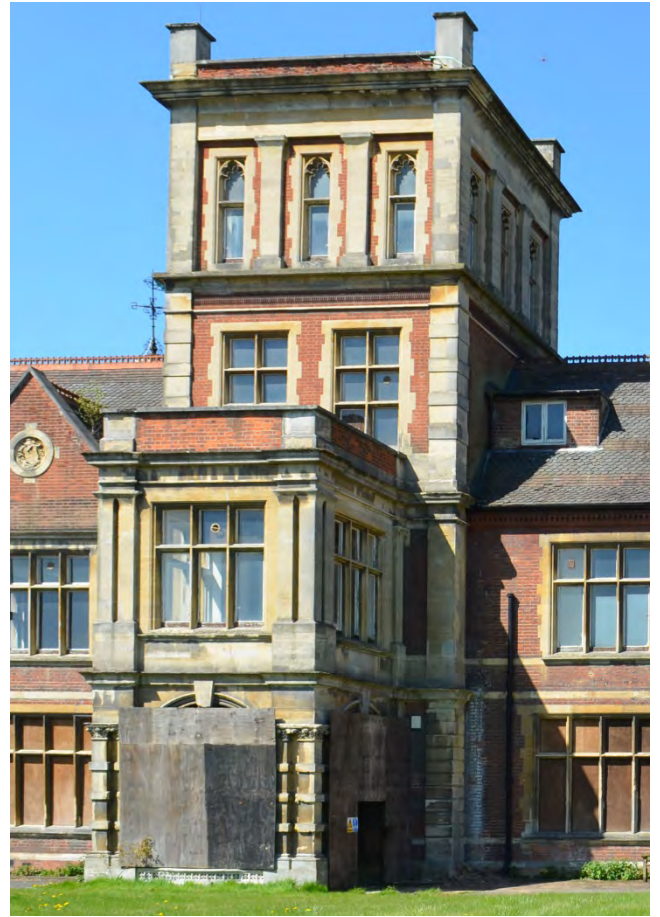
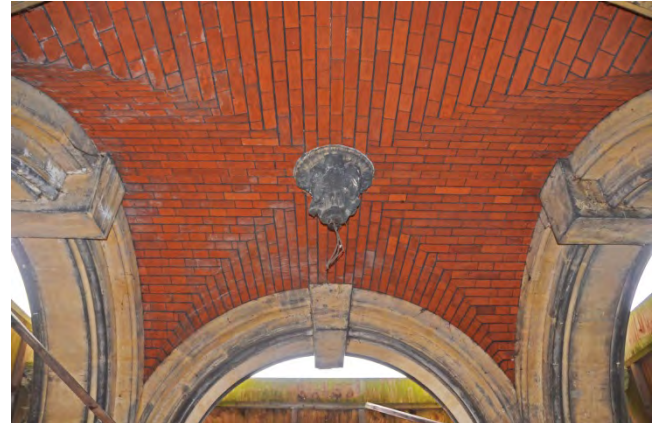
- 2.21 The image above shows the fine detailing around the springing points of the entrance arch to the porte-cochère. The photograph opposite shows the fine intersecting brick vaulting detail to the area above. All of this appears to be in a structurally stable condition and capable of refurbishment.

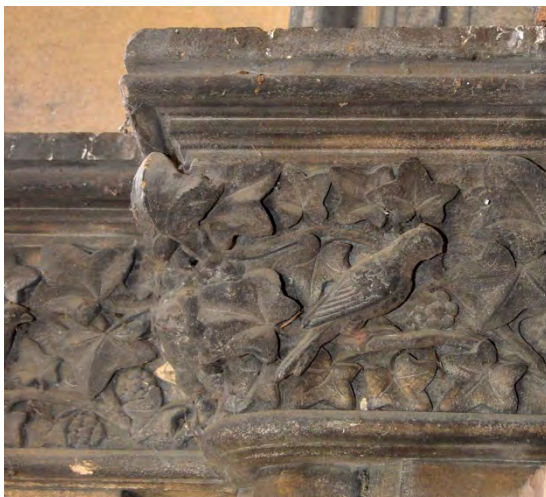
Further detailing around the internal areas of the porte-cochère remains as illustrated opposite. The carvings are generally in reasonable condition and a significant historic record of the building.

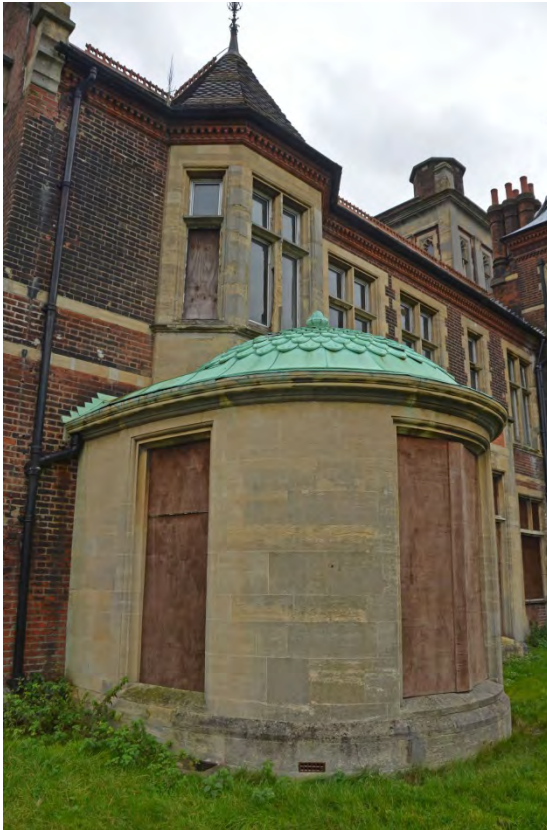
On the south side of the building a small later addition, believed to have been constructed around 1900 with a domed copper roof is present as illustrated in the photograph opposite. The stonework and roof structure are generally in reasonable condition and capable of refurbishment if desired.

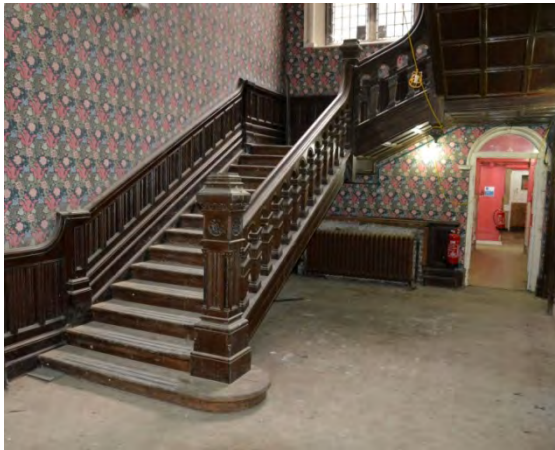
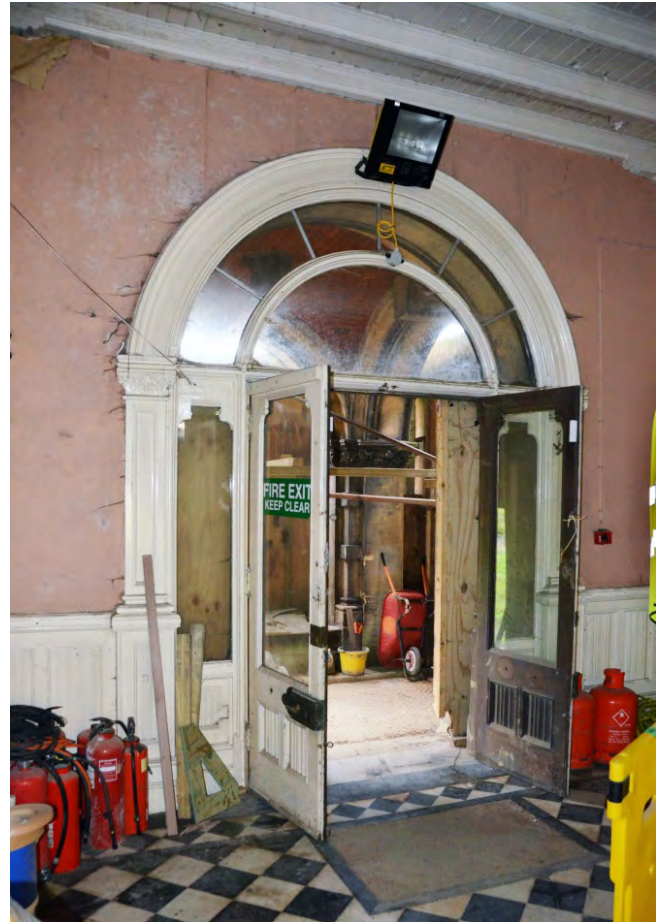
- 3.01 From the porte-cochère the entrance leads through double doors with fanlight over into a lobby and then on to the main hall and grand staircase as shown below. Although dilapidated through lack of maintenance there are no significant structural issues to prevent refurbishment.

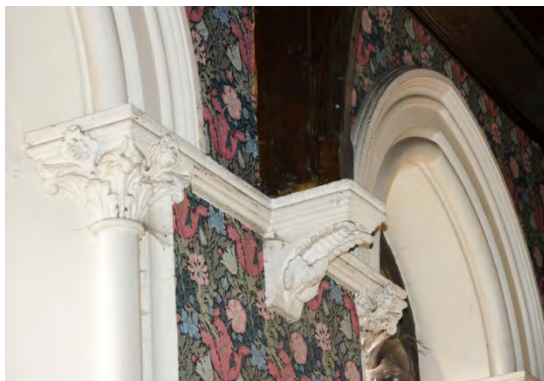
The photograph opposite shows the detailing around the base of the timber arch braces. No significant structural movement was identified.

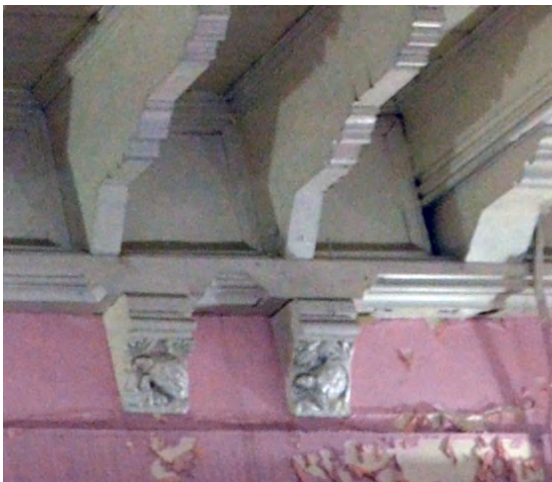
The photograph opposite shows the first floor timber joists and beam bearings with profiled sprockets and ornate corbels below.

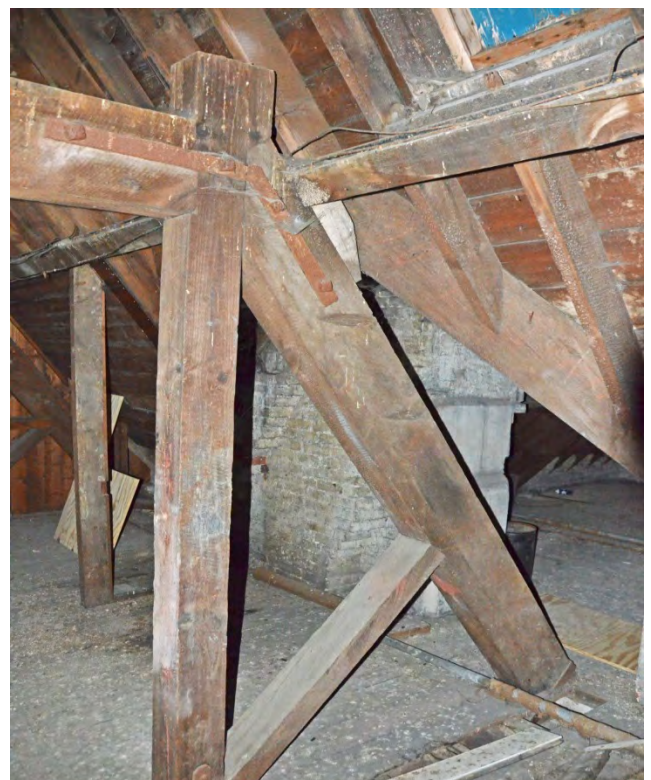
- 4.03 This external evidence is supported by internal evidence on accessible roof voids with large timber trusses present and in good condition where they are visible. The photograph opposite shows a typical roof truss connection with all elements retaining good lines and levels.

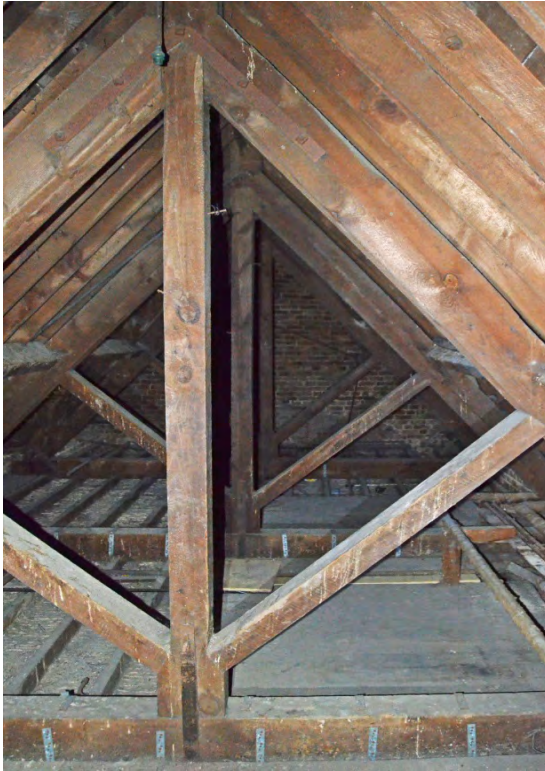
The photograph opposite illustrates a typical roof void with robust traditional king post trusses supporting a series of timber purlins and common rafters. The structure is in good condition generally and providing effective and efficient service to the existing building.

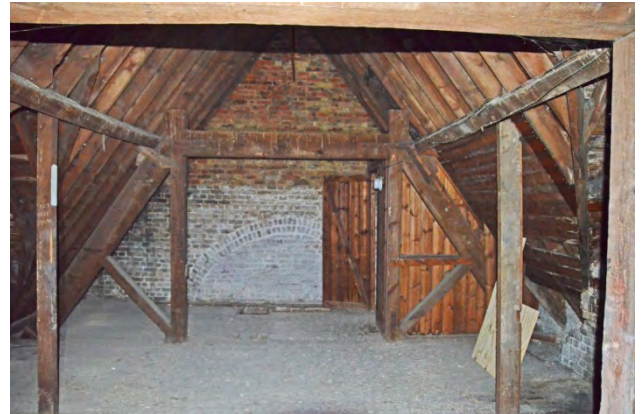
4.05 Other roof areas include more open attic voids with boarded floors and Queen Post truss arrangements as illustrated in the photograph opposite. As with the other areas inspected the trusses generally appear in good condition, providing effective service.

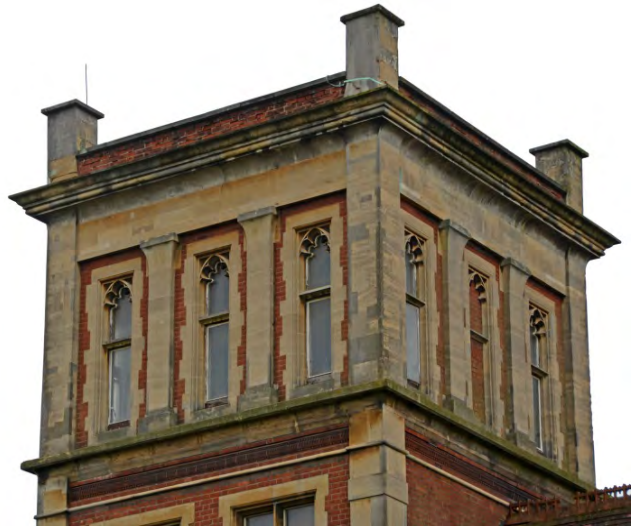
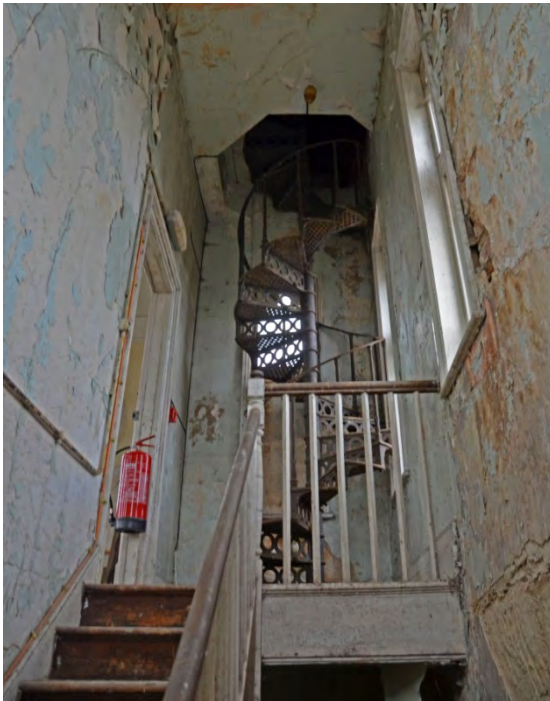
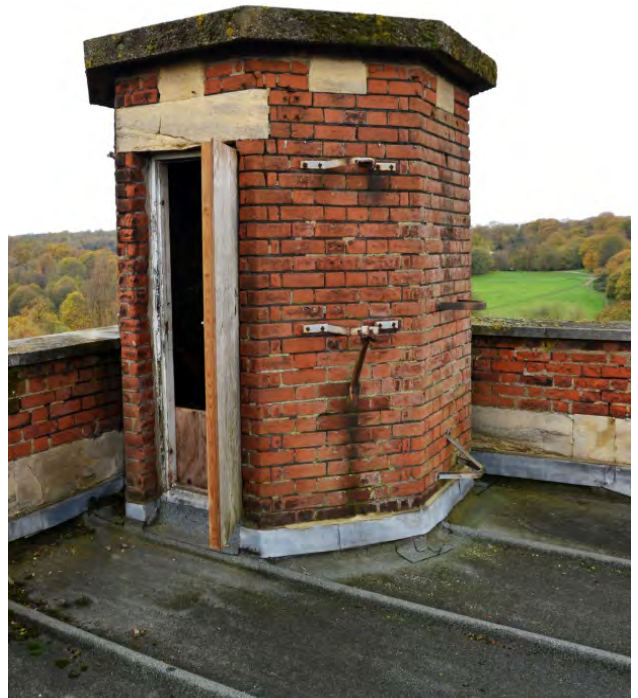
4.07 A principal and defining feature of the building is the single tower located above the east elevation and illustrated in the photograph opposite. Although some of the historic detailing has been lost the remaining masonry is in reasonable condition with no evidence of significant structural defects. Patch mortar repairs to stonework generally has been noted previously and is also present to the tower. The roof viewing area is accessed via a spiral stair as shown in the images below. Local defects are present to stone and brick requiring repair, however the overall configuration is considered to be reasonably structurally stable.
