**REPORT TO CLIENT
ASBESTOS DEMOLITION SURVEY**

WITHIN
UPRN 02912
25 Green Wood Place
London
NW5 1LB
On Behalf Of
London Borough of Camden
Contract Code: 607-02912
Date of Issue: 18th September 2014
First Issue

An Asbestos Pre-Demolition Survey was carried out within 25 Greenwood Place, London, NW5 1LB.

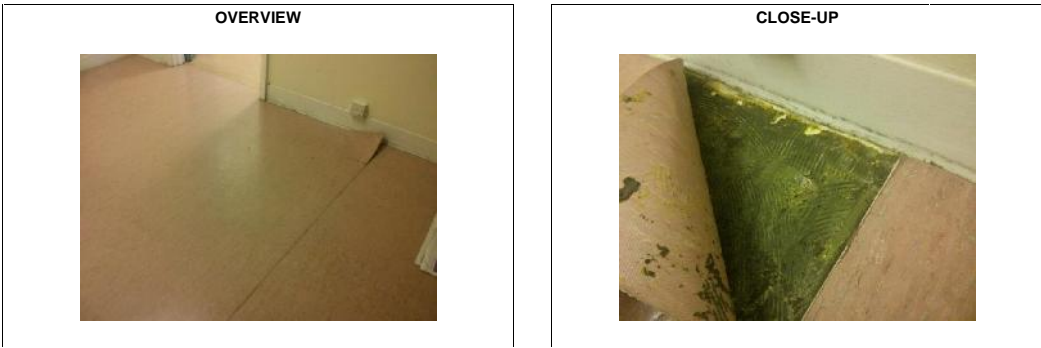
Floor:	G	Location description:	Kitchen
Room/Area:	006	Sample Number:	011
Material:	Vinyl/Thermo plastic	Item:	Beige flooring below pink vinyl
Measured Extent:	12 m²	Asbestos Type:	No asbestos detected
Damage/Condition:	Low	Notes: Plasterboard ceiling. Strammit board soffit. Solid walls. Timber ceiling joists. Plastic skirting. Pink modern vinyl to floor. Pipes penetrate concrete floor.

Recommendations:	No Action Required
------------------	--------------------

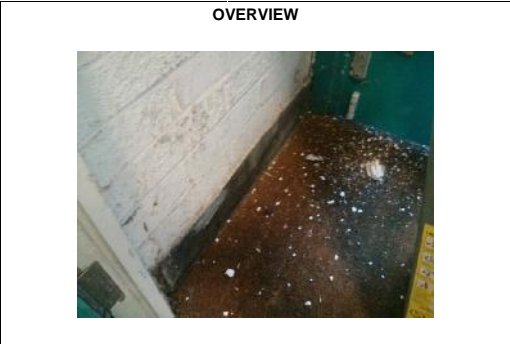
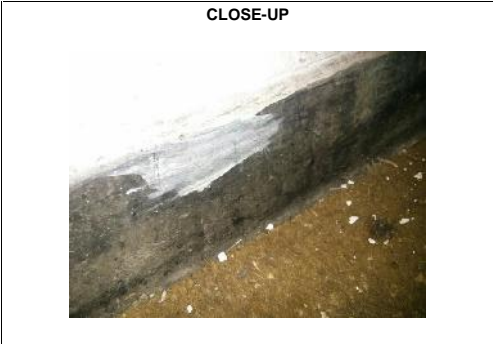
Floor:	G	Location description:	Lobbys
Room/Area:	008	Sample Number:	012
Material:	Composites	Item:	Black skirting
Measured Extent:	1 m	Asbestos Type:	No asbestos detected
Damage/Condition:	Low		
Notes:	Plasterboard ceiling. Strammit board soffit. Solid walls. Timber ceiling joists. Modern blue floor covering. MDF wall panel.

Recommendations:	No Action Required						
Material Assessment Scores							
Product:	1	Condition/damage:	1	Surface treatment :	0	Asbestos Type:	0
Priority Assessment							
Normal occupant Activity:	0						
Location:	0						
Accessibility:	0						
Extent / amount:	0						
Number of occupants:	0	Frequency of use of area:	0				
Average time area is in use:	0	Type of maintenance activity:	0				
Frequency of maintenance activity:	0						
Scores							
Material Assessment Score:		Priority Assessment Score:		Total Risk Score:

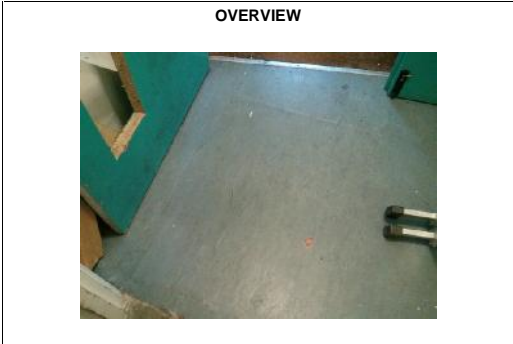
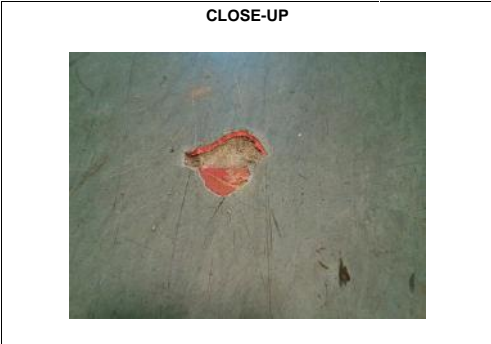
Floor:	G	Location description:	Lobbys
Room/Area:	008	Sample Number:	013
Material:	Vinyl/Thermo plastic	Item:	Red vinyl below modern vinyl
Measured Extent:	2.5 m²	Asbestos Type:	No asbestos detected
Damage/Condition:	Low		
Notes:

Recommendations:	No Action Required						
Material Assessment Scores							
Product:	1	Condition/damage:	1	Surface treatment :	0	Asbestos Type:	0
Priority Assessment							
Normal occupant Activity:	0						
Location:	0						
Accessibility:	0						
Extent / amount:	0						
Number of occupants:	0	Frequency of use of area:	0				
Average time area is in use:	0	Type of maintenance activity:	0				
Frequency of maintenance activity:	0						
Scores							
Material Assessment Score:		Priority Assessment Score:		Total Risk Score:

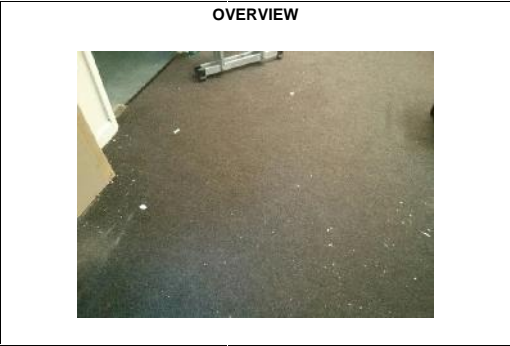
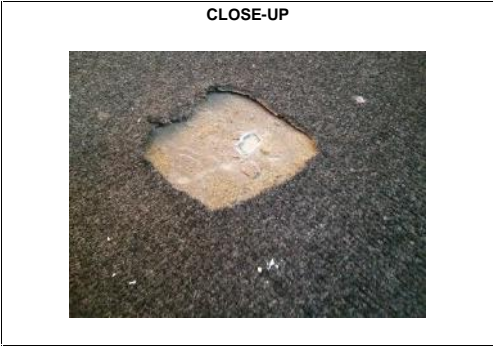
Floor:	G	Location description:	Welfare room
Room/Area:	010	Sample Number:	014
Material:	Vinyl/Thermo plastic	Item:	Beige vinyl below carpet
Measured Extent:	16 m ²	Asbestos Type:	No asbestos detected
Damage/Condition:	Low		
Notes:	Plasterboard ceiling. Strammit board soffit. Solid walls. Timber ceiling joists. Plasterboard boxing housing pipework. Plasterboard partition wall.

Recommendations:	No Action Required						
Material Assessment Scores							
Product:	1	Condition/damage:	1	Surface treatment :	0	Asbestos Type:	0
Priority Assessment							
Normal occupant Activity:	0						
Location:	0						
Accessibility:	0						
Extent / amount:	0						
Number of occupants:	0	Frequency of use of area:	0				
Average time area is in use:	0	Type of maintenance activity:	0				
Frequency of maintenance activity:	0						
Scores							
Material Assessment Score:		Priority Assessment Score:		Total Risk Score:

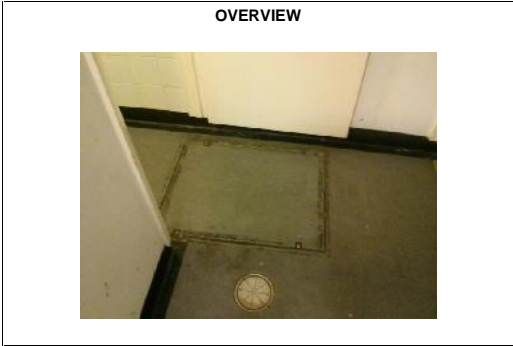
Floor:	G	Location description:	Toilets
Room/Area:	011	Sample Number:	P
Material:		Item:	Floor duct
Measured Extent:		Asbestos Type:	
Damage/Condition:			
Notes:	No access into floor duct without specialist equipment.

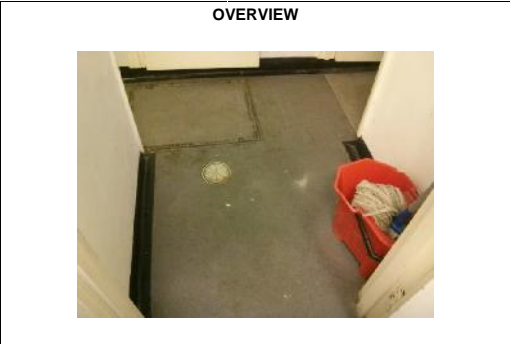
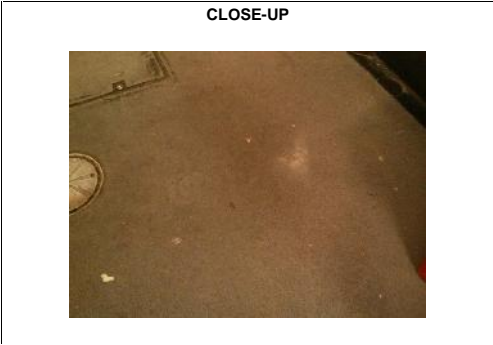
Floor:	G	Location description:	Toilets
Room/Area:	011	Sample Number:	015
Material:	Vinyl/Thermo plastic	Item:	Grey vinyl with screed
Measured Extent:	10 m²	Asbestos Type:	No asbestos detected
Damage/Condition:	Low		
Notes:	Plasterboard ceiling. Strammit board soffit. Solid walls. Timber ceiling joists. Plasterboard partition. Metal skylight. modern toilet cisterns. Plasterboard up stand to skylight.

Recommendations:	No Action Required						
Material Assessment Scores							
Product:	1	Condition/damage:	1	Surface treatment :	0	Asbestos Type:	0
Priority Assessment							
Normal occupant Activity:	0						
Location:	0						
Accessibility:	0						
Extent / amount:	0						
Number of occupants:	0	Frequency of use of area:	0				
Average time area is in use:	0	Type of maintenance activity:	0				
Frequency of maintenance activity:	0						
Scores							
Material Assessment Score:		Priority Assessment Score:		Total Risk Score:

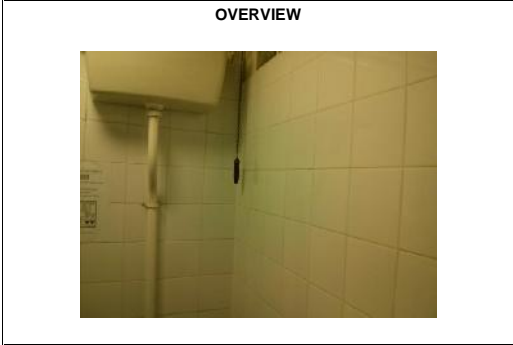
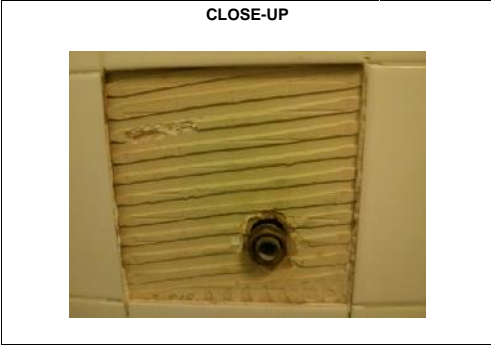
Floor:	G	Location description:	Toilets
Room/Area:	011	Sample Number:	016
Material:	Composites	Item:	Tile grout
Measured Extent:	30 m²	Asbestos Type:	No asbestos detected
Damage/Condition:	Good		
Notes:

Recommendations:	No Action Required						
Material Assessment Scores							
Product:	1	Condition/damage:	0	Surface treatment :	0	Asbestos Type:	0
Priority Assessment							
Normal occupant Activity:	0						
Location:	0						
Accessibility:	0						
Extent / amount:	0						
Number of occupants:	0	Frequency of use of area:	0				
Average time area is in use:	0	Type of maintenance activity:	0				
Frequency of maintenance activity:	0						
Scores							
Material Assessment Score:		Priority Assessment Score:		Total Risk Score:

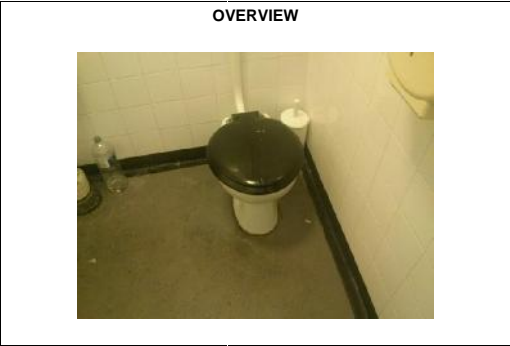
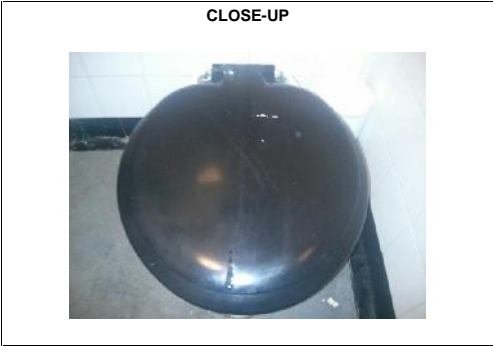
Floor:	G	Location description:	Toilets
Room/Area:	011	Sample Number:	017
Material:	Vinyl/Thermo plastic	Item:	Toilet seat
Measured Extent:	1 No.	Asbestos Type:	No asbestos detected
Damage/Condition:	Low		
Notes:

Recommendations:	No Action Required
------------------	--------------------

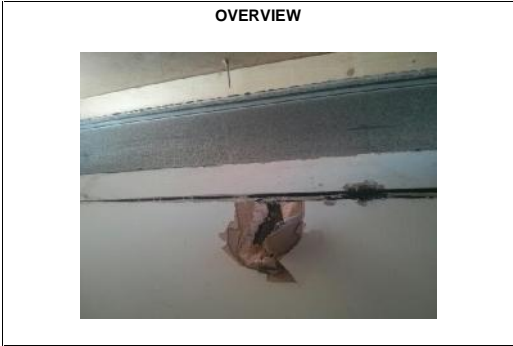
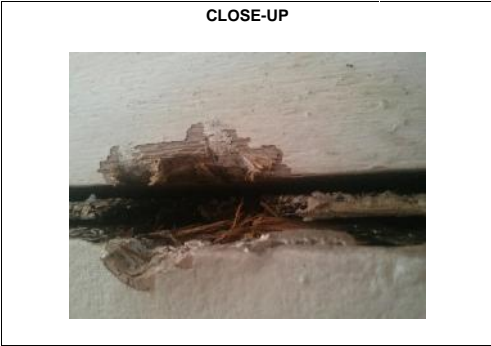
Floor:	G	Location description:	Toilets
Room/Area:	011	Sample Number:	018
Material:	Bituminous	Item:	Roofing felt below skylight
Measured Extent:	4 m visible	Asbestos Type:	No asbestos detected
Damage/Condition:	Low		
Notes:

Recommendations:	No Action Required
------------------	--------------------

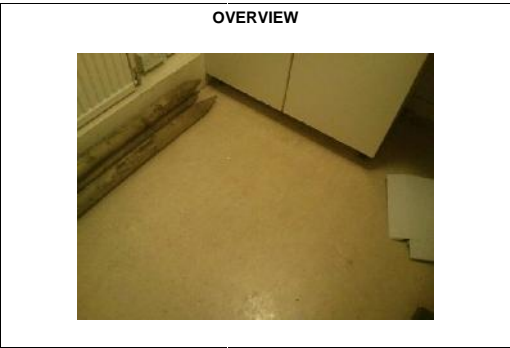
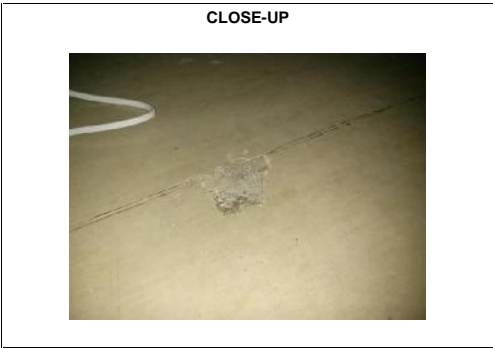
Floor:	G	Location description:	Kitchen
Room/Area:	013	Sample Number:	019
Material:	Vinyl/Thermo plastic	Item:	Beige vinyl flooring
Measured Extent:	8 m²	Asbestos Type:	No asbestos detected
Damage/Condition:	Low		
Notes:	Plasterboard ceiling. Strammit board soffit. Solid walls. Timber ceiling joists. Plasterboard partition walls. Sink pad present previously sampled NAD. Metal skylight. Plasterboard up stand.

Recommendations:	No Action Required						
Material Assessment Scores							
Product:	1	Condition/damage:	1	Surface treatment :	0	Asbestos Type:	0
Priority Assessment							
Normal occupant Activity:	0						
Location:	0						
Accessibility:	0						
Extent / amount:	0						
Number of occupants:	0	Frequency of use of area:	0				
Average time area is in use:	0	Type of maintenance activity:	0				
Frequency of maintenance activity:	0						
Scores							
Material Assessment Score:		Priority Assessment Score:		Total Risk Score:

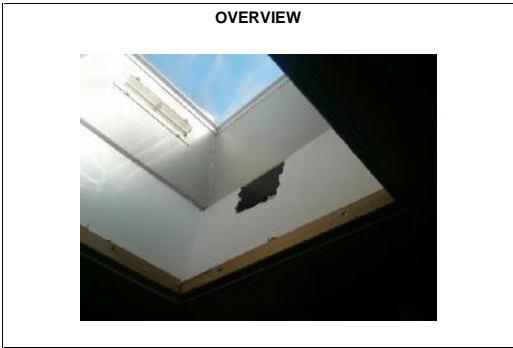
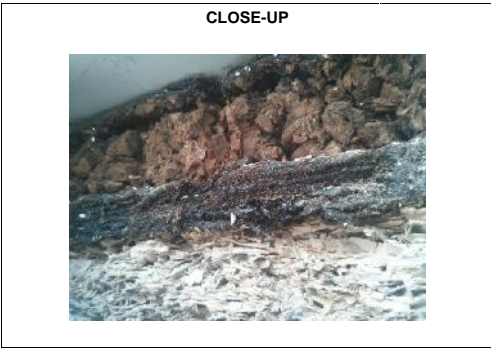
Floor:	G	Location description:	Kitchen
Room/Area:	013	Sample Number:	020
Material:	Composites	Item:	Full depth roof sample
Measured Extent:	unquantified	Asbestos Type:	No asbestos detected
Damage/Condition:	Low		
Notes:	Skylight has been fitted revealing the full construction of the flat roof.

Recommendations:	No Action Required						
Material Assessment Scores							
Product:	1	Condition/damage:	1	Surface treatment :	0	Asbestos Type:	0
Priority Assessment							
Normal occupant Activity:	0						
Location:	0						
Accessibility:	0						
Extent / amount:	0						
Number of occupants:	0	Frequency of use of area:	0				
Average time area is in use:	0	Type of maintenance activity:	0				
Frequency of maintenance activity:	0						
Scores							
Material Assessment Score:		Priority Assessment Score:		Total Risk Score:

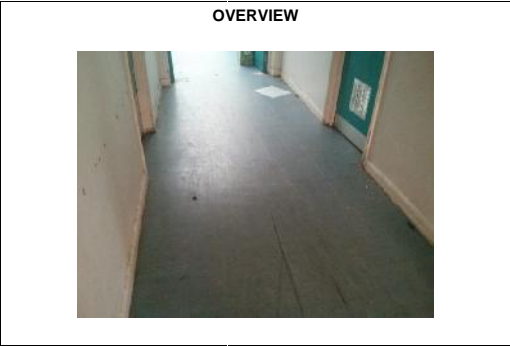
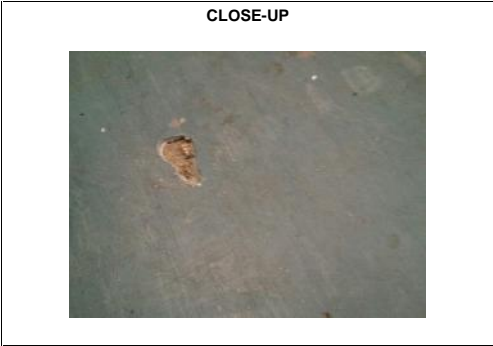
Floor:	G	Location description:	Corridor
Room/Area:	016	Sample Number:	021
Material:	Vinyl/Thermo plastic	Item:	Beige blue floor covering
Measured Extent:	22 m²	Asbestos Type:	No asbestos detected
Damage/Condition:			
Notes:	Plasterboard ceiling. Strammit board soffit. Solid walls. Timber ceiling joists. Plasterboard door surrounds. RSJ. Plasterboard partition with man made mineral fibre core. Metal skylight. Plasterboard up stand to skylight.

Recommendations:	No Action Required						
Material Assessment Scores							
Product:	1	Condition/damage:		Surface treatment :	0	Asbestos Type:	0
Priority Assessment							
Normal occupant Activity:	0						
Location:	0						
Accessibility:	0						
Extent / amount:	0						
Number of occupants:	0	Frequency of use of area:	0				
Average time area is in use:	0	Type of maintenance activity:	0				
Frequency of maintenance activity:	0						
Scores							
Material Assessment Score:		Priority Assessment Score:		Total Risk Score:

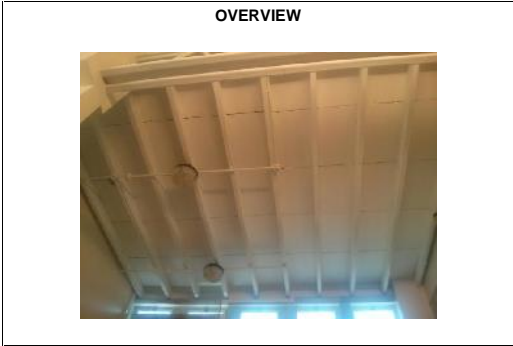
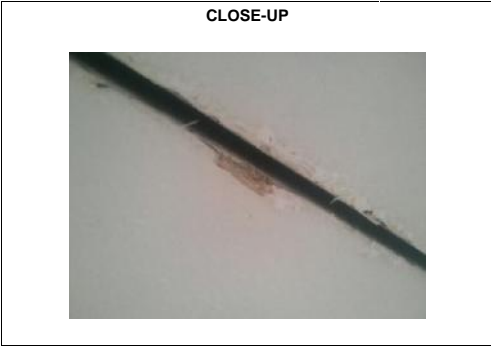
Floor:	G	Location description:	Lobby and 2 stores
Room/Area:	017	Sample Number:	022
Material:	Insulating board	Item:	Ceiling panels
Measured Extent:	30 m²	Asbestos Type:	No asbestos detected
Damage/Condition:	Good		
Notes:

Recommendations:	No Action Required						
Material Assessment Scores							
Product:	2	Condition/damage:	0	Surface treatment :	1	Asbestos Type:	0
Priority Assessment							
Normal occupant Activity:	0						
Location:	0						
Accessibility:	0						
Extent / amount:	0						
Number of occupants:	0	Frequency of use of area:	0				
Average time area is in use:	0	Type of maintenance activity:	0				
Frequency of maintenance activity:	0						
Scores							
Material Assessment Score:		Priority Assessment Score:		Total Risk Score:

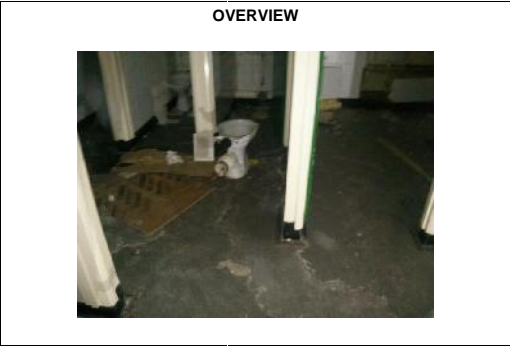
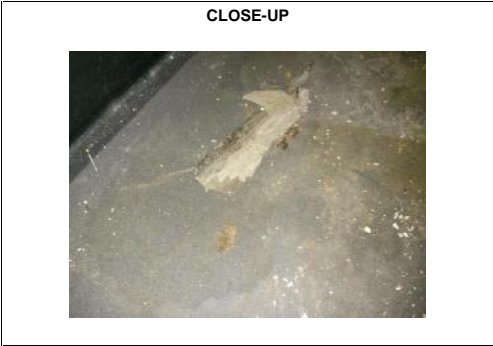
Floor:	G	Location description:	Toilets
Room/Area:	019	Sample Number:	023
Material:	Vinyl/Thermo plastic	Item:	Floor covering
Measured Extent:	50 m²	Asbestos Type:	No asbestos detected
Damage/Condition:	Low		
Notes:	Plasterboard ceiling. Strammit board soffit. Solid walls. Timber ceiling joists. Quarry tiles to concrete floor. Plastic skirting. Concrete partitions between cubicles. Plastic soil pipes. Timber boxing's. Fibreglass and metal air vent to ceiling. Toilet seat noted to floor.

Recommendations:	No Action Required						
Material Assessment Scores							
Product:	1	Condition/damage:	1	Surface treatment :	0	Asbestos Type:	0
Priority Assessment							
Normal occupant Activity:	0						
Location:	0						
Accessibility:	0						
Extent / amount:	0						
Number of occupants:	0	Frequency of use of area:	0				
Average time area is in use:	0	Type of maintenance activity:	0				
Frequency of maintenance activity:	0						
Scores							
Material Assessment Score:		Priority Assessment Score:		Total Risk Score:

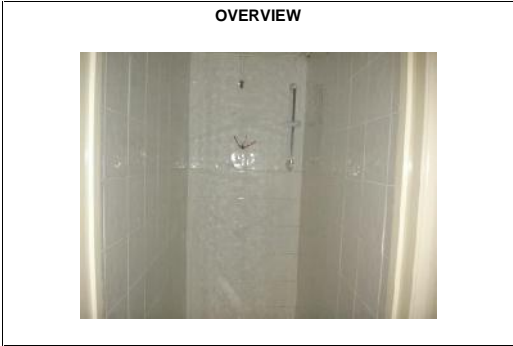
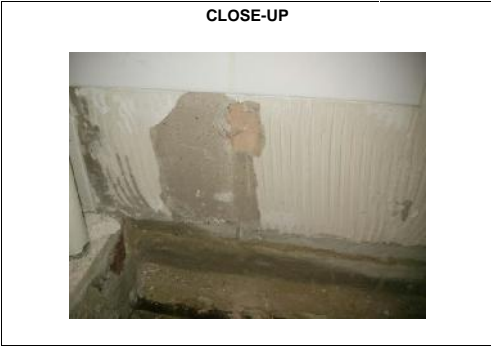
Floor:	G	Location description:	Toilets
Room/Area:	019	Sample Number:	024
Material:	Vinyl/Thermo plastic	Item:	Tile grout
Measured Extent:	56 m²	Asbestos Type:	No asbestos detected
Damage/Condition:	Good		
Notes:

Recommendations:	No Action Required						
Material Assessment Scores							
Product:	1	Condition/damage:	0	Surface treatment :	0	Asbestos Type:	0
Priority Assessment							
Normal occupant Activity:	0						
Location:	0						
Accessibility:	0						
Extent / amount:	0						
Number of occupants:	0	Frequency of use of area:	0				
Average time area is in use:	0	Type of maintenance activity:	0				
Frequency of maintenance activity:	0						
Scores							
Material Assessment Score:		Priority Assessment Score:		Total Risk Score:

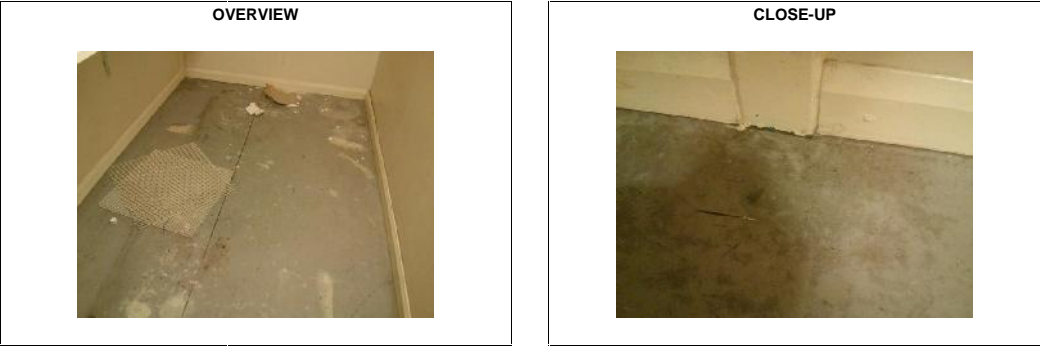
Floor:	G	Location description:	Room
Room/Area:	022	Sample Number:	025
Material:	Vinyl/Thermo plastic	Item:	Floor covering
Measured Extent:	10 m²	Asbestos Type:	No asbestos detected
Damage/Condition:	Low		
Notes:	Plasterboard ceiling. Strammit board soffit. Solid walls. Timber ceiling joists. Plasterboard partition walls.

Recommendations:	No Action Required						
Material Assessment Scores							
Product:	1	Condition/damage:	1	Surface treatment :	0	Asbestos Type:	0
Priority Assessment							
Normal occupant Activity:	0						
Location:	0						
Accessibility:	0						
Extent / amount:	0						
Number of occupants:	0	Frequency of use of area:	0				
Average time area is in use:	0	Type of maintenance activity:	0				
Frequency of maintenance activity:	0						
Scores							
Material Assessment Score:		Priority Assessment Score:		Total Risk Score:

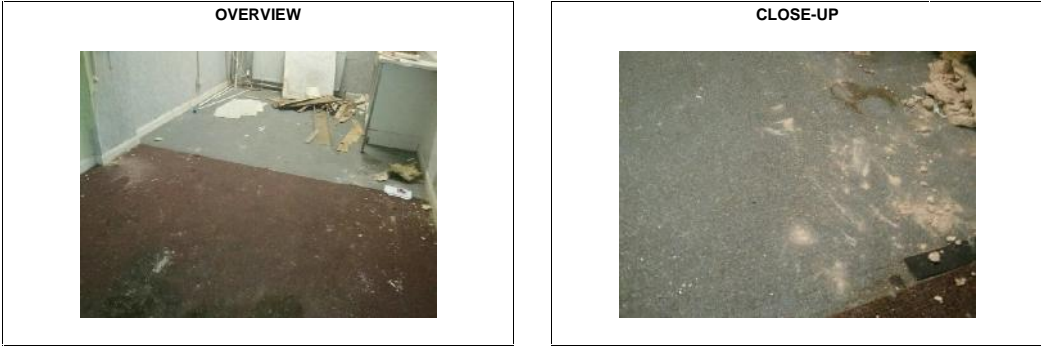
Floor:	G	Location description:	Rooms
Room/Area:	027	Sample Number:	026
Material:	Vinyl/Thermo plastic	Item:	Beige floor covering below carpet
Measured Extent:	30 m²	Asbestos Type:	No asbestos detected
Damage/Condition:	Low		
Notes:	Plasterboard ceiling. Strammit board soffit. Solid walls. Timber ceiling joists. Plasterboard partitions with man made mineral fibre core. Sink pads noted previously sampled NAD.

Recommendations:	No Action Required						
Material Assessment Scores							
Product:	1	Condition/damage:	1	Surface treatment :	0	Asbestos Type:	0
Priority Assessment							
Normal occupant Activity:	0						
Location:	0						
Accessibility:	0						
Extent / amount:	0						
Number of occupants:	0	Frequency of use of area:	0				
Average time area is in use:	0	Type of maintenance activity:	0				
Frequency of maintenance activity:	0						
Scores							
Material Assessment Score:		Priority Assessment Score:		Total Risk Score:

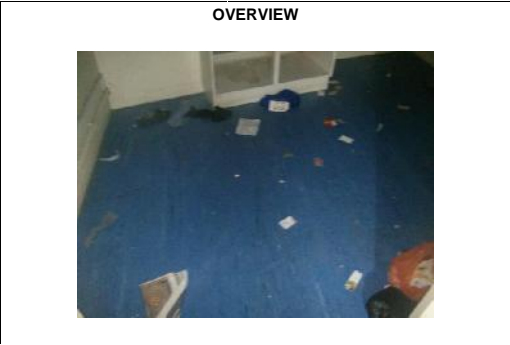
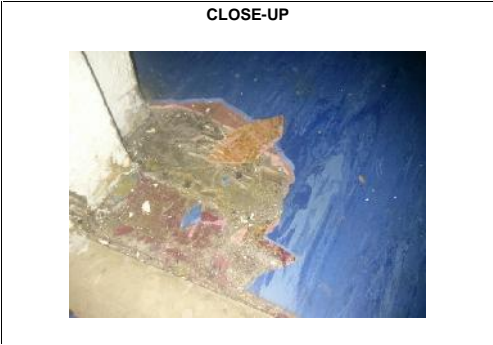
Floor:	G	Location description:	Room and kitchen
Room/Area:	030	Sample Number:	027
Material:	Vinyl/Thermo plastic	Item:	Pink floor covering
Measured Extent:	8 m²	Asbestos Type:	No asbestos detected
Damage/Condition:	Low		
Notes:	Plasterboard ceiling. Strammit board soffit. Solid walls. Timber ceiling joists. Modern vinyl onto concrete floor. Plasterboard partitions. Sink pads noted already sampled NAD. Pink floor covering only in kitchen. Timber boxing housing ceiling mounted pipework. Plasterboard to skylight up stand with timber behind.

Recommendations:	No Action Required						
Material Assessment Scores							
Product:	1	Condition/damage:	1	Surface treatment :	0	Asbestos Type:	0
Priority Assessment							
Normal occupant Activity:	0						
Location:	0						
Accessibility:	0						
Extent / amount:	0						
Number of occupants:	0	Frequency of use of area:	0				
Average time area is in use:	0	Type of maintenance activity:	0				
Frequency of maintenance activity:	0						
Scores							
Material Assessment Score:		Priority Assessment Score:		Total Risk Score:

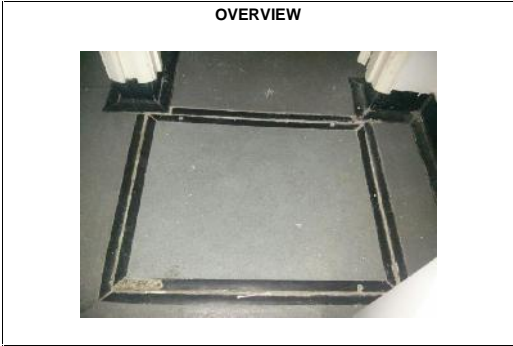
Floor:	G	Location description:	Toilets
Room/Area:	031	Sample Number:	P
Material:		Item:	Floor drains
Measured Extent:		Asbestos Type:	
Damage/Condition:			
Notes:	No access into fixed drains. Plasterboard up stands to metal skylight. Timber lining to ceiling vent.

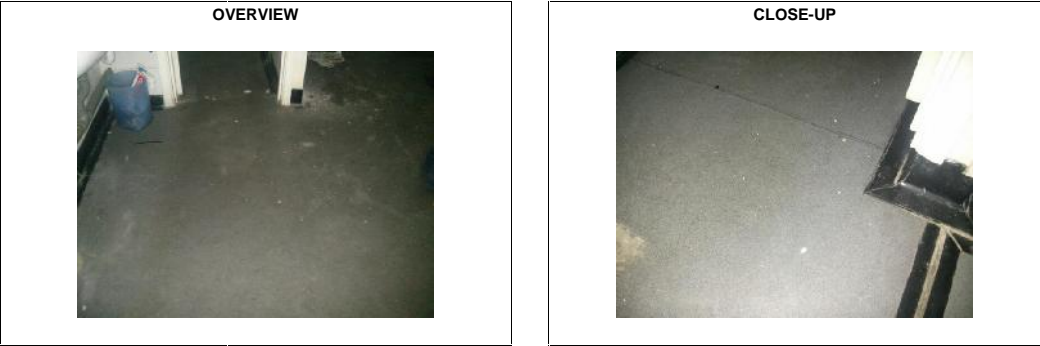
Floor:	G	Location description:	Toilets
Room/Area:	031	Sample Number:	028
Material:	Vinyl/Thermo plastic	Item:	Floor covering and screed
Measured Extent:	25 m²	Asbestos Type:	No asbestos detected
Damage/Condition:	Low	Notes:	Plasterboard ceiling. Strammit board soffit. Solid walls. Timber ceiling joists. Breeze block toilet partition walls with ceramic tiles.

Recommendations:	No Action Required						
Material Assessment Scores							
Product:	1	Condition/damage:	1	Surface treatment :	0	Asbestos Type:	0
Priority Assessment							
Normal occupant Activity:	0						
Location:	0						
Accessibility:	0						
Extent / amount:	0						
Number of occupants:	0	Frequency of use of area:	0				
Average time area is in use:	0	Type of maintenance activity:	0				
Frequency of maintenance activity:	0						
Scores							
Material Assessment Score:		Priority Assessment Score:		Total Risk Score:

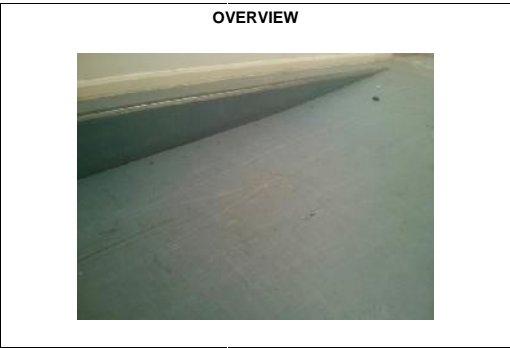
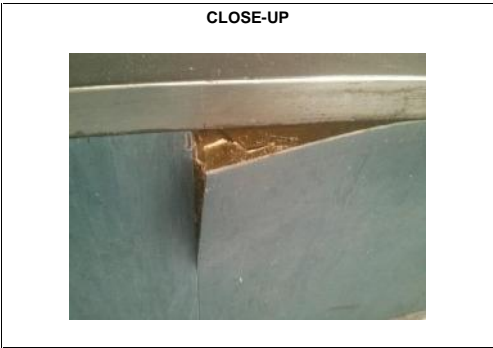
Floor:	G	Location description:	Corridor
Room/Area:	033	Sample Number:	030
Material:	Vinyl/Thermo plastic	Item:	Green bongo below blue vinyl
Measured Extent:	25 m²	Asbestos Type:	No asbestos detected
Damage/Condition:	Low		
Notes:	Modern ceiling tiles. Plasterboard boxing. Man made mineral insulation to pipework. Plasterboard partition walls with man made mineral fibre core. Modern floor covering with concrete floor below. Fibreboard secondary ceiling.

Recommendations:	No Action Required						
Material Assessment Scores							
Product:	1	Condition/damage:	1	Surface treatment :	0	Asbestos Type:	0
Priority Assessment							
Normal occupant Activity:	0						
Location:	0						
Accessibility:	0						
Extent / amount:	0						
Number of occupants:	0	Frequency of use of area:	0				
Average time area is in use:	0	Type of maintenance activity:	0				
Frequency of maintenance activity:	0						
Scores							
Material Assessment Score:		Priority Assessment Score:		Total Risk Score:

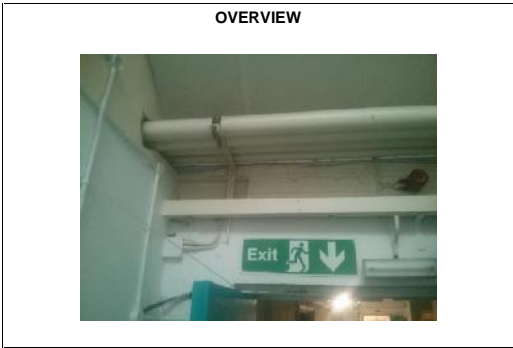
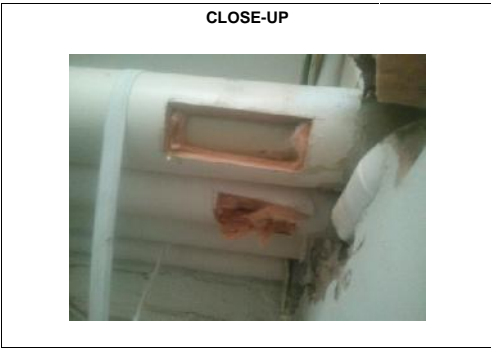
Floor:	G	Location description:	Corridor
Room/Area:	033	Sample Number:	031
Material:	Insulation, lagging, sprays	Item:	Pipe insulation
Measured Extent:	6 m	Asbestos Type:	No asbestos detected
Damage/Condition:	Low		
Notes:

Recommendations:	No Action Required						
Material Assessment Scores							
Product:	3	Condition/damage:	1	Surface treatment :	2	Asbestos Type:	0
Priority Assessment							
Normal occupant Activity:	0						
Location:	0						
Accessibility:	0						
Extent / amount:	0						
Number of occupants:	0	Frequency of use of area:	0				
Average time area is in use:	0	Type of maintenance activity:	0				
Frequency of maintenance activity:	0						
Scores							
Material Assessment Score:		Priority Assessment Score:		Total Risk Score:

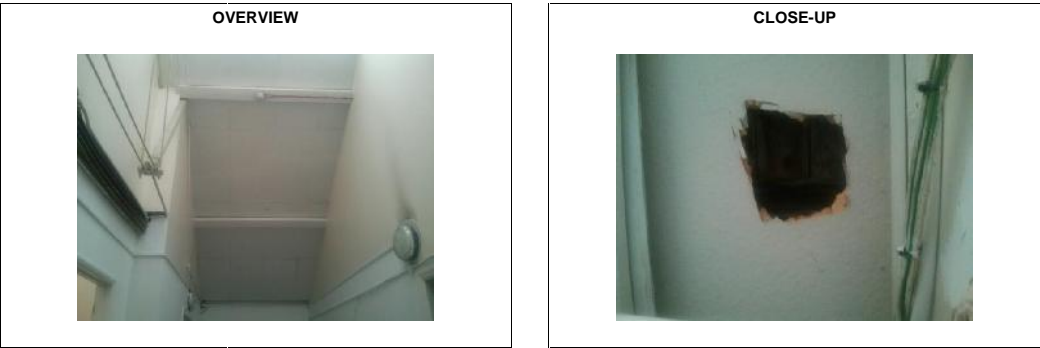
Floor:	G	Location description:	Corridor
Room/Area:	033	Sample Number:	032
Material:	Insulating board	Item:	Compressed fibreboard ceiling tile
Measured Extent:	32 m²	Asbestos Type:	No asbestos detected
Damage/Condition:	Low		
Notes:

Recommendations:	No Action Required
------------------	--------------------

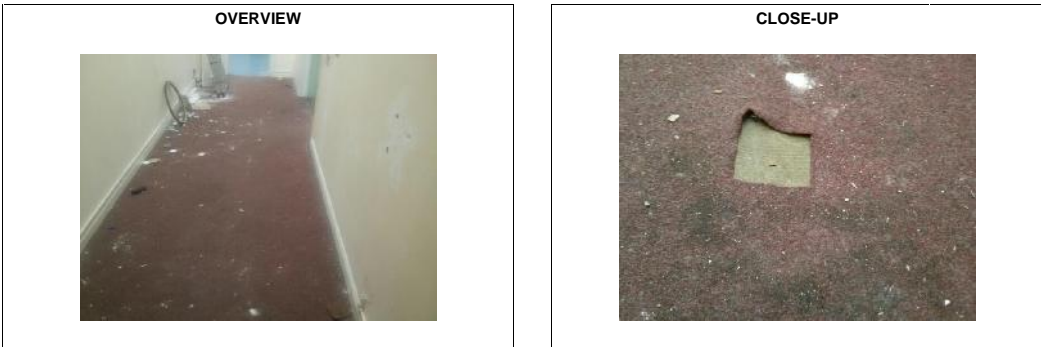
Floor:	G	Location description:	Rooms
Room/Area:	034	Sample Number:	033
Material:	Vinyl/Thermo plastic	Item:	Green vinyl below carpets
Measured Extent:	90 m²	Asbestos Type:	No asbestos detected
Damage/Condition:	Low		
Notes:	Material also noted below modern vinyl. Modern ceiling tiles. Plasterboard boxing. Man made mineral insulation to pipework. Plasterboard partition walls with man made mineral fibre core. Modern floor covering with concrete floor below. Fibreboard secondary ceiling. Metal water tank with man made mineral fibre insulation. Sadia water heater present. No obvious mastic seals to ceiling vent. Plasterboard and timber skylights.

Recommendations:	No Action Required
------------------	--------------------

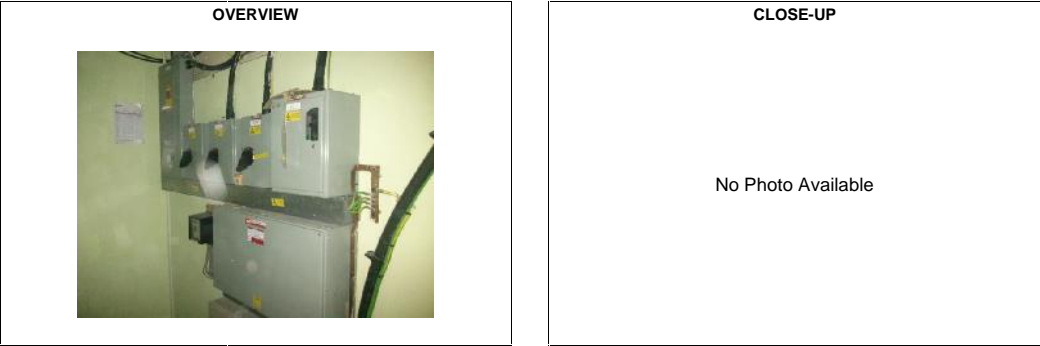
Floor:	G	Location description:	Electrical cupboard and store
Room/Area:	035	Sample Number:	P
Material:		Item:	Electrics
Measured Extent:		Asbestos Type:	
Damage/Condition:			
Notes:	Presumed live electrics.

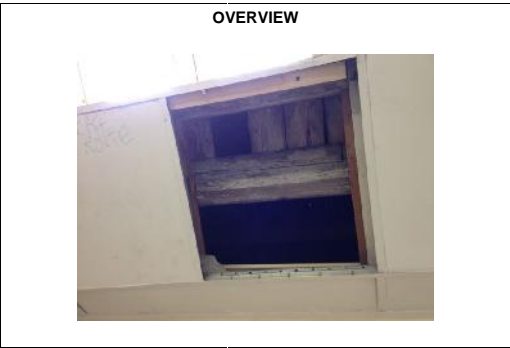
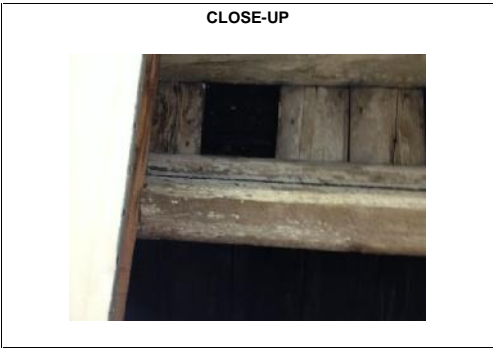
Floor:	G	Location description:	Rooms
Room/Area:	037	Sample Number:	035
Material:	Bituminous	Item:	Bituminous roofing material
Measured Extent:	1 m visible	Asbestos Type:	No asbestos detected
Damage/Condition:	Low		
Notes:	Noted within ceiling void behind timber roof structure.

Recommendations:	No Action Required
------------------	--------------------

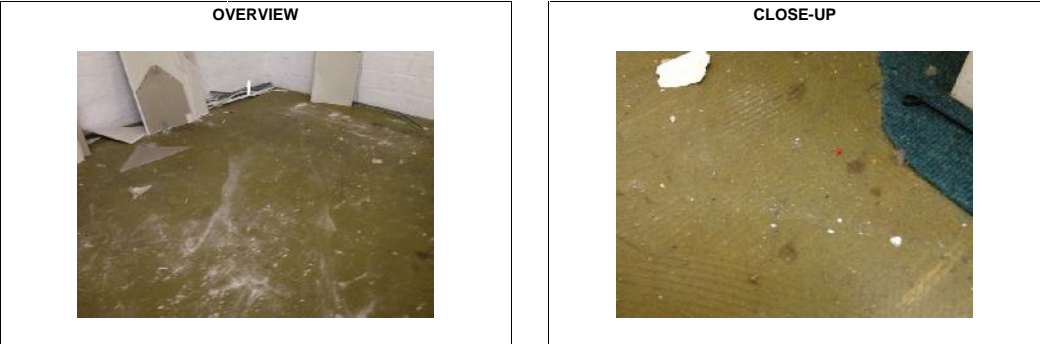
Floor:	G	Location description:	Rooms
Room/Area:	038	Sample Number:	036
Material:	Vinyl/Thermo plastic	Item:	Vinyl below carpet
Measured Extent:	90 m²	Asbestos Type:	No asbestos detected
Damage/Condition:	Low		
Notes:	Modern plasterboard ceiling tiles. Fibreboard secondary ceiling. Timber boxing to radiator and pipework. Concrete floor. Plasterboard partition walls man made mineral fibre core.

Recommendations:	No Action Required						
Material Assessment Scores							
Product:	1	Condition/damage:	1	Surface treatment :	0	Asbestos Type:	0
Priority Assessment							
Normal occupant Activity:	0						
Location:	0						
Accessibility:	0						
Extent / amount:	0						
Number of occupants:	0	Frequency of use of area:	0				
Average time area is in use:	0	Type of maintenance activity:	0				
Frequency of maintenance activity:	0						
Scores							
Material Assessment Score:		Priority Assessment Score:		Total Risk Score:

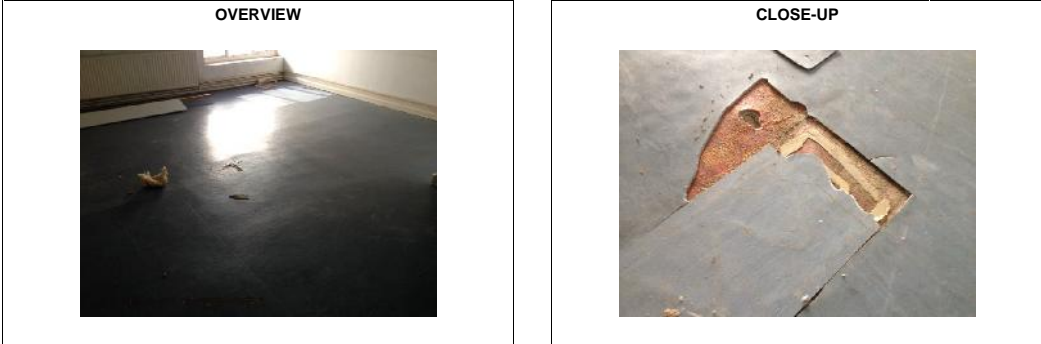
Floor:	G	Location description:	Rooms
Room/Area:	043	Sample Number:	037
Material:	Vinyl/Thermo plastic	Item:	Floor coverings
Measured Extent:	40 m²	Asbestos Type:	No asbestos detected
Damage/Condition:	Low		
Notes:	Plasterboard ceiling tiles. Fibreboard secondary ceiling. Timber roof structure. Plasterboard walls. Brick walls. Timber floor boards. Timber and plasterboard boxing housing pipework.

Recommendations:	No Action Required						
Material Assessment Scores							
Product:	1	Condition/damage:	1	Surface treatment :	0	Asbestos Type:	0
Priority Assessment							
Normal occupant Activity:	0						
Location:	0						
Accessibility:	0						
Extent / amount:	0						
Number of occupants:	0	Frequency of use of area:	0				
Average time area is in use:	0	Type of maintenance activity:	0				
Frequency of maintenance activity:	0						
Scores							
Material Assessment Score:		Priority Assessment Score:		Total Risk Score:

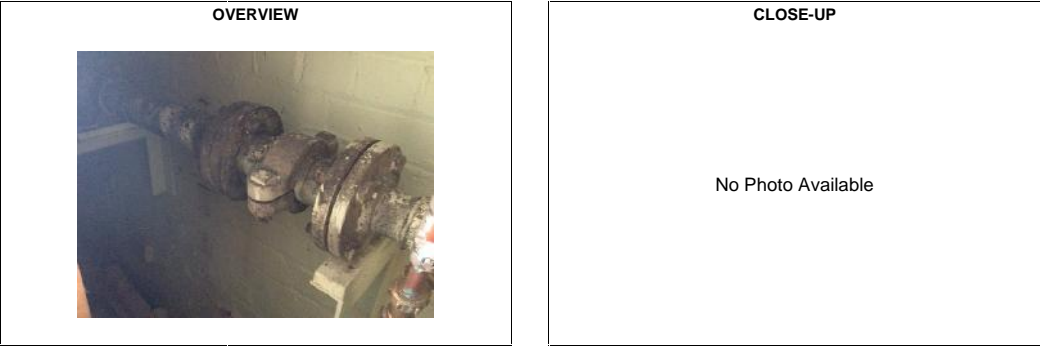
Floor:	G	Location description:	Void space
Room/Area:	044	Sample Number:	P
Material:	Gasket	Item:	Gaskets
Measured Extent:		Asbestos Type:	
Damage/Condition:			
Notes:	Man made mineral fibre insulation to pipework. Plasterboard partition wall. Concrete floor. Gaskets too tight to sample.

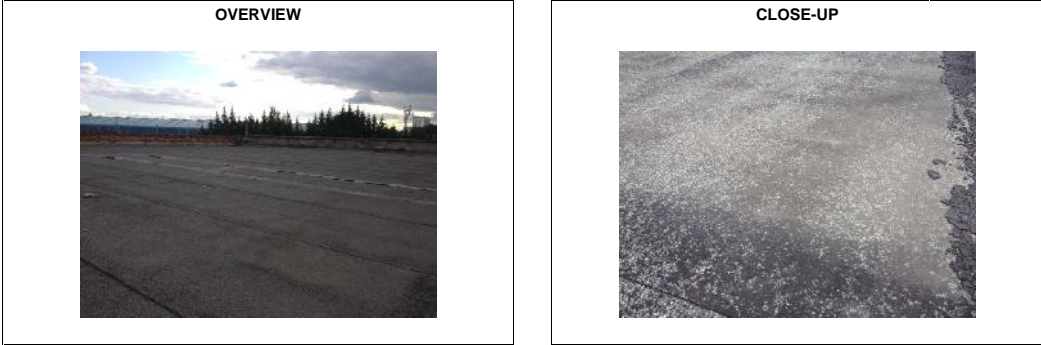
Floor:	Ext	Location description:	Flat roof 3
Room/Area:	045	Sample Number:	038
Material:	Bituminous	Item:	Roof Felt
Measured Extent:	200 m²	Asbestos Type:	No asbestos detected
Damage/Condition:	Good		
Notes:	Cannot fully assess as would significantly damage.

Recommendations:	No Action Required		
------------------	--------------------	--	--

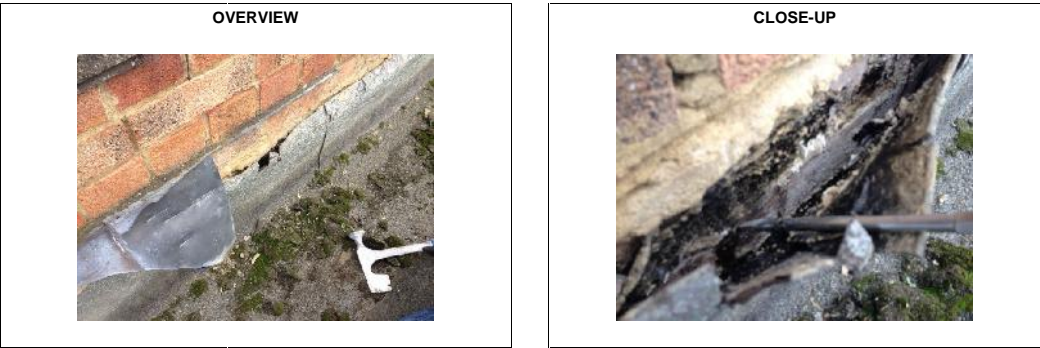
Floor:	Ext	Location description:	Flat roof 1
Room/Area:	045	Sample Number:	039
Material:	Bituminous	Item:	Roofing felt up stand
Measured Extent:	m	Asbestos Type:	No asbestos detected
Damage/Condition:	Low	Notes:	Two layers felt and backing.

Recommendations:	No Action Required
------------------	--------------------

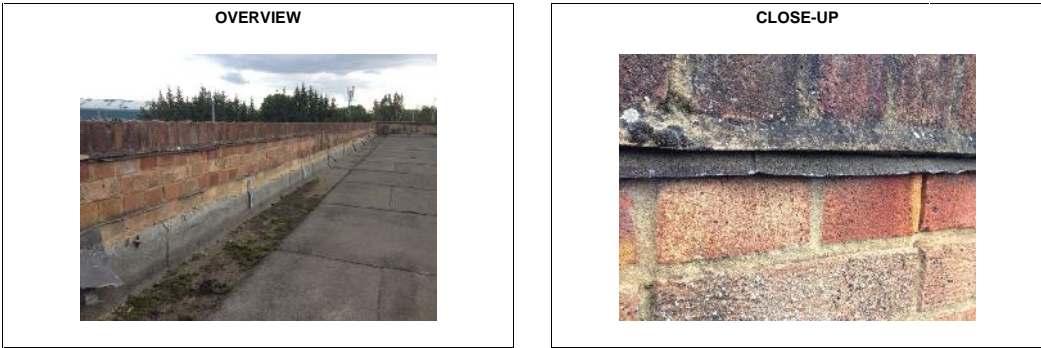
Floor:	Ext	Location description:	Flat roof 1
Room/Area:	045	Sample Number:	040
Material:	Bituminous	Item:	Bitumen to parapet wall
Measured Extent:	20 m	Asbestos Type:	No asbestos detected
Damage/Condition:	Low	Notes:

Recommendations:	No Action Required
------------------	--------------------

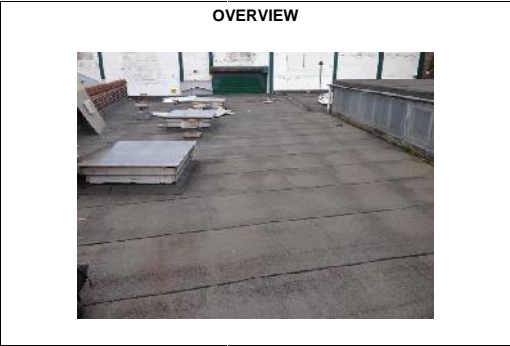
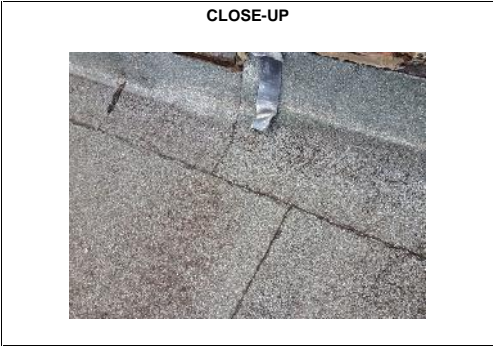
Floor:	Ext	Location description:	Flat roof 2
Room/Area:	046	Sample Number:	041
Material:	Bituminous	Item:	Roof felt
Measured Extent:	200 m²	Asbestos Type:	No asbestos detected
Damage/Condition:	Low		
Notes:	Metal skylights.

Recommendations:	No Action Required
------------------	--------------------

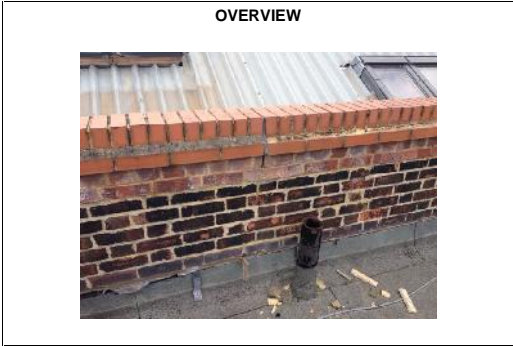
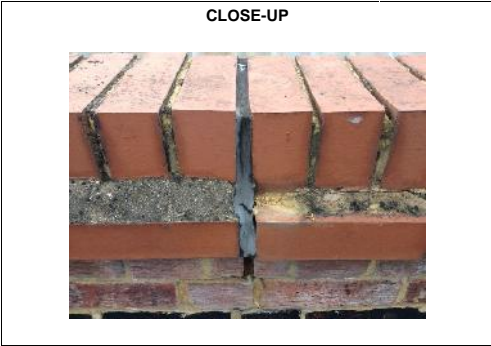
Floor:	Ext	Location description:	Flat roof 2
Room/Area:	046	Sample Number:	042
Material:	Bituminous	Item:	Joint sealant
Measured Extent:	3 m	Asbestos Type:	No asbestos detected
Damage/Condition:	Low		
Notes:	Metal soil pipes. Metal vent covers.

Recommendations:	No Action Required
------------------	--------------------

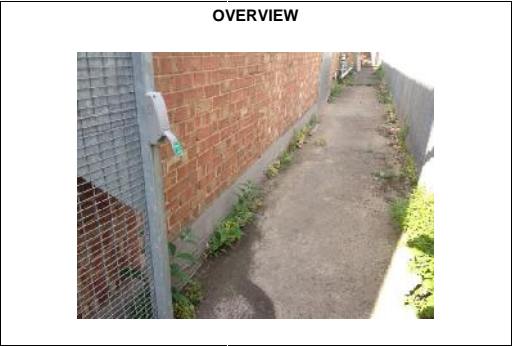
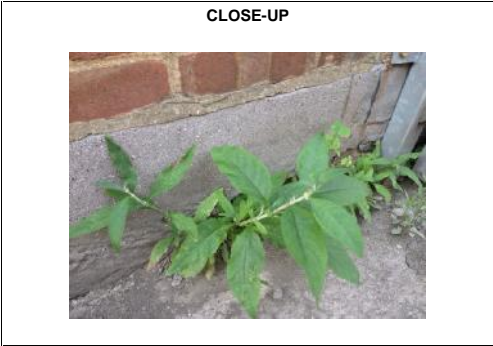
Floor:	Ext	Location description:	External
Room/Area:	048	Sample Number:	043
Material:	Bituminous	Item:	Low level damp proofing
Measured Extent:	36 m	Asbestos Type:	No asbestos detected
Damage/Condition:	Low		
Notes:

Recommendations:	No Action Required
------------------	--------------------

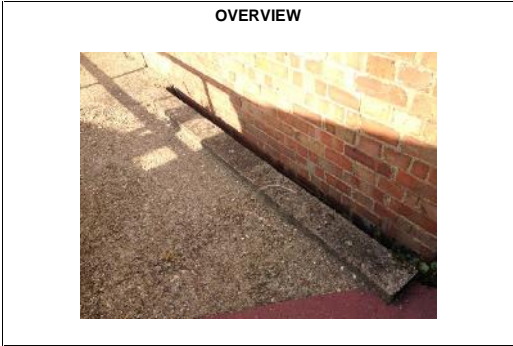
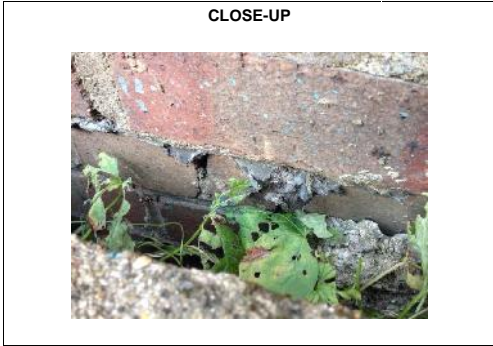
Floor:	Ext	Location description:	External
Room/Area:	048	Sample Number:	044
Material:	Bituminous	Item:	Damp proof course
Measured Extent:	Not quantified Not quantified	Asbestos Type:	No asbestos detected
Damage/Condition:	Low		
Notes:	Metal and plastic rain water goods. Stone, UPVC and timber cills.

Recommendations:	No Action Required
------------------	--------------------
