ARBORICULTURAL IMPACT ASSESSMENT REPORT  
& OUTLINE METHOD STATEMENT:

10 Hampstead Square  
London  
NW3 1AB

Ref: SAV/10HMQ/AIM/01

Date: 2<sup>nd</sup> August 2016

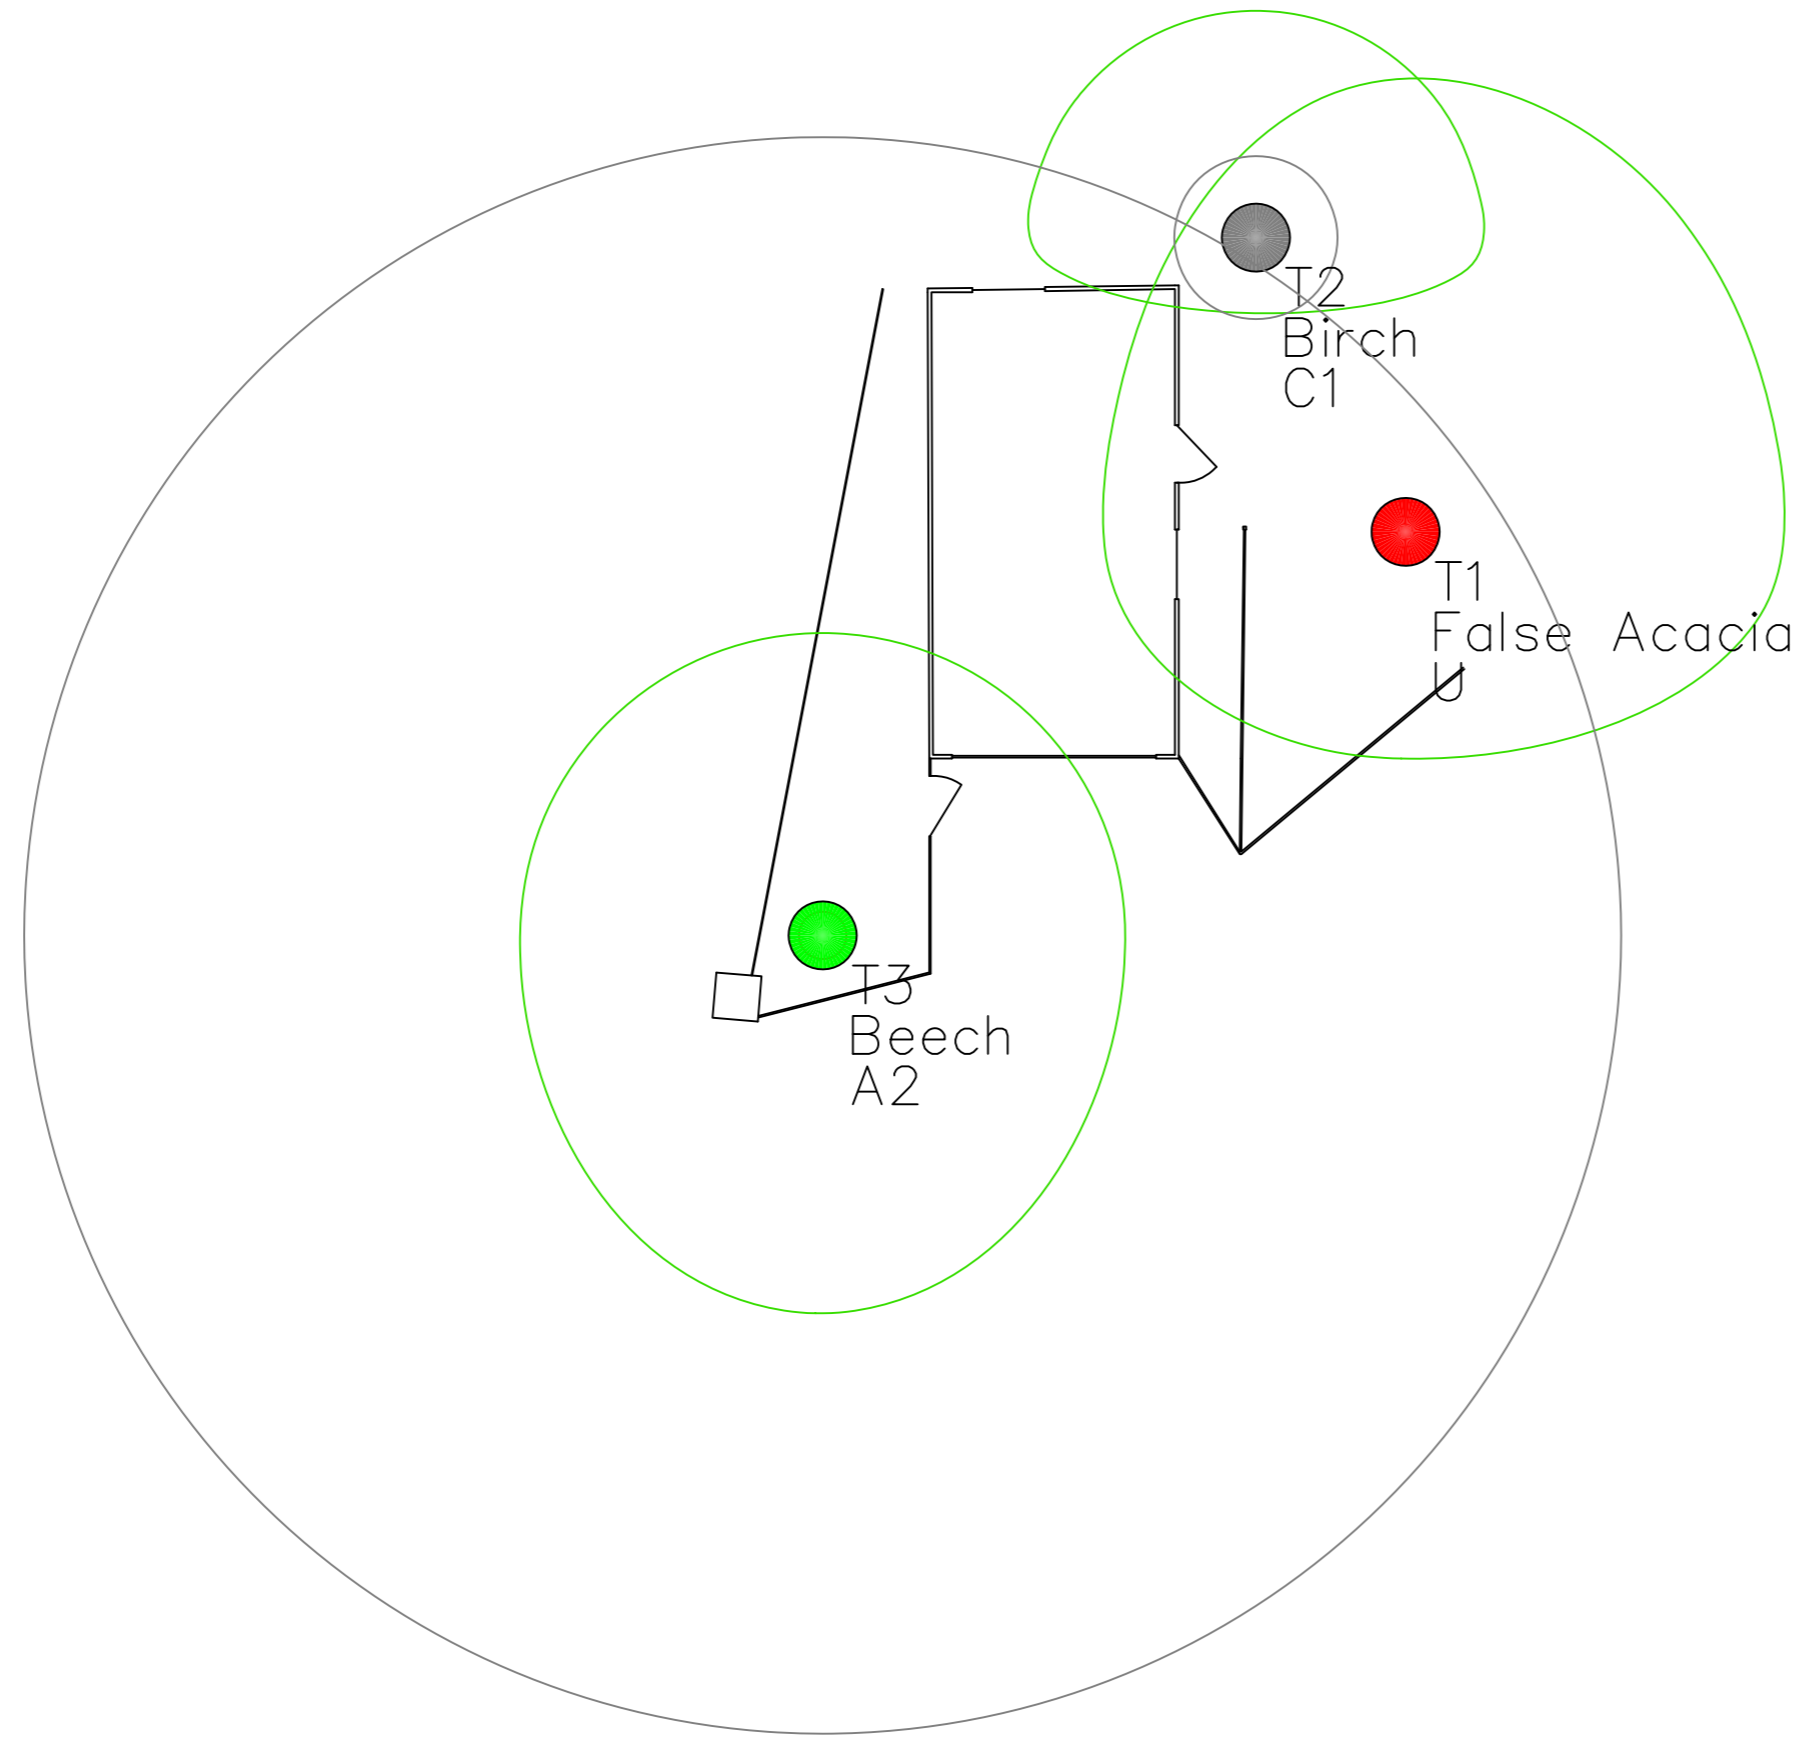
TREE CONSTRAINTS PLAN

4.1.11 In this instance, the high quality copper beech T3 has the potential to pose significant constraints to development. It should however be noted that the light nature of construction likely to be involved in these proposals means these constraints will have a lesser impact.
