### **ARBORICULTURAL IMPACT ASSESSMENT REPORT RELATING TO THE TREES WITHIN, AND ADJACENT TO, NUMBER 62 AVENUE ROAD, ST. JOHN'S WOOD, LONDON.**

FH-JGP-Architects-62-Avenue-Road-London-2011

13<sup>th</sup> July 2011

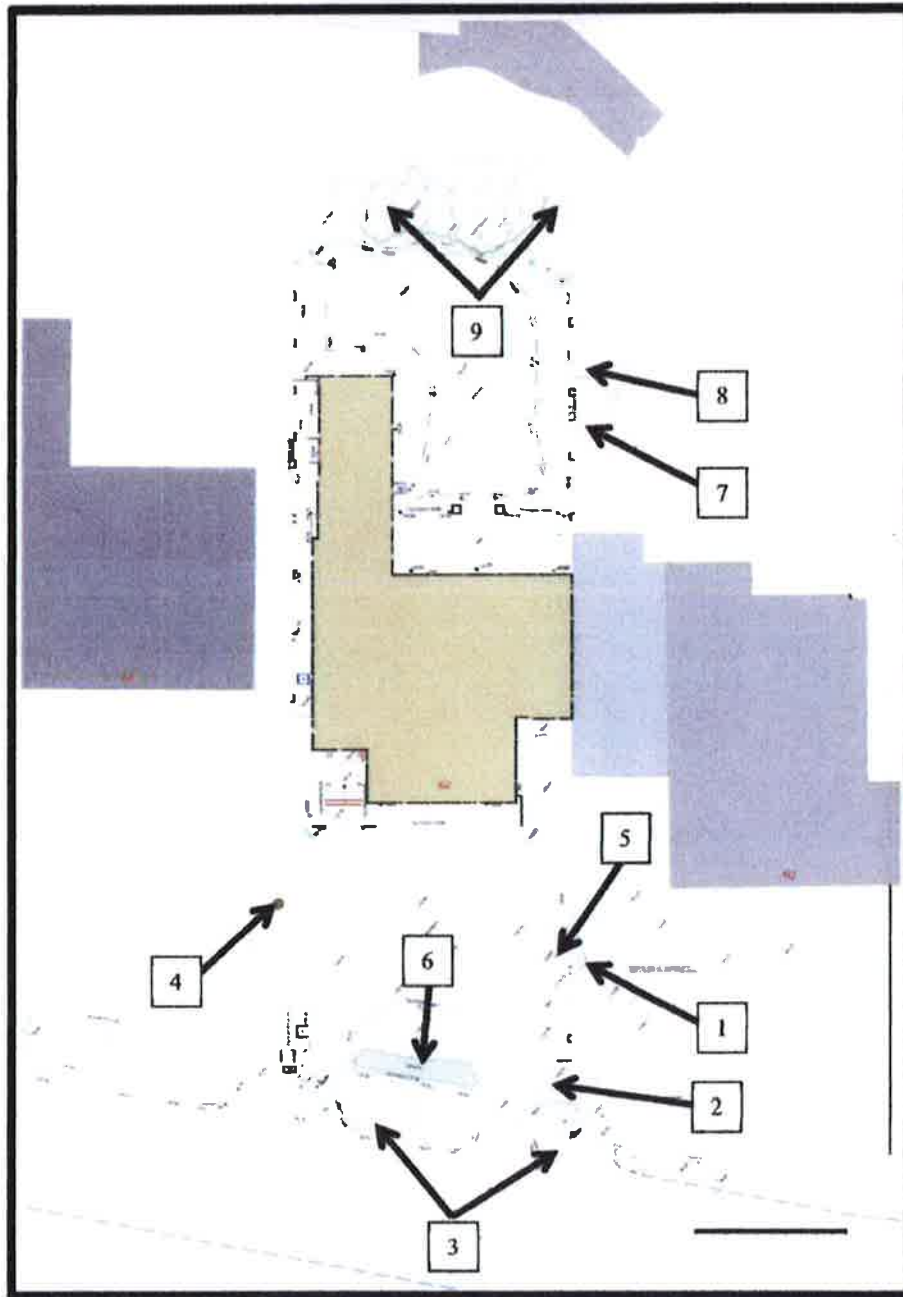
**Plan showing the location of the trees.**

individual trees, and are correlated with the numbers on the plan.

Tree 1: An extremely poor quality Whitebeam (*Sorbus aria*) growing in the front garden of number 60 Avenue Road, approximately 1.0 metre from the south-eastern boundary wall of number 62. It is currently approximately 9.0 metres tall, with an average crown

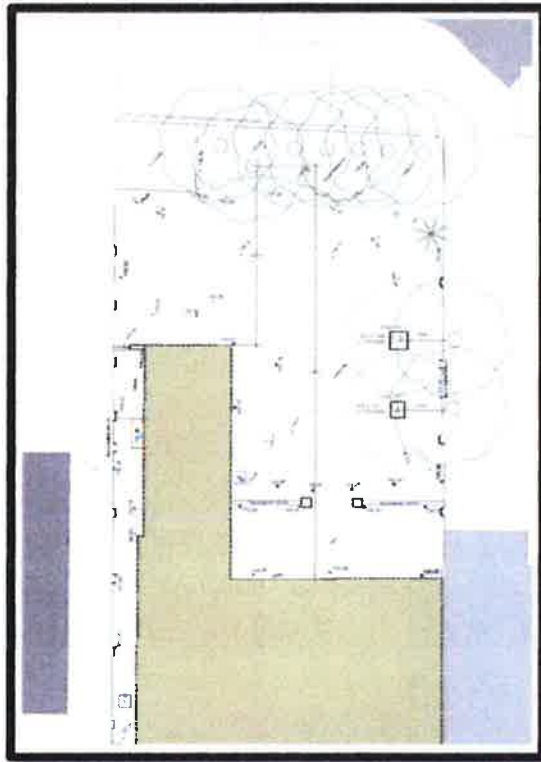
**Plan produced by GJP Architects showing the location of the trial pits.**

excavations, the works were stopped. The directive was that no roots of over 25mm should be severed.
