**Addison Lee,
6 – 9 Spring Place,
Camden,
London.
NW5 3BH.**

Management Survey and Asbestos Register
June 2013

Report type: Survey and Assessment of Asbestos Containing Materials

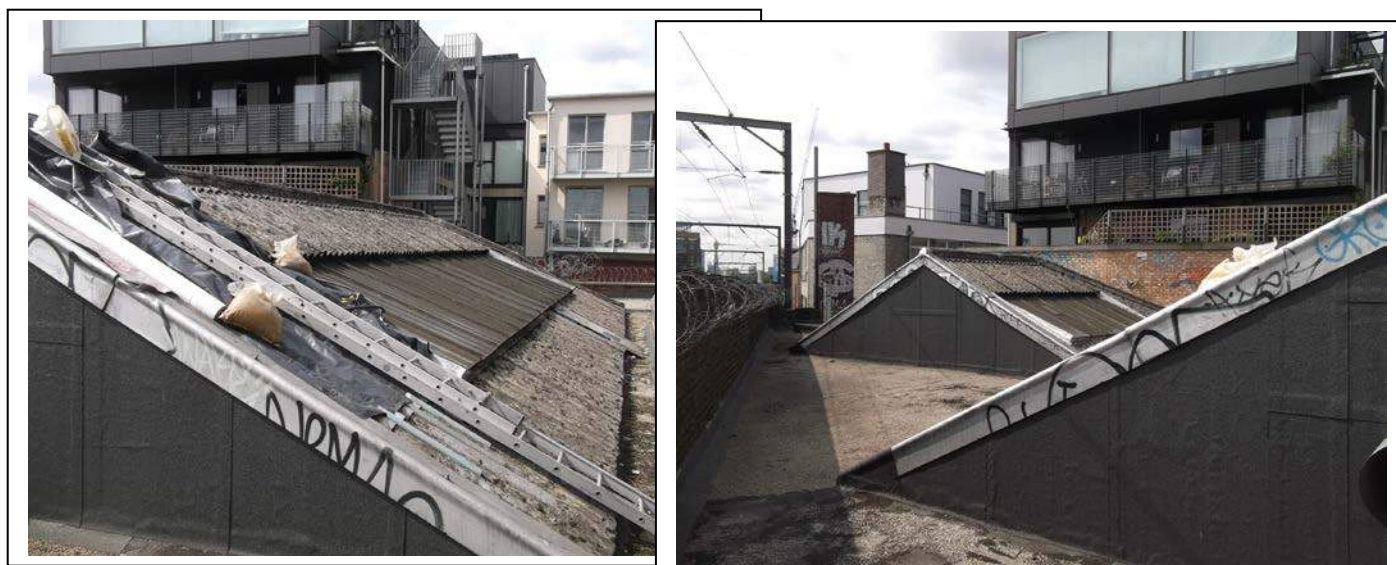
The above pictures show the rear roof sections with gravel over a bitumen roofing material, 2 apex roof sections with corrugated cement roof sheets, cement hip and ridge tiles and glazed skylights (**see samples 5029.03, 04 & 05, these returning positive for asbestos, all cement roofing products should be treated as asbestos containing**), there are brick work parapets with concrete coping stones and a natural slate damp proof course, a metal flue and vent pipe and lead flashings, there is modern mineral felt patch work and blanking panels

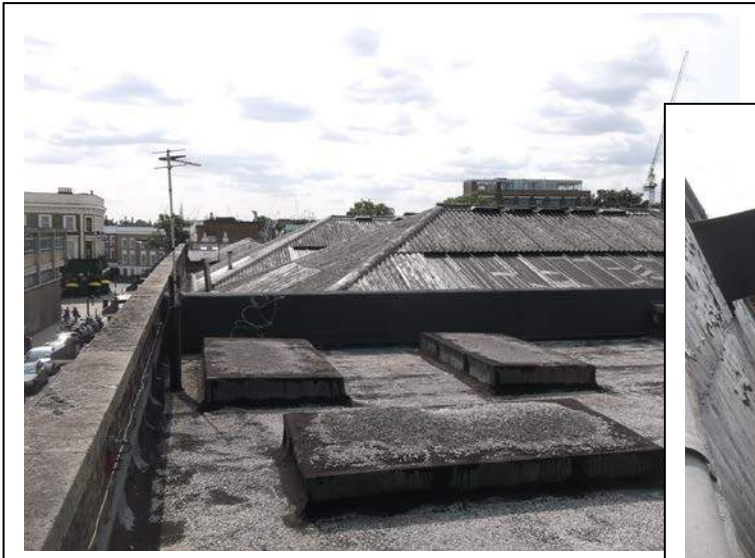
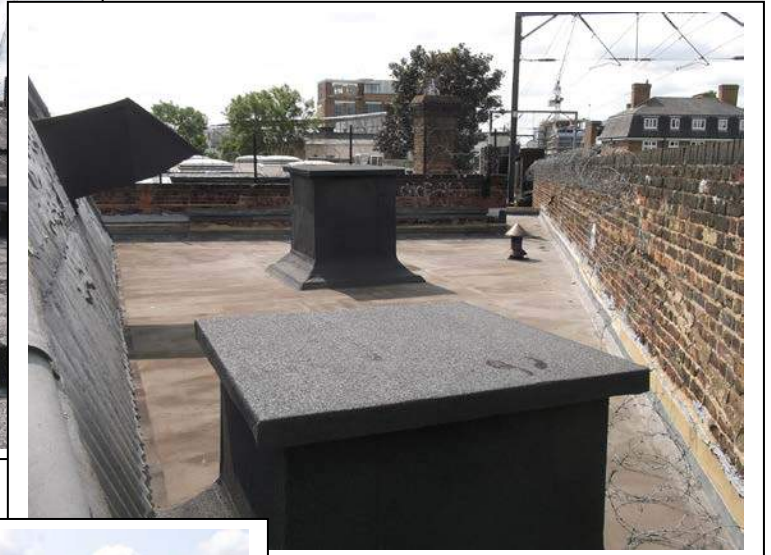
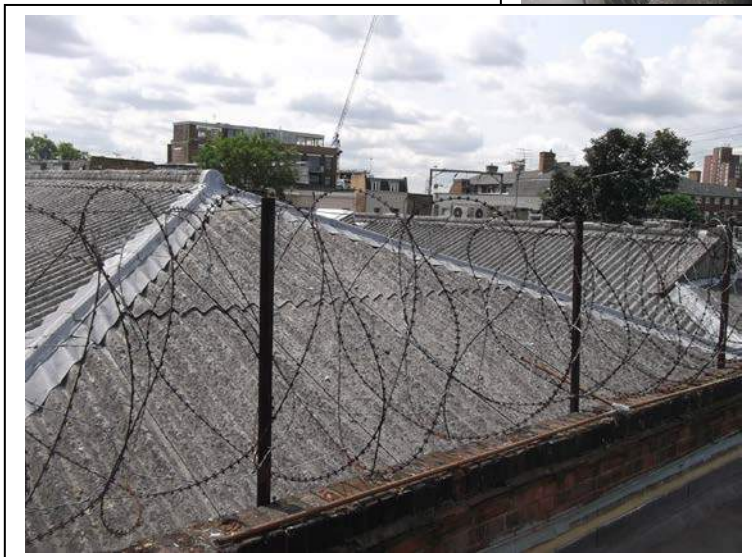
The above pictures show the front roof areas with corrugated cement roof sheets, cement hips and ridge tiles and reinforced glass skylights (see samples 5029.06 & 07, these returning positive for asbestos, all cement roofing products should be treated as asbestos containing), there is modern torch on mineral felt to the flat roof areas with brick work parapets, and concrete coping stones, there are metal vents and lead flashings around the roof areas.
