Drain Doctor Plumbing & Drainage

12 Platts Lane

11 August 2016

CCTVSURVEY/REPORT

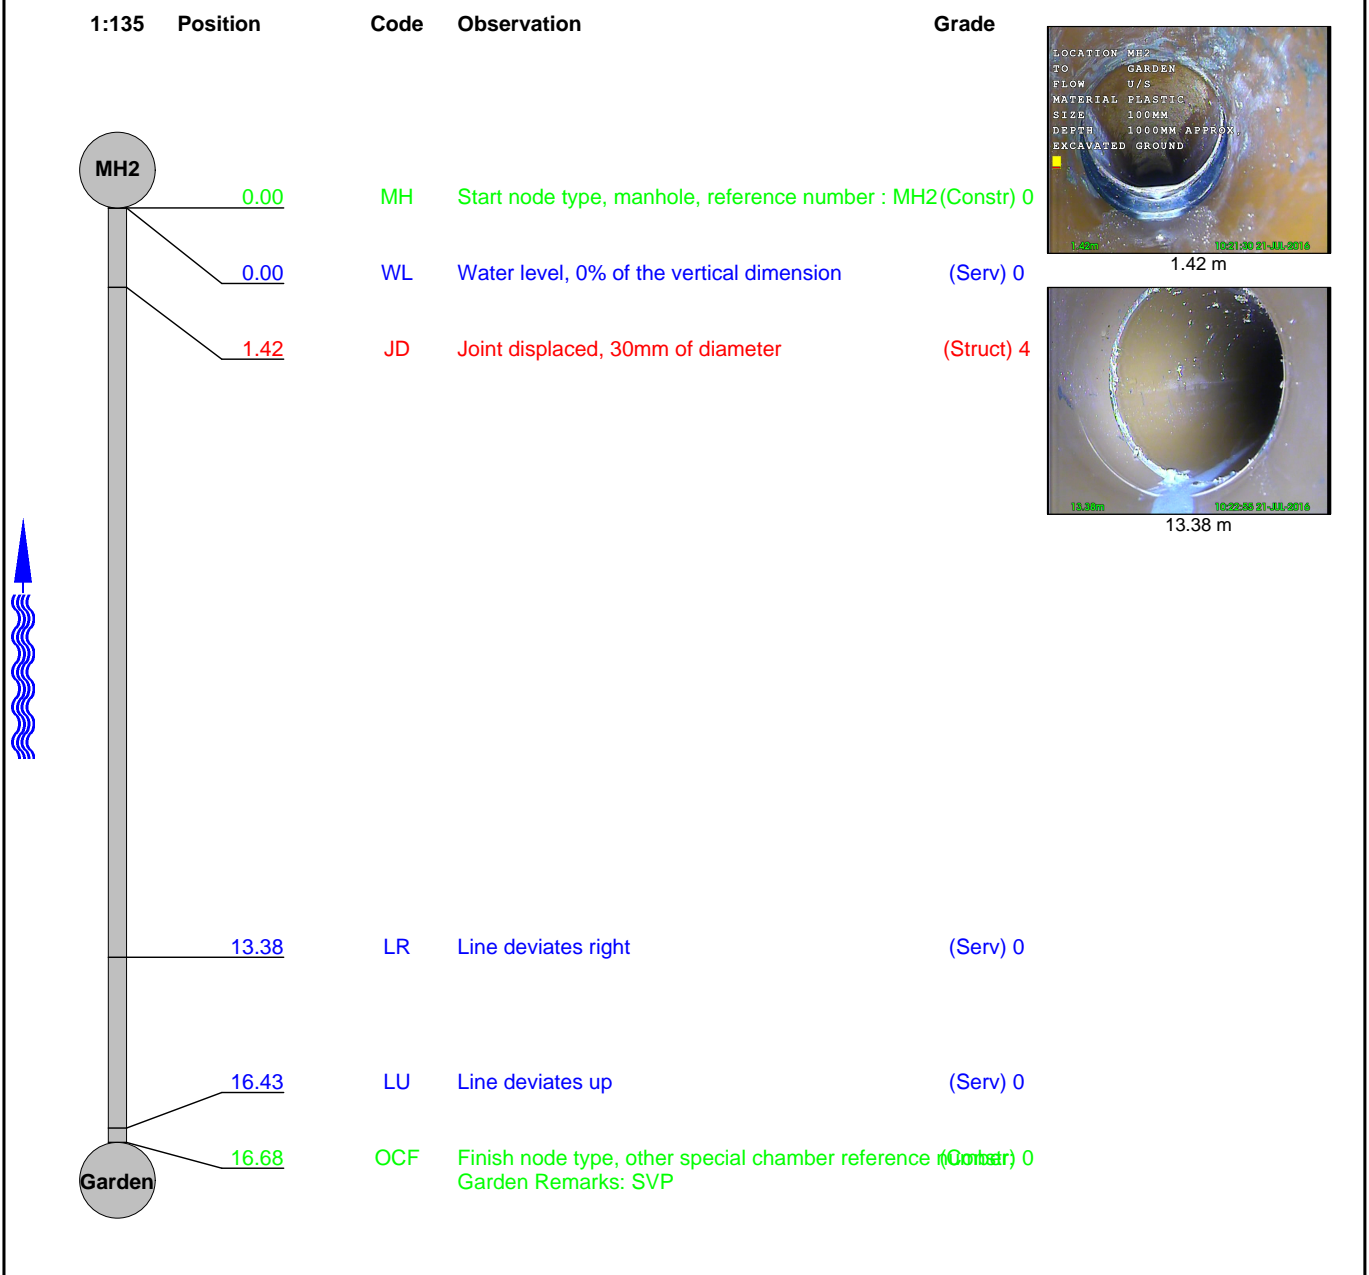
This line is a recent addition and is manufactured from PVC. We noted a very large displaced joint in the line which is likely to worsen over time. This can be repaired using 'No Dig' technology. I would recommend fitting a Point to Point structural repair to repair the joint.

Structural Defects					Constructional Features				
Service Defects					Miscellaneous Features				
STR no def	STR peak	STR mean	STR total	STR grade	SER no def	SER peak	SER mean	SER total	SER grade
1	80	4.8	80	4	0	0	0	0	1

Section 2, Supply and fit 'Point to Point repair on line. Total cost £435.00+vat.

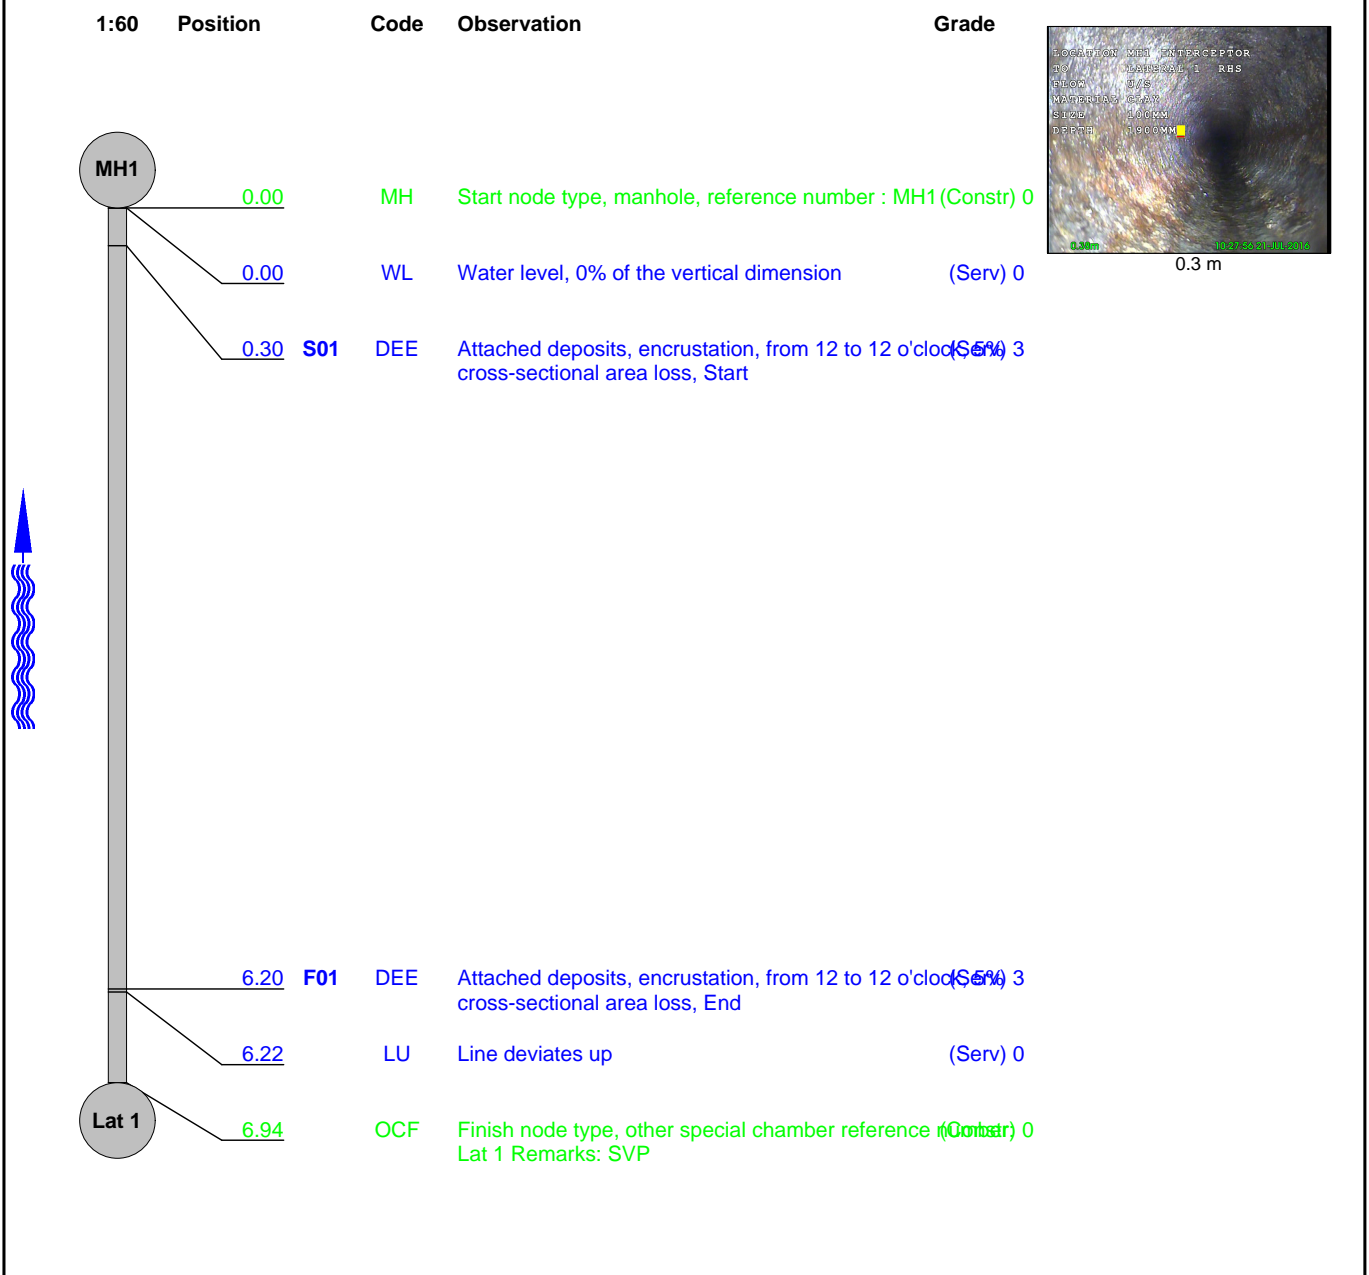
This line would benefit from a de-scale to improve mechanical efficiency. Structurally the line is in good condition.

Structural Defects					Constructional Features				
Service Defects					Miscellaneous Features				
STR no def	STR peak	STR mean	STR total	STR grade	SER no def	SER peak	SER mean	SER total	SER grade
0	0	0	0	1	1	2	1.7	11.8	3
