Arboricultural Survey (BS5837:2012) & Impact Assessment Report

Senior School
University College School
Frognaal
London
NW3 6XH

10th June 2016

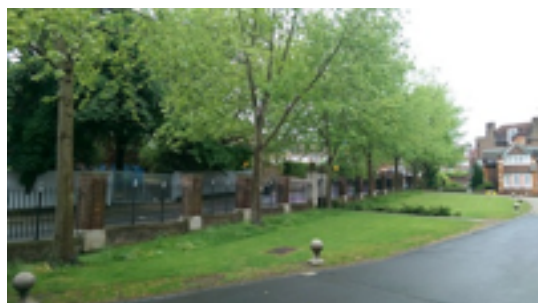
C.1 Photograph of trees T1 - T7, located on the boundary with Frognal, Senior Branch, University College School, as viewed in a north westerly direction

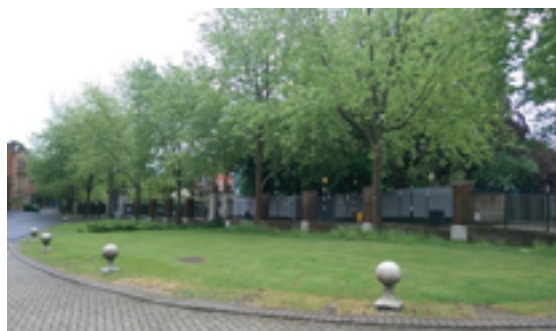
C.3 Photograph of trees T3 - T10, located on the boundary with Frognal, Senior Branch, University College School, as viewed in a southerly direction

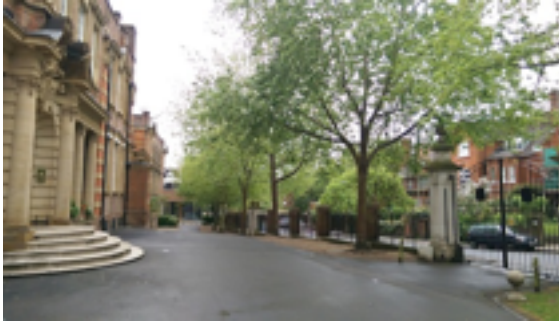
T9	Maple	13	410	N: 5 E: 5 S: 4 W:5	M	G	G	B.1	20 years +	Tree is generally structurally sound. Main stem has some damage at 1.0m on western side. Main union for crown break at 3m. The base of the tree is currently surrounded by the gravel area for parking cars. Many roots within a 1.5m radius of the tree are exposed and damaged. Crown of tree is broad and spreading comparatively to others in avenue.	No action required at present	4.9
T10	Maple	15	390	N: 4 E: 4 S: 4 W:5	M	G	G	B.1	20 years +	Tree leans slightly to the south being slightly unbalanced in this direction. Main unions at 3-6m generally sound. The base of the tree is surrounded by a gravel area for parking cars w/ many roots within a 1.5m radius of the tree are exposed and have been damaged.	No action required at present	4.7

T11	Maple	14	370	N: 4 E: 5 S: 4 W:4	M	G	G	B.1	20 years +	Main stem generally straight to crown break at 3-4m where 4 main stems originate. The base of the tree is surrounded by a gravel area for parking cars with many roots within a 1.5m radius of the tree are exposed and have been damaged. There is damage to the bark from the base to a height of 0.6m from ground level which has occluded well.	No action required at present	4.4
T12	Maple	13	330	N: 5 E: 4 S: 4 W:4	M	G	F	B.1	20 years +	Tree has a good straight main stem with buttress roots in fact. Main union at 3m with 3 stems originating. Compact but balanced crown shape, smaller than specimens not surrounded by car parking and sparse foliage in upper crown. Many roots within a 1.5m radius of the tree are exposed and have been damaged.	No action required at present	4.0
T13	Maple	12	320	N: 4 E: 5 S: 5 W:4	M	F	F	B.1	20 years +	Tree is generally structurally sound with a straight main stem to 3-5m where multiple lateral and vertical stems originate. As with neighboring trees the base of the tree is surrounded by a gravel area for parking cars. Many roots within a 1.5m radius of the tree are exposed and have been damaged. There is some decay to the main stem from a height of 0.1m to 0.7m from ground level; possibly from impact damage and has occluded well. Tree does show early signs of dieback in upper crown with declining vigour in mid \ lower crown	No action required at present	3.8

T14	Maple	12	260	N: 4 E: 3 S: 3 W:4	M	G	F	B.1	20 years +	Tree is structurally sound but is a smaller specimen than those surrounding. The base of the tree is surrounded by a gravel area for parking cars with some root damage evident. This tree has low vigour due to the proximity to the adjacent Willow and likely compaction / root severance from the installation of moped parking area directly adjacent. The crown of tree is generally structurally sound. Tree has smallest stem of avenue.	No action required at present	3.1
T15	Willow	13	890	N: 4 E: 5 S: 8 W:5	M	F	G	B.1	15-20 years	Tree is generally structurally sound at the base although there is increased there are significant ground works surrounding. The tree has a significant lean to the south with good compensating buttress roots. There is one main stem with a 1st lateral branch at a height of 2m from ground level. At the main crown break at a height of 4m from ground level 2 main stems originate. The western stem was previously crown reduced at 9m to reduce end weighting within upper crown. The eastern stem was previously reduced at 9-11m. The tree was last reduced 2 years ago to previous reduction points.	Crown reduce to previous reduction points retaining some of furnishing growth to balance. Crown thin 15% and remove any remaining deadwood. Crown lift & remove all epicormic growth to 5m	10.7

C.5 Photograph of trees T9 - T15, located on the boundary with Frognal, Senior Branch, University College School, as viewed in a southerly direction

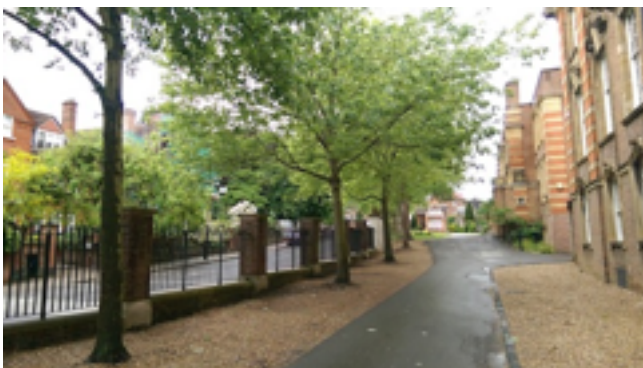
C.8 Photograph of trees T9 - T15, located on the boundary with Frognal, Senior Branch, University College School, as viewed in a northerly direction

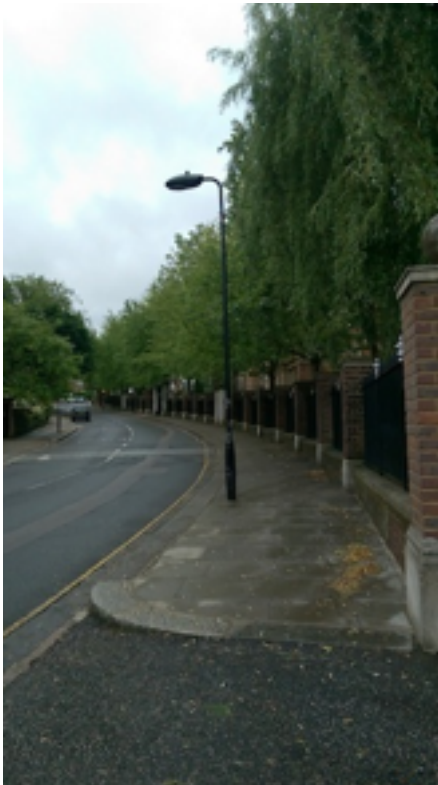
C.10 Photograph of Frogna / UCS boundary streetscape, as viewed in a northerly direction from the public highway at pedestrian and vehicular entrance
