Your ref:
Our ref: 1-38-2779

3rd October 2016

Re: 20, Belsize Square, London, NW3 4HT

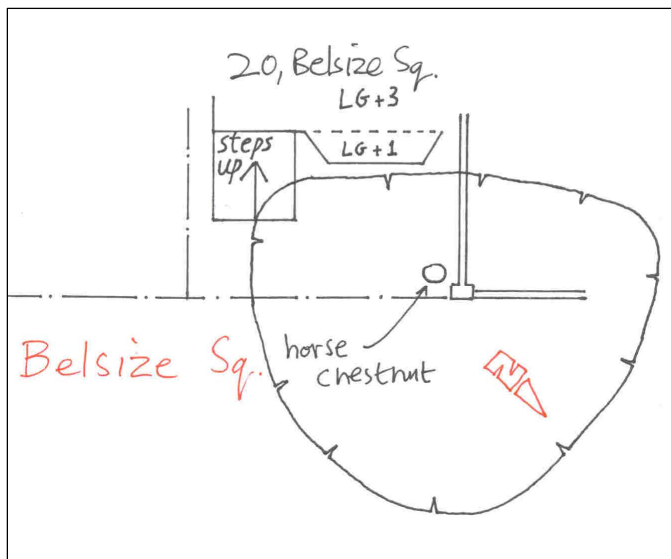
The tree was in 2011 about 13m in height and then measured 850mm in trunk diameter at about 1.5m +GL. The tree now measures 1018mm at 1.5m +GL and is about 16m in height.

2) The tree was once pollarded to around 2m above ground level (in excess of forty years ago) from which point two large stems have arisen which then sub-divide at around 3m above ground level and go on to form a crown of lower order branches in the usual way.
