## FURTHER INVESTIGATION REPORT:

42 Avenue Road

Ref: GMT\_42AVR\_PCS\_01a Date: 12<sup>th</sup> September 2016

Carry out Resistograph Decay detection on the main stem of various species at the above address.

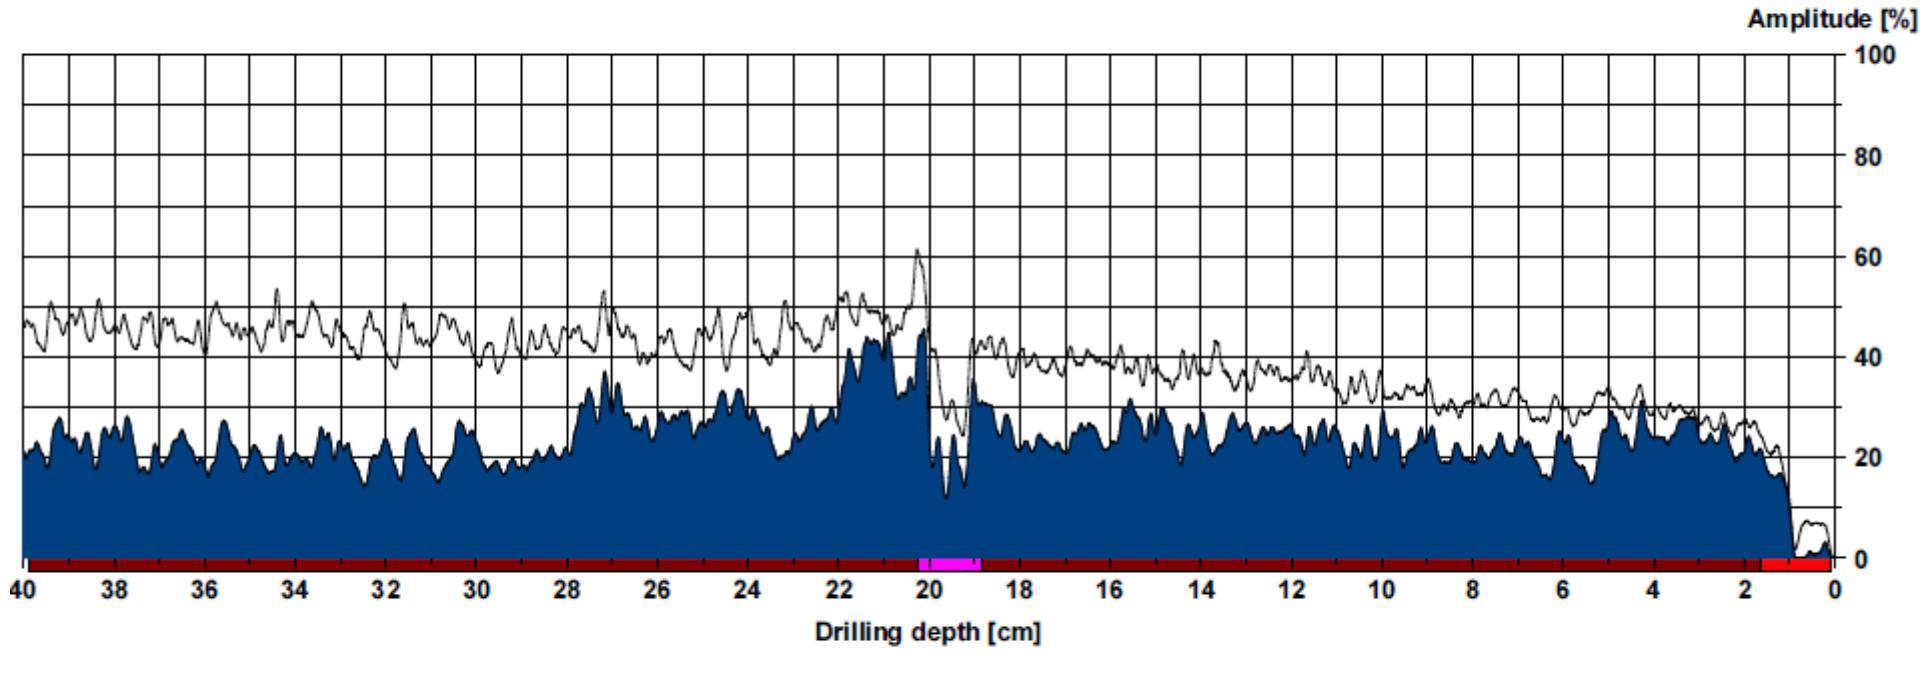
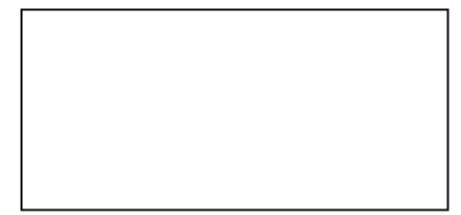
# Assessment From 0,1 cm to 1,6 cm : Bark From 1,6 cm to 18,9 cm : Good wood From 18,9 cm to 20,2 cm : Crack From 20,2 cm to 39,9 cm : Good wood From 0,0 cm to 0,0 cm : Arboi From 0,0 cm to 0,0 cm :

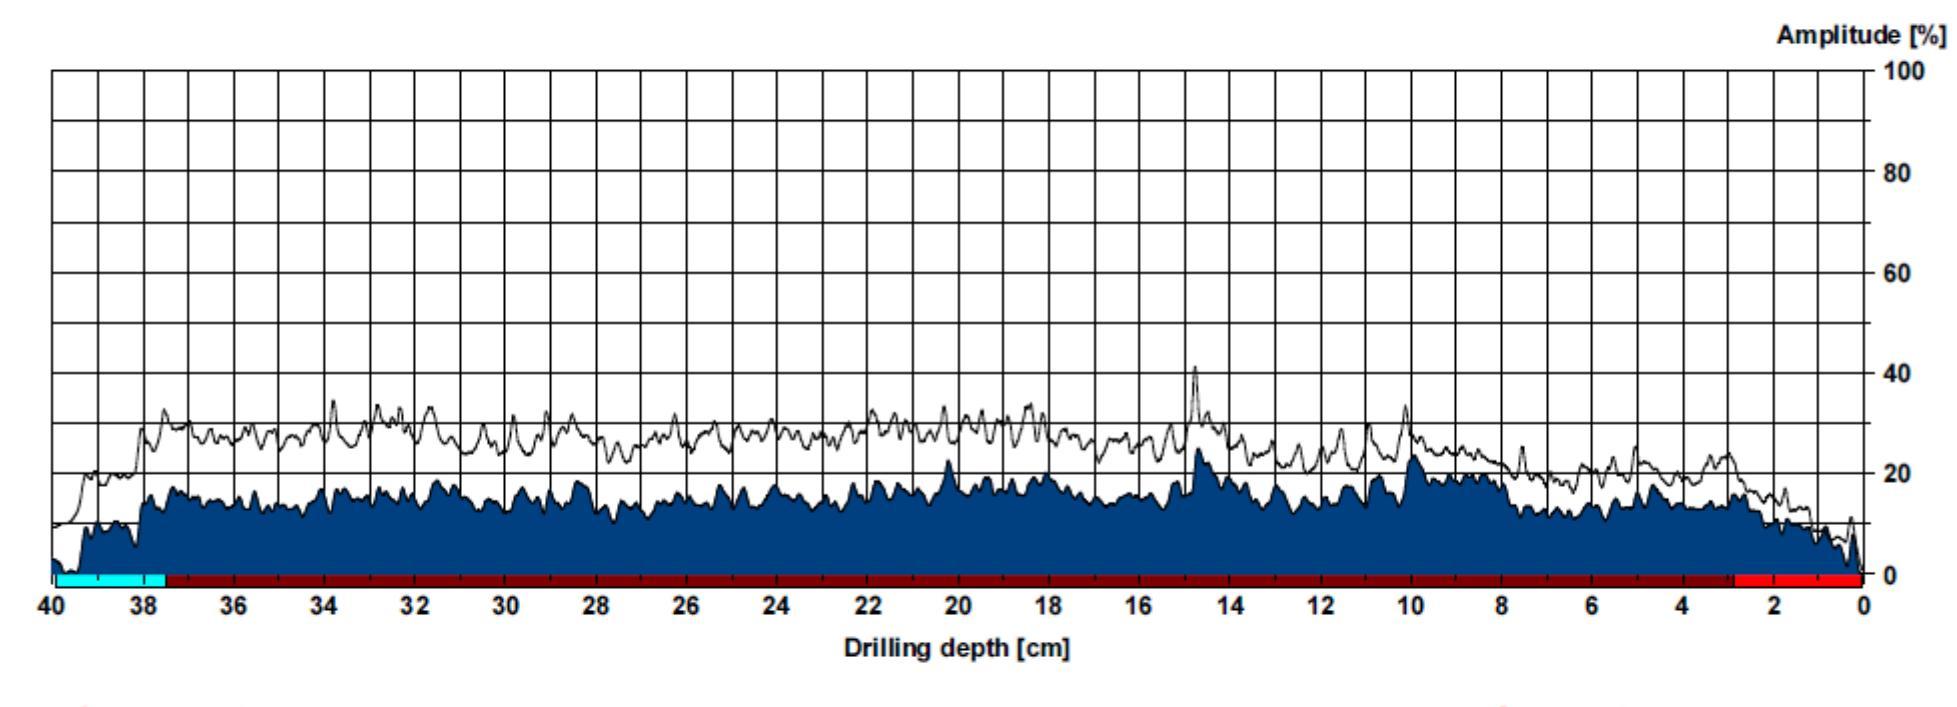
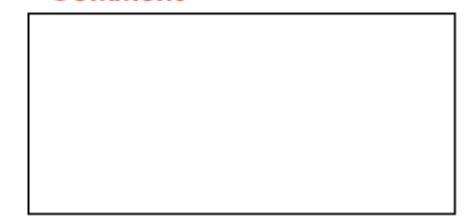
Arbo	From From From From From From From	0,0 cm 2,9 cm 37,5 cm 0,0 cm 0,0 cm 0,0 cm	to to to to to	2,9 cm 37,5 cm 39,9 cm 0,0 cm 0,0 cm 0,0 cm	Bark Good wood Decay
------	--	---	----------------	--	----------------------------
