ARBORICULTURAL IMPACT ASSESSMENT REPORT
BS 5837:2012 'Trees in relation to design, demolition and construction.
Recommendations'

79 Dartmouth Park Hill

For the garden room

DATE: 03.10.16
OUR REF: SHA 242

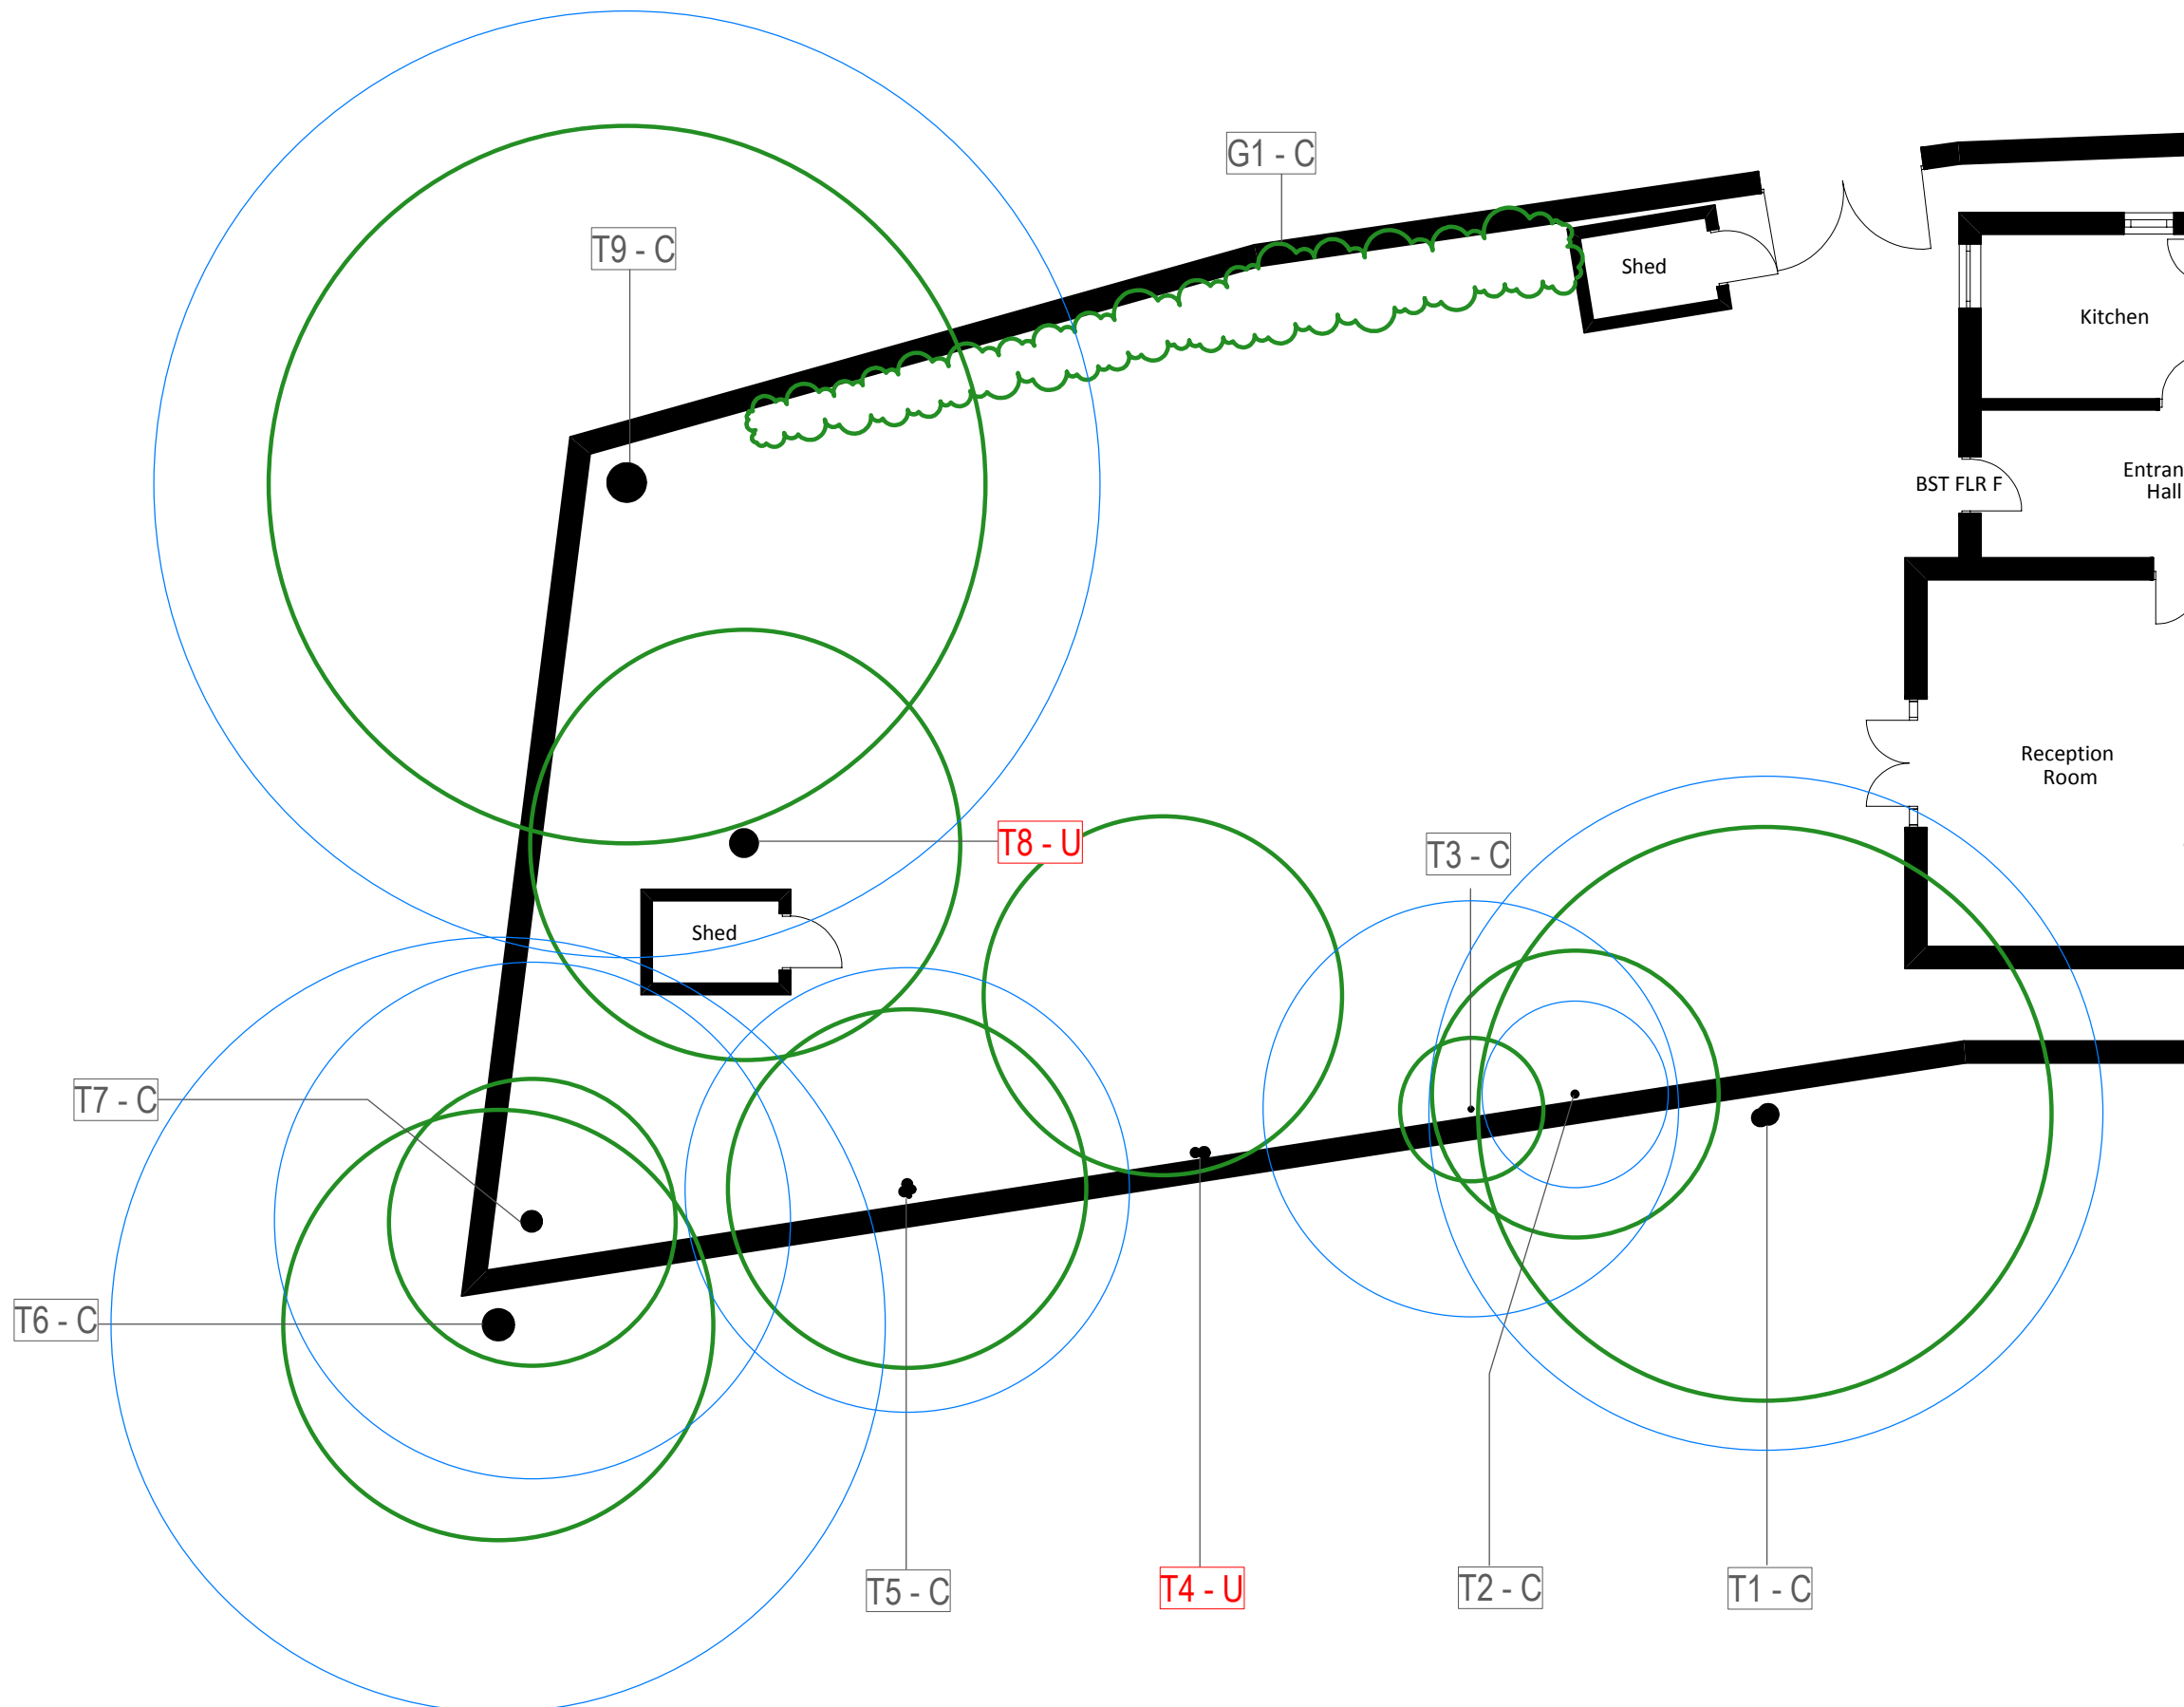
Tree survey plan SHA 242 TSP

- T1 - C Category C - low quality and value
- T1 - U Category U - unsuitable for retention
-
