### Structural Survey

### 27 Russell Square

February 2016

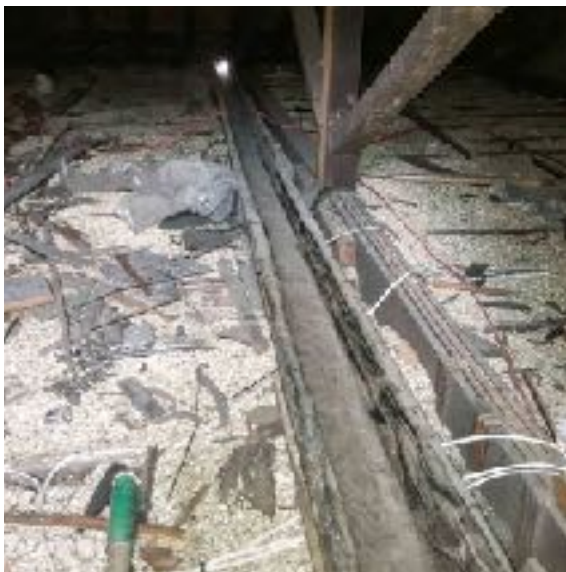
9. View of Internal Open Channel Rainwater Gutter.

The internal structure of the pitched roofs comprised king post timber trusses supporting purlins and then rafters, with ceiling joists spanning between the trusses. There seemed to be three trusses within each roof; one in the centre and two adjacent to the party walls, all spanning from the external walls onto the central spine wall of the building. All appeared to good condition. Within the rear roof pitch was an open channel lead lined gutter that received stormwater from a central gulley in the valley gutter. This internal gutter then appeared to have a central gulley, with an overflow that fell to the rear of the building. This internal gutter also presumably received stormwater from the front gutter. It was impossible to establish how the inner gulley then distributed stormwater, although it was noted that the rear elevation appeared to have two outlets for stormwater; one at the rear parapet gutter level and another some 450 millimetres below, possibly receiving the inner gulley via another pipe within the third floor ceiling zone.
