Flat 8 Inverforth House  
Historic Report, Design and Access Statement.

Additional Information - Ceiling Significance.  
Assessment of the Grade II listed building, including a schedule of significance.

June 2016

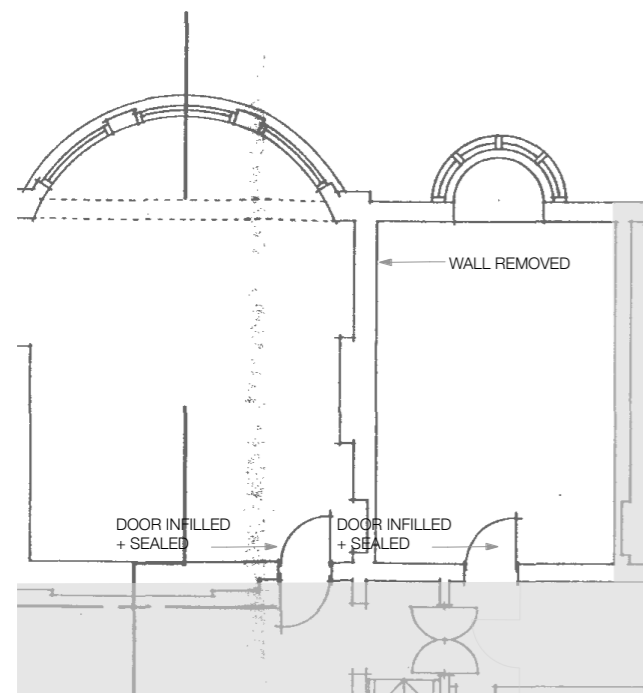
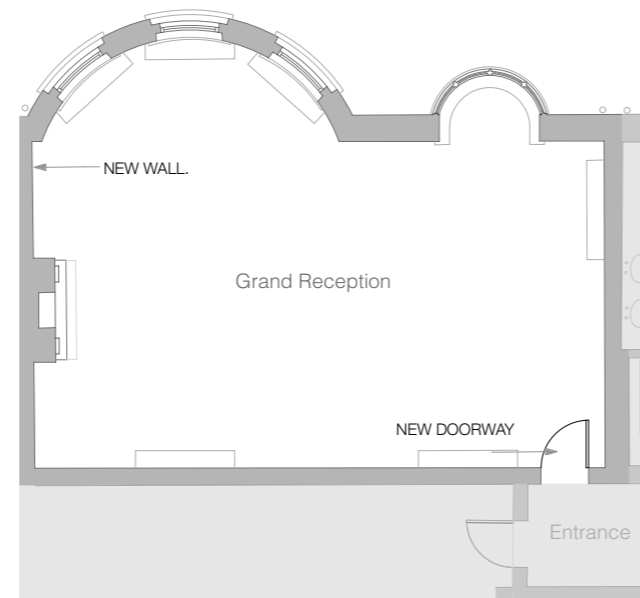
In the case of the Grand Reception there have been significant changes to the general plan form. The process of forming one large room from two separate smaller rooms in the 1990's refurbishment will have seen to the replacement of the original ceiling.

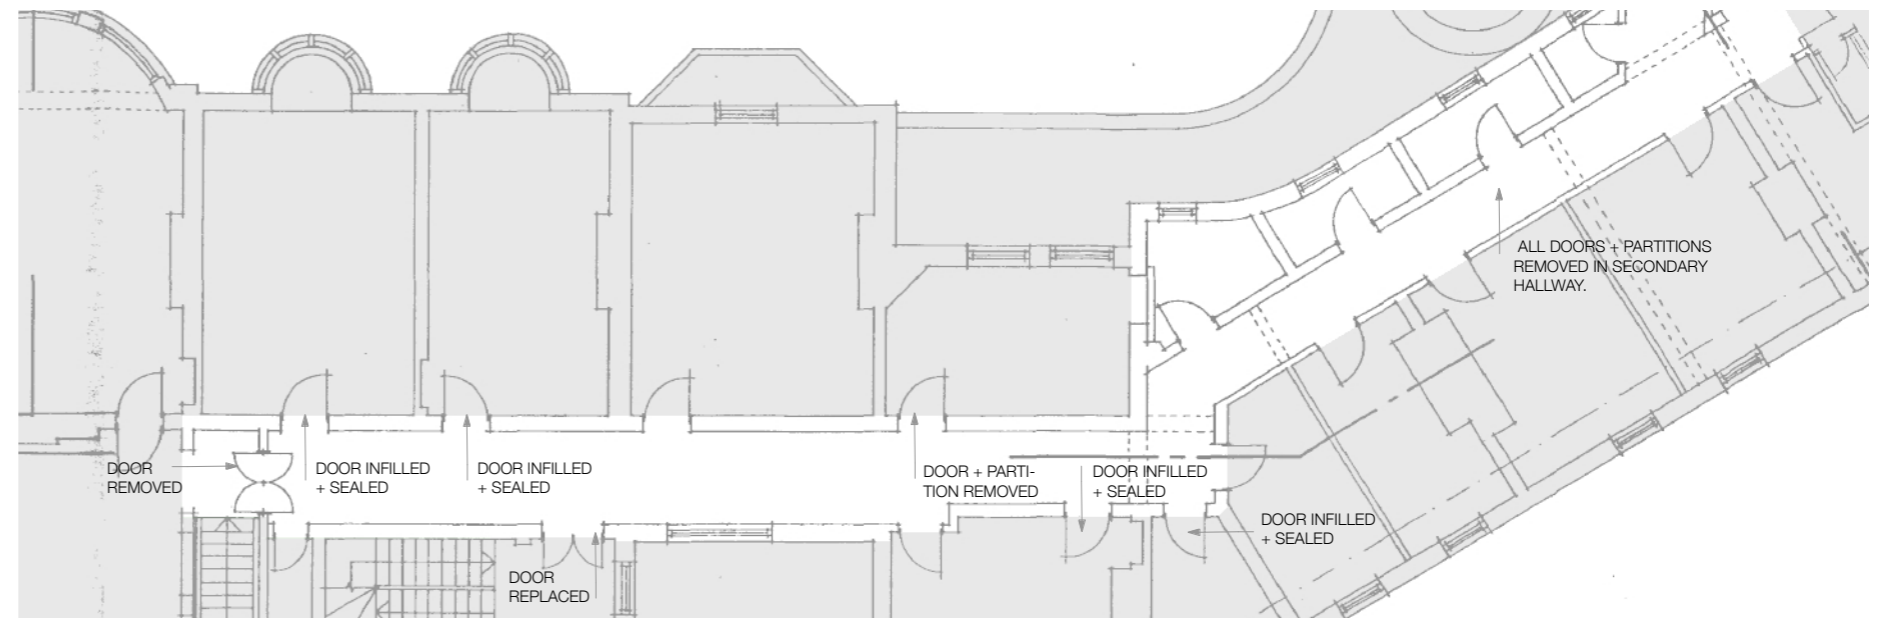
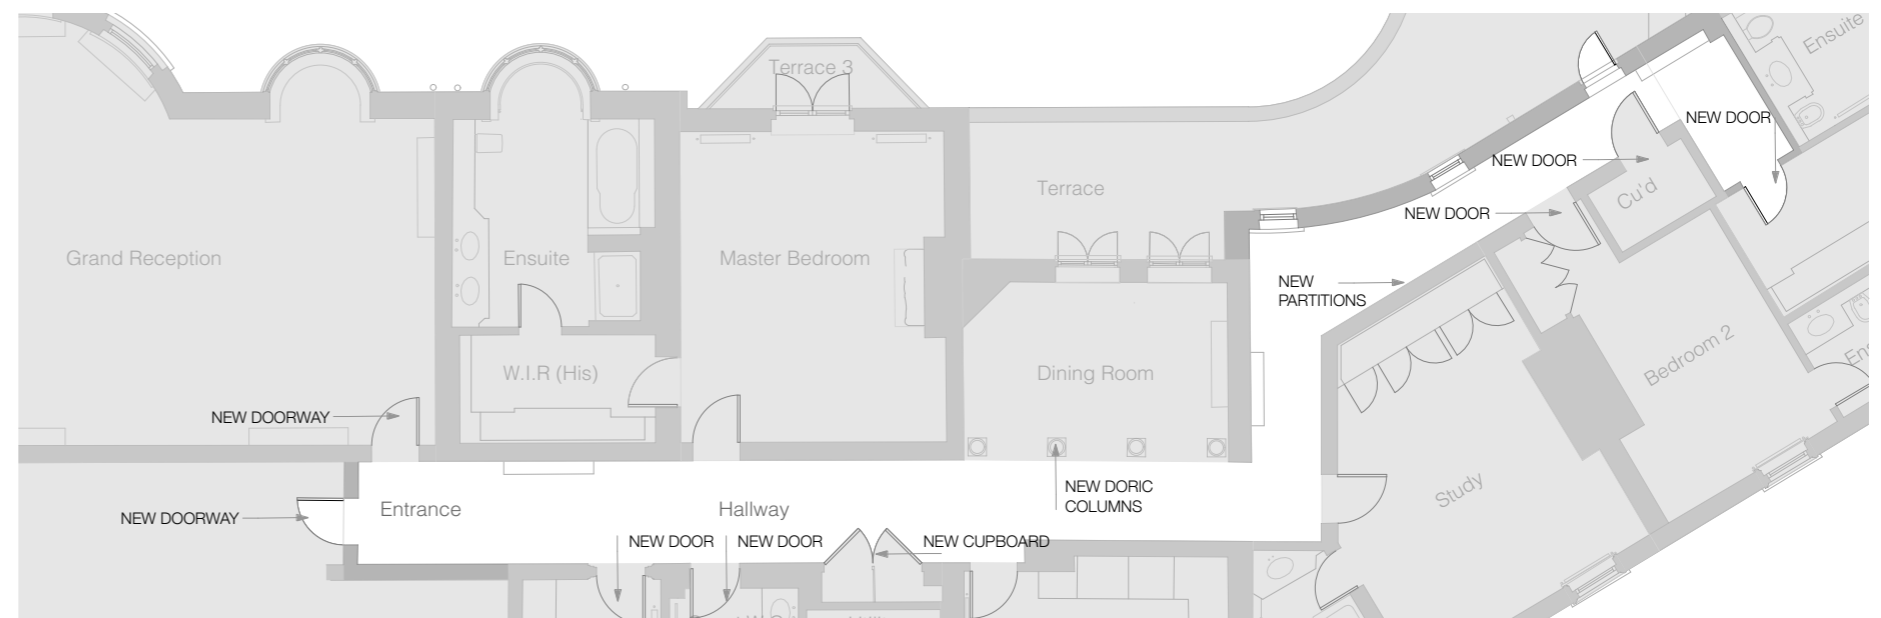
Original Survey Plan of First Floor 1993  
Thomas Brent Associates.

The Main Hallway and Secondary Hallway ceilings are both of two layers of plasterboard with a voided secondary ceiling above. This modern construction of each ceiling indicates the replacement of the original ceilings in the 1990's refurbishment.

Both of these ceilings are non original.

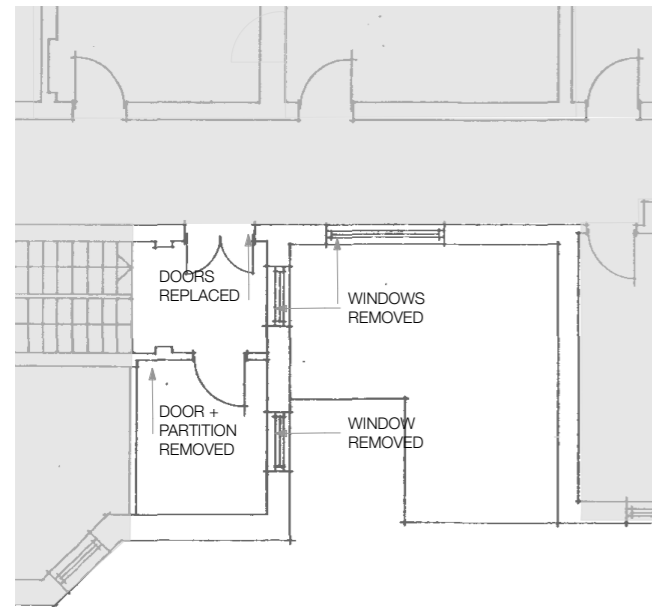
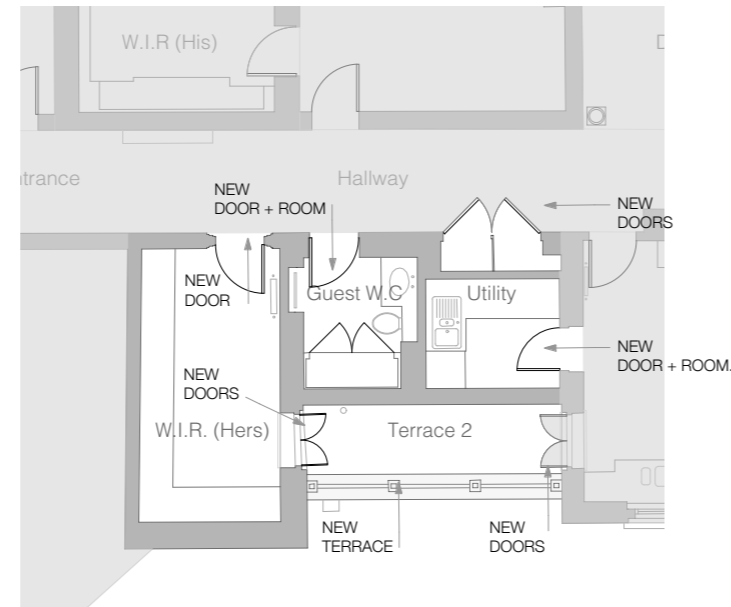
Original Survey Plan of First Floor 1993  
Thomas Brent Associates.

The second Dressing Room, as seen in the Survey Plan of 2016, did not exist in the 1993 Survey Plan. The formation of this room from a staircase landing and smaller room indicate the ceiling was replaced to form the larger dressing room ceiling.

This ceiling is non original.

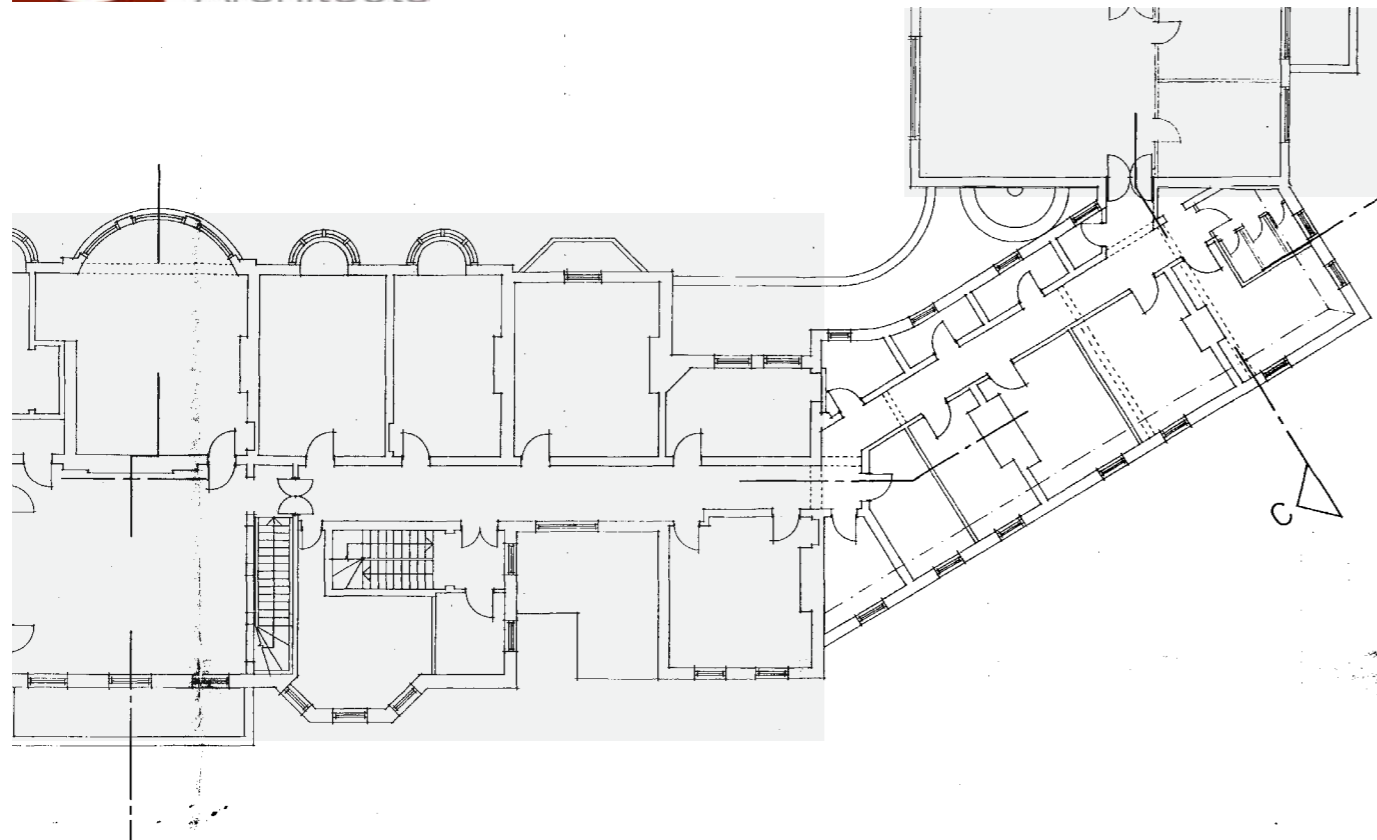
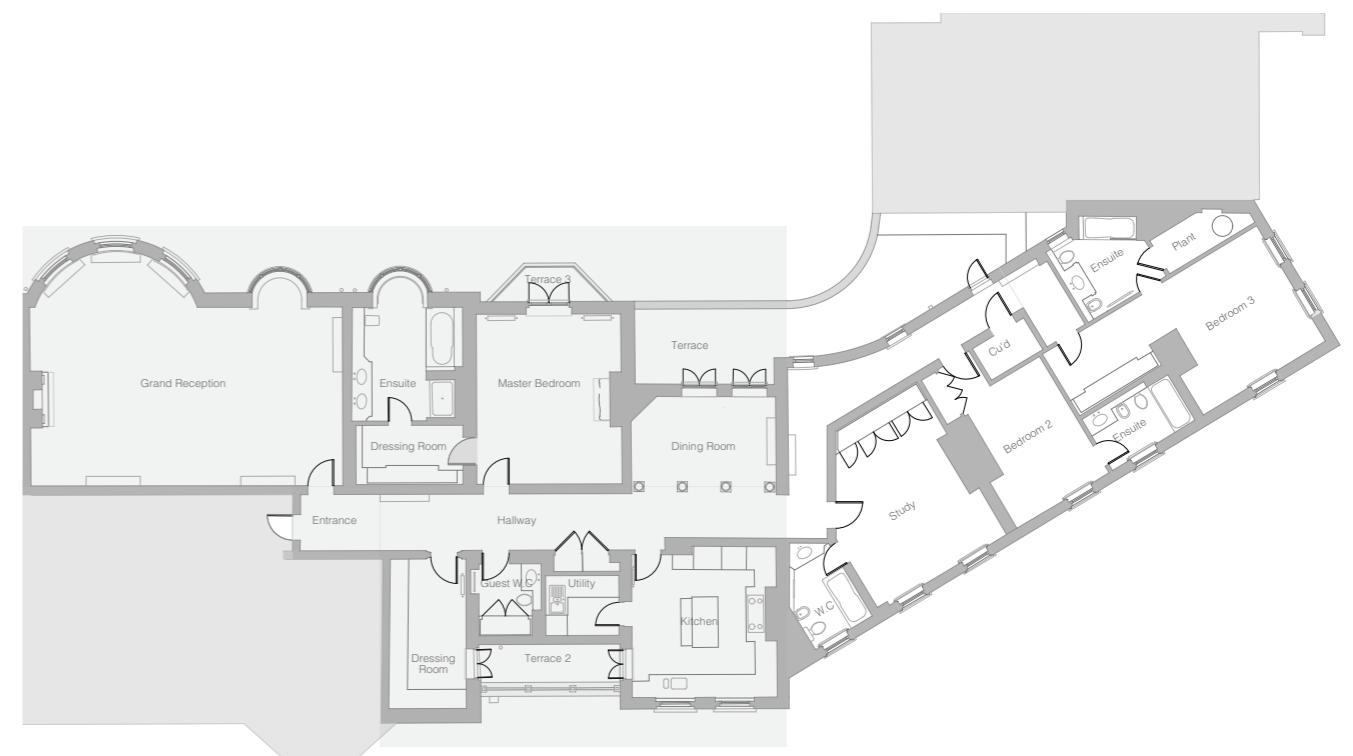
Original Survey Plan of First Floor 1993  
Thomas Brent Associates.

The ceiling to the kitchen is constructed of two layers of plasterboard with a voided secondary ceiling above. This modern construction indicates the ceiling was replaced in the 1990's refurbishment.

This ceiling is non original.
