# *Heritage Surveys Limited*

## Conservation Plan & Statement of Heritage Significance Report

136-180, 181-203, 204 - 238 Levita  
House and 62 – 76 Chalton Street  
Ossulston Estate  
Chalton Street  
London  
NW1 1JJ

Report date: October 2016

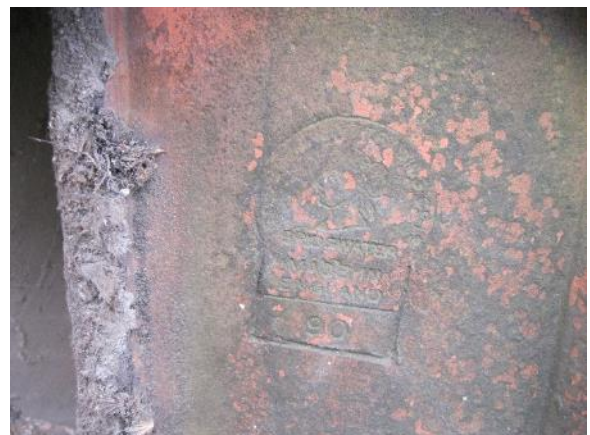
Based on a visual non-intrusive inspection, the roof structure appears to be in reasonable condition with no major deflection evident. Existing tiles are most probably original with some exceptions (see below) and are English Bridgewater pantiles (see photo). A large number of tiles are cracked, some of which will be mechanical damage, with some evidence of weathering. There is no sarking felt under the tiling. The property is prone to leaks, particularly in wind driven rain or in the event that tiles are damaged. (Photos 10 to 15). Evidence of water penetration is visible in the roof voids and former drying rooms, where lath and plaster ceilings have partially collapsed.

The proposal is to strip all of the pitched roof coverings and replace with new Sandtoft Bridgewater matching profile tiles (please refer to Appendix 2).

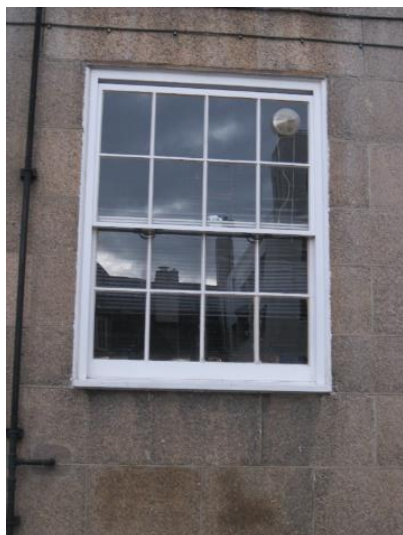
*Existing sash window in 1-21 Levita House*

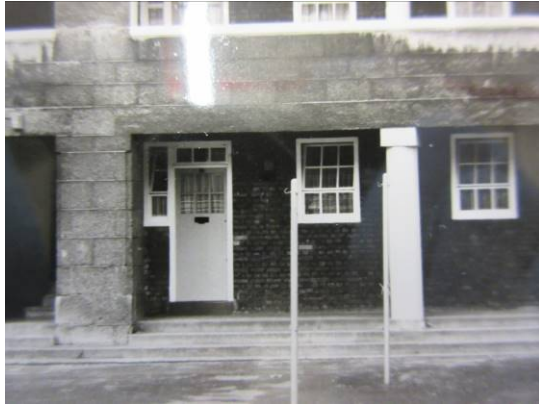
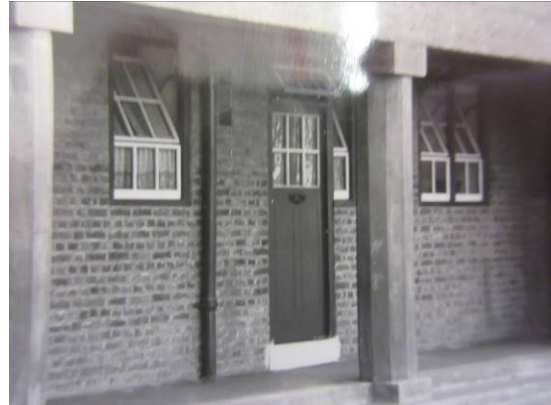
Flat entrance doors are not original and are currently timber with “half glazed” upper panels. (Photo 27). The archive photos below from similar archetype blocks indicate the high waisted panelled and 6 pane glazed style provided before these modern replacements, it is unclear if these archive photos are original as built.

The proposal is to replace the doors to achieve a Secured by Design standard in terms of locking mechanisms and also to the current recommendations in relation to fire precautions.

The style of the replacement doors will be similar to those installed on Walker House and 1-21 Levita but with visual appearance of 6 glazed panes and 3 vertical panels more in keeping with the doors seen in the archive photographs. The vertical panels are to be shallow rebated style to match similar to the panel style of those on 38 – 60 Levita rather than deeper moulded sections. The proposals are indicated on drawing 5675 A (31) Type I Proposed Revision A which shows existing and proposed.

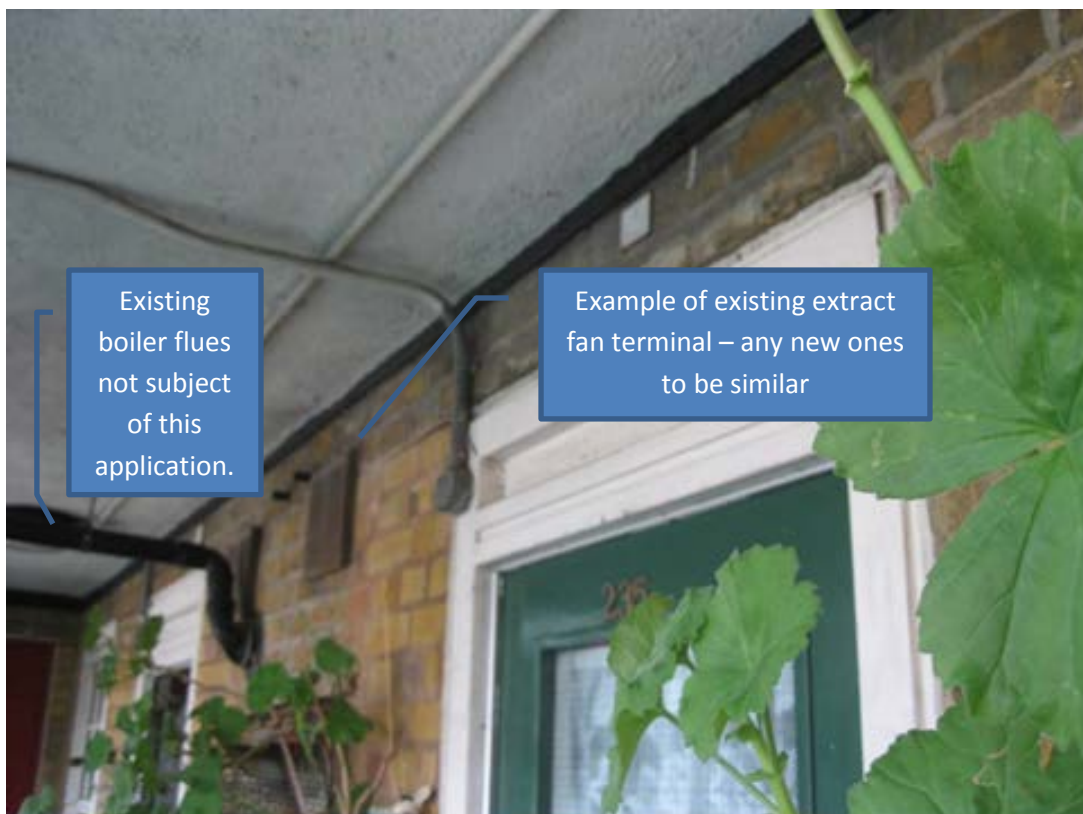
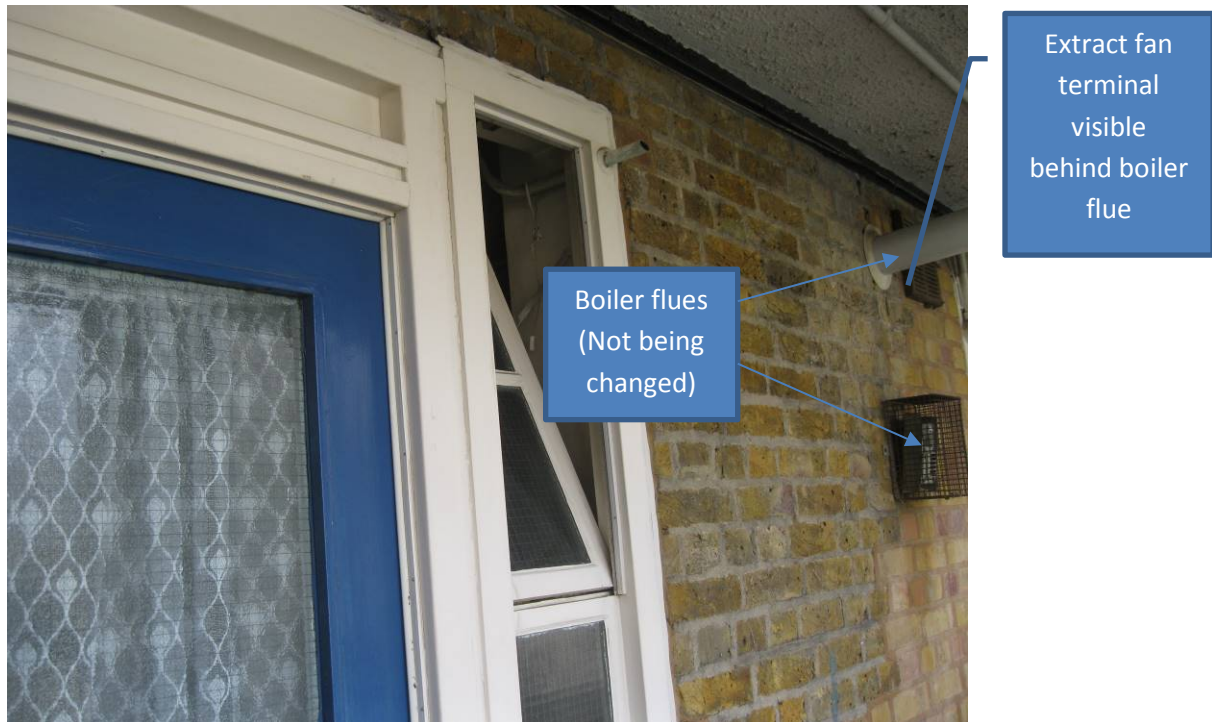
Many of the properties already incorporate mechanical extract fans to kitchens and bathrooms as indicated in the photos above. The proposed works will replace these where they are defective in tenanted properties and provide fans where none are provided at present, also to tenanted properties. Leasehold properties will not be subject to any fan works, if leaseholders require fans they will need to make their own applications.

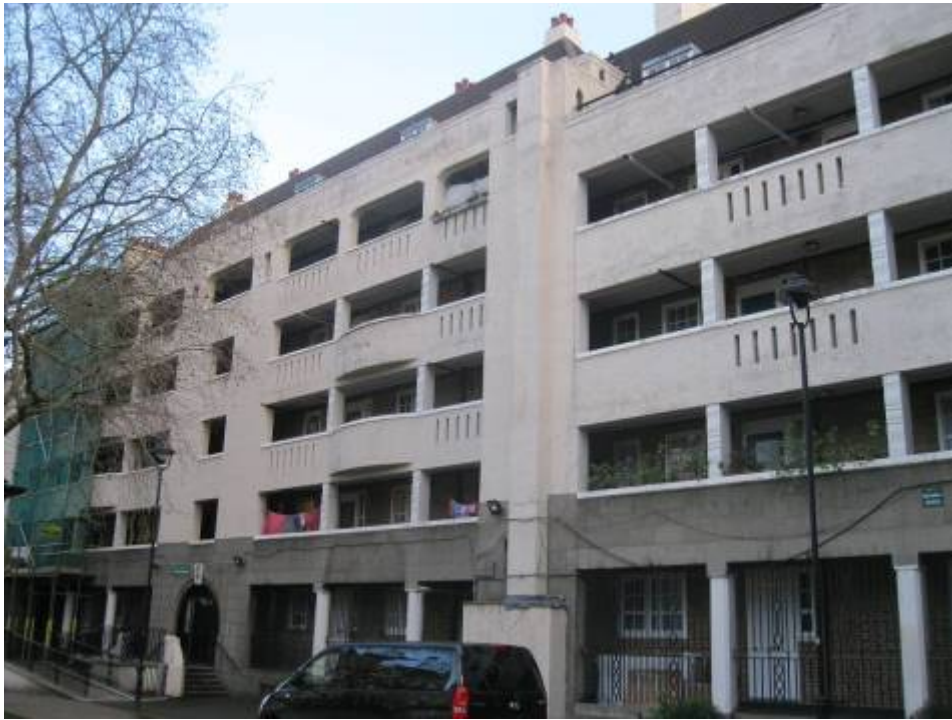
**Photograph 1** 204 – 238 north elevation

The external walls are of load bearing brickwork with a stone effect façade to the ground storey, and thereafter finished with a painted roughcast render (Photos 1, 3, 4, 5, 6, 7 and 8). The access balcony elevations are finished in yellow stock brickwork with red bricks to the stairs.

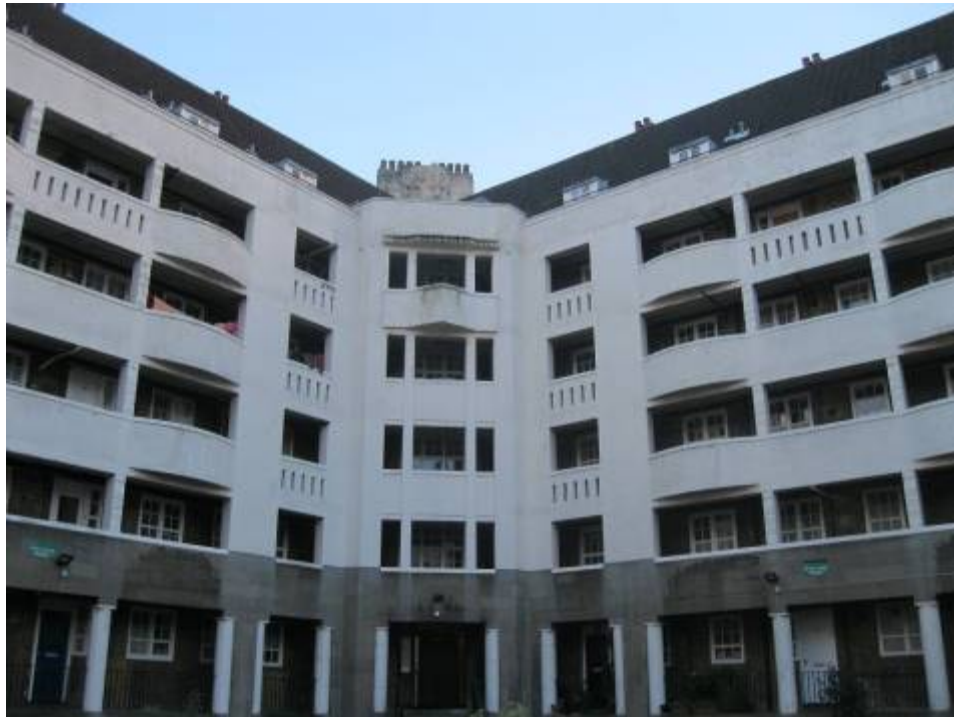
**Photograph 3**      **136 – 180 Levita**

Construction is of load bearing brickwork, rendered with coloured rough cast finish with ground floor elevations to appear as stonework (photos 1, 3 - 8). Asphalt covered concrete communal access balconies are provided, most probably of filler joist construction.

All of the blocks include tall, brick built and rendered chimney stacks (e.g. photos 3 - 8).
