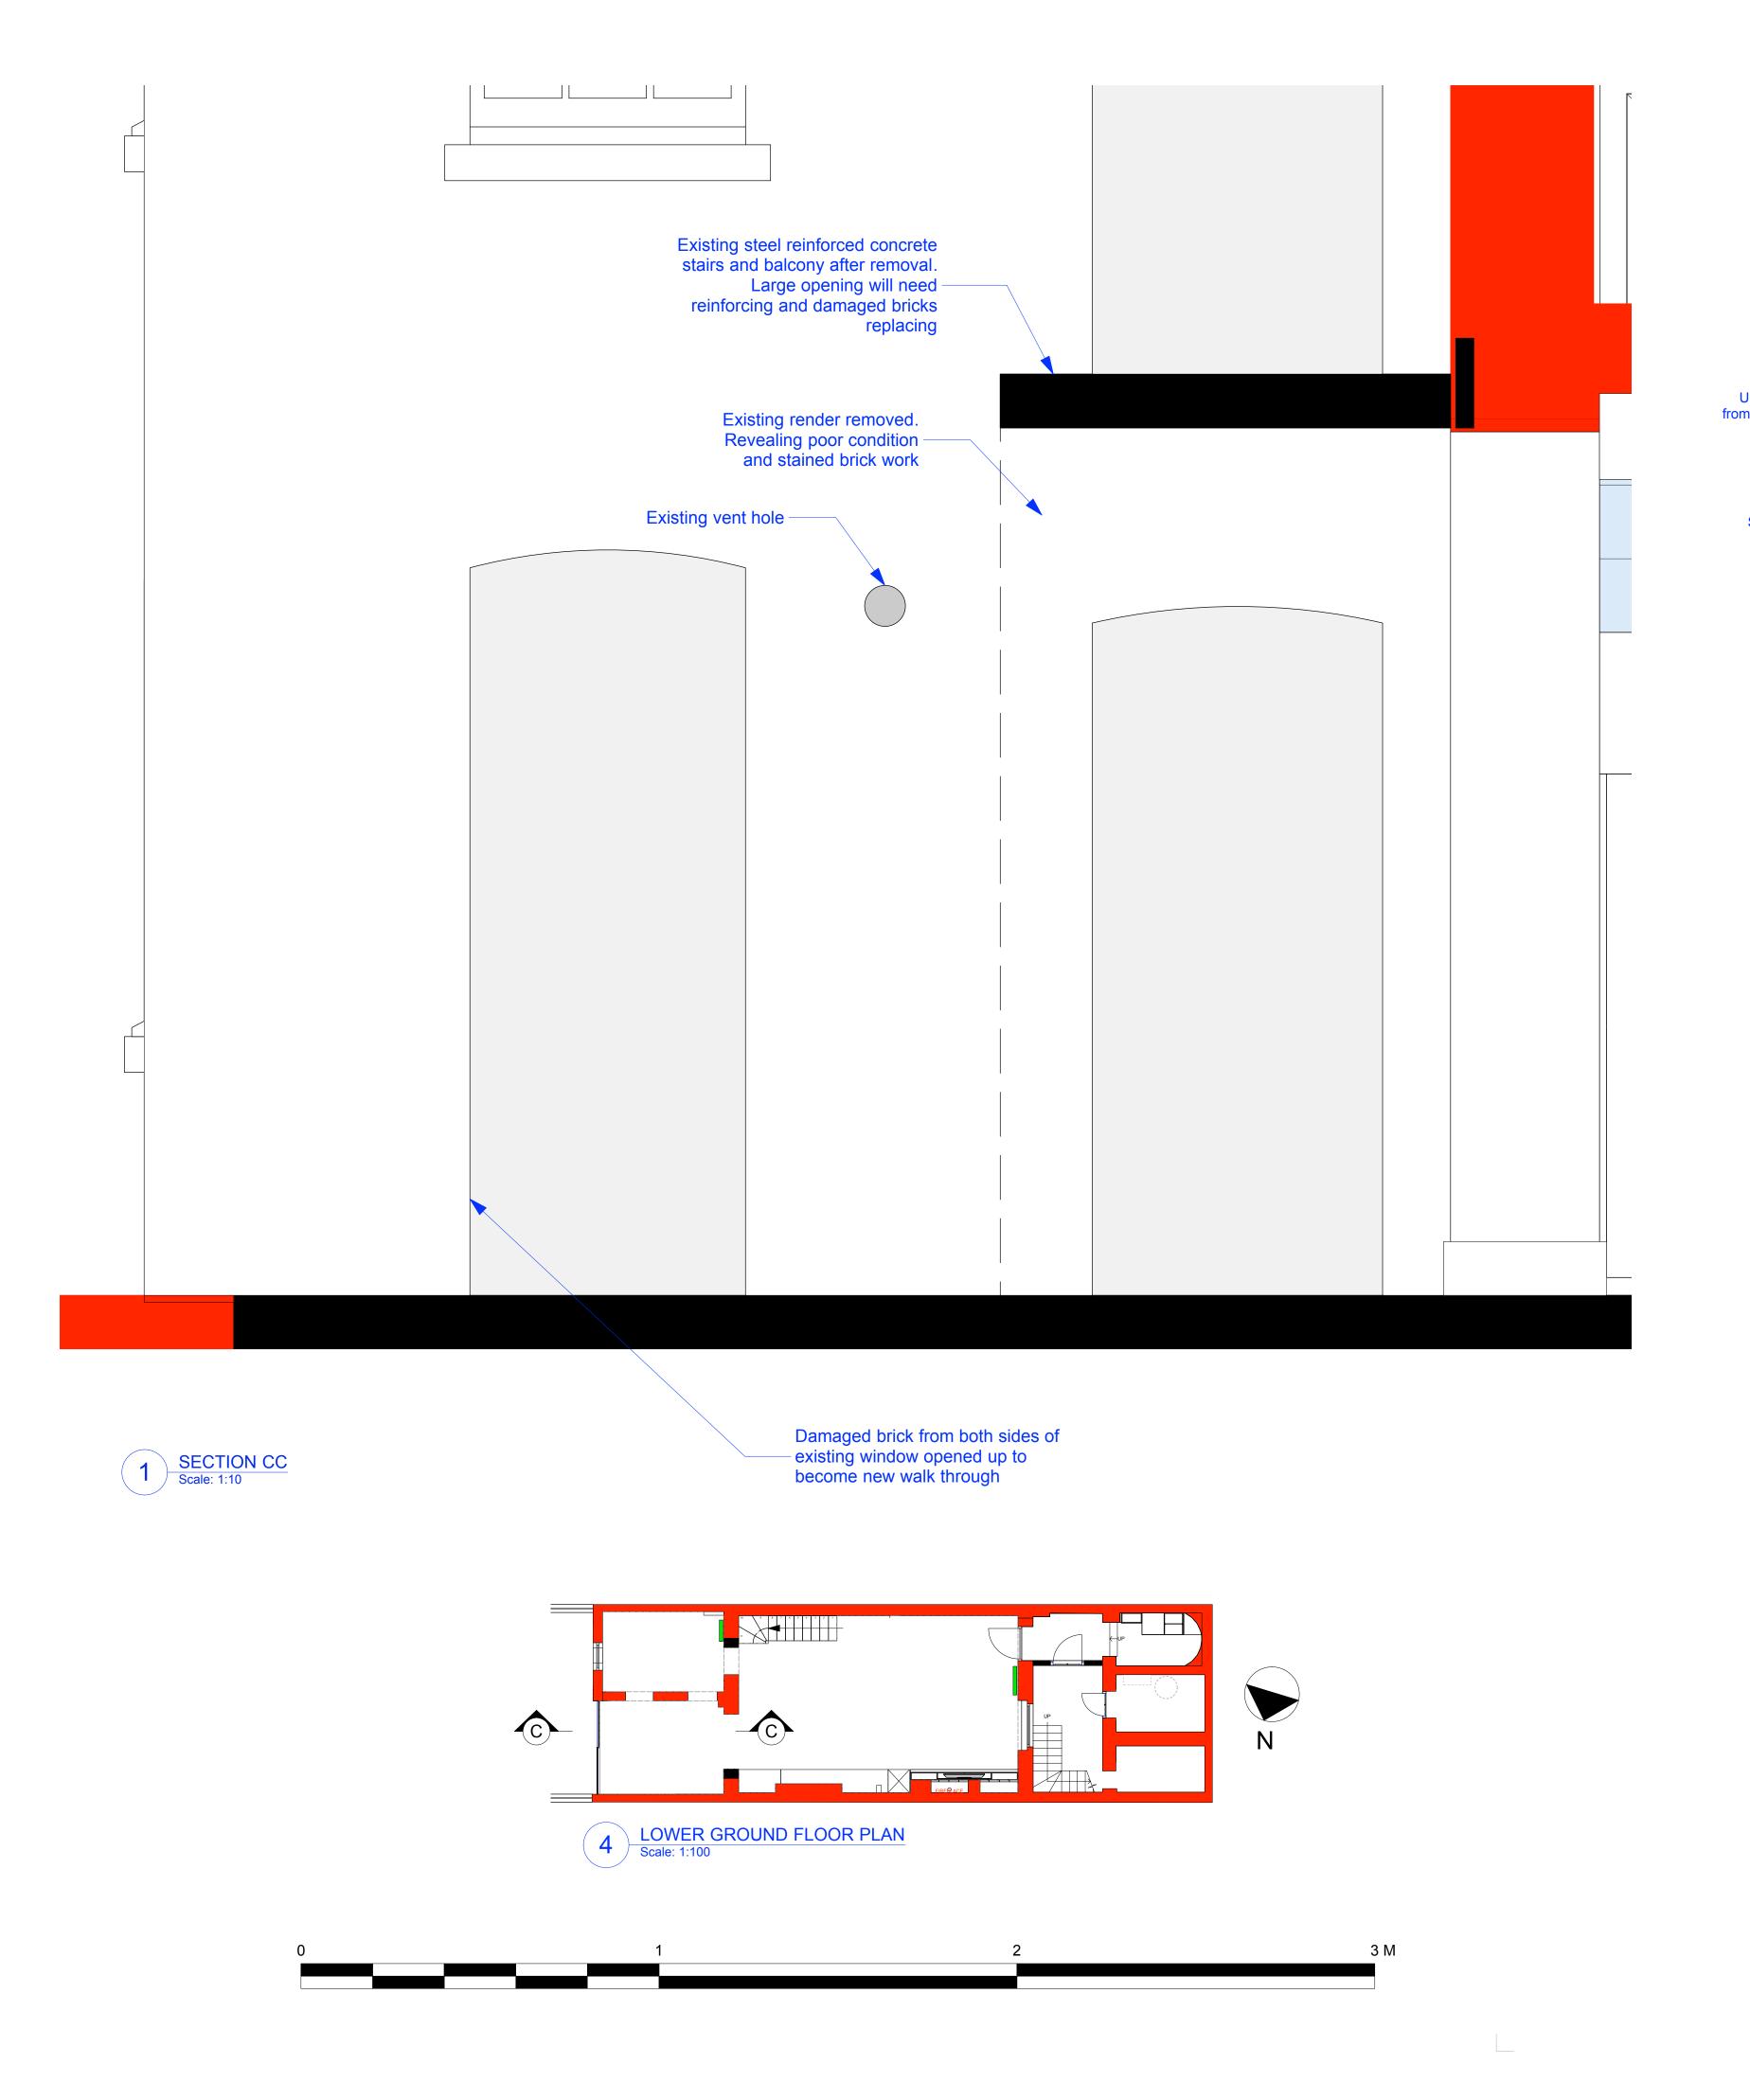
Damaged and poor condition brick work from stair and balcony removal

Existing render removed from return wall after stiar and balcony removal

Existing brick work

- damaged from stair
and balcony removal

Existing render in poor condition

Soil vent pipe removed has left large fixing holes
