3rd ADDENDUM TECHNICAL REPORT

Crawford Reference: SU1404491

**4B Hampstead Hill Gardens
Hampstead
London
NW3 2PL**

SUBSIDENCE CLAIM

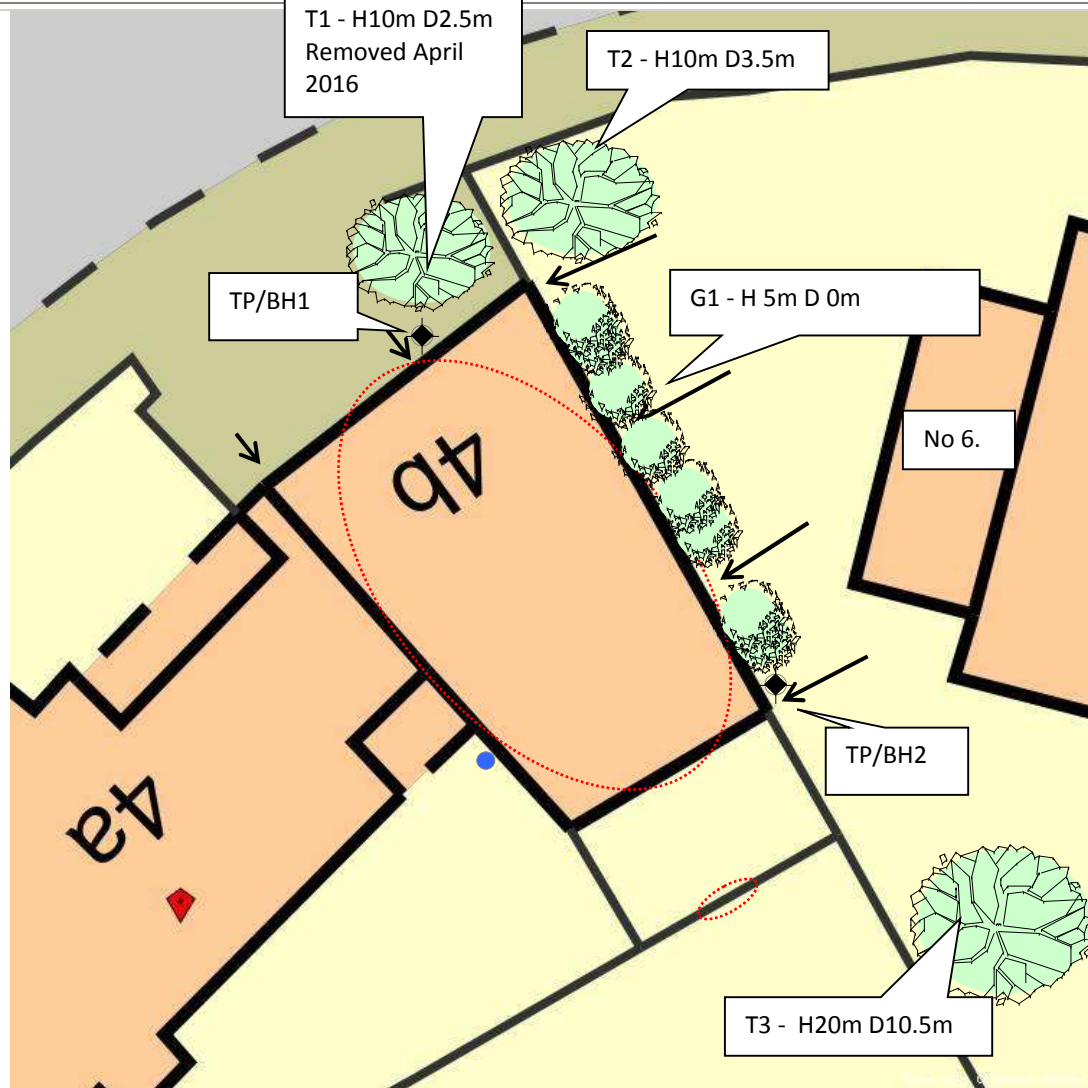
Site Plan

2 x Hornbeam trees T1 and T2 and a wisteria within been identified as the cause of the damage to the property.

Following the removal of T1 ongoing seasonal movement has been recorded confirming the influence of the remaining tree T2. The movement is pronounced on points 1, 2, 3 toward the front and left flank of the property, which are the points closest to the nearby Hornbeam tree, T2. The Hornbeam tree T2 is therefore considered to be the primary cause of the recent movement with the wisteria seen as a secondary cause.

The cause of the movement needs to be dealt with first. From the results of the site investigation, we are satisfied that the main cause of movement to the property, Hornbeam T2, can be removed.
