BEDFORD SQUARE No.48  
LONDON

FIRST FLOOR FRONT ROOM  
Decorative Ceiling Condition

November 2016

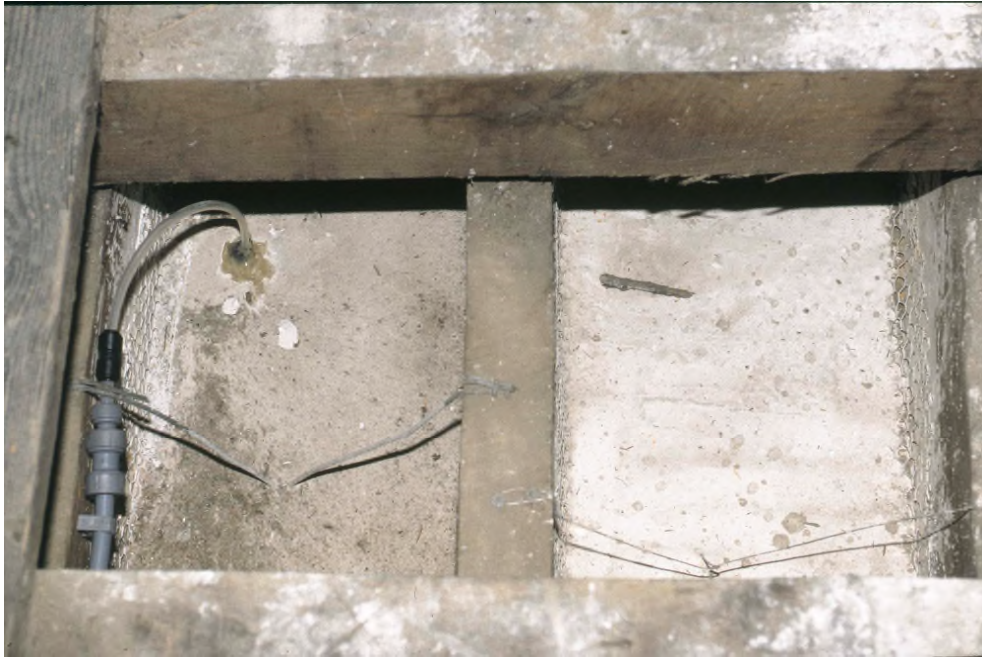
Plate A Illustrating inappropriate repair method applied to the back of an original ceiling (1605-08) at Knole House, Kent with poured plaster of Paris and chicken wire reinforcement together with galvanised wire ties passing through the ceiling face. The result is the wholesale obscuring of the structure beneath and creation of rigid inflexible blocks of plaster.

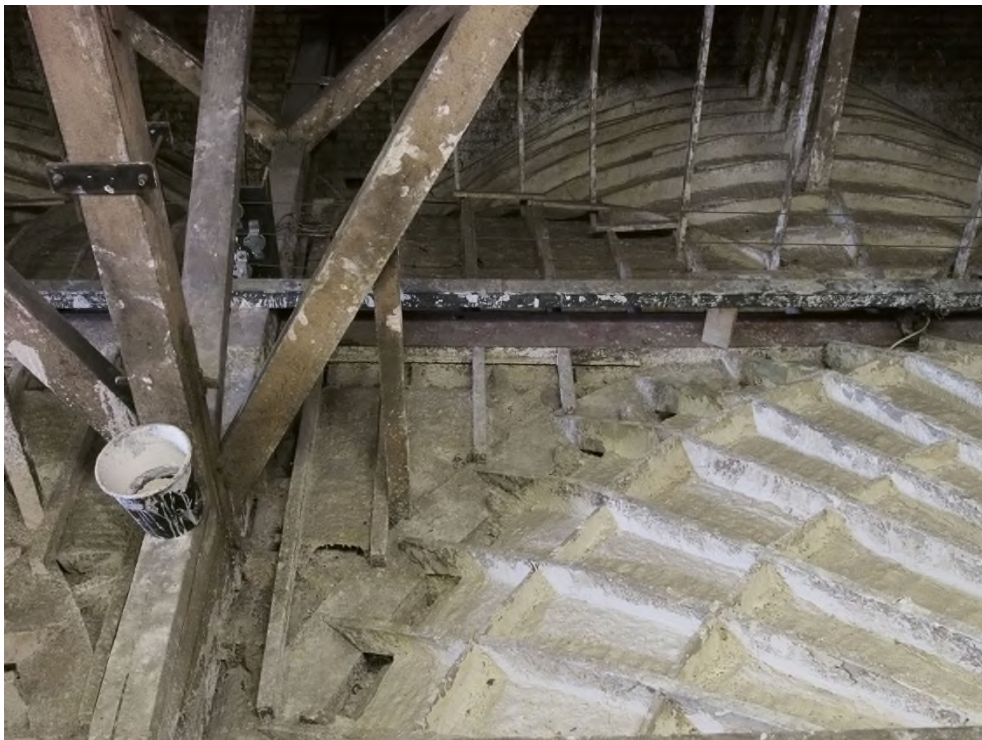
Plate B Illustrating inappropriate repair method applied to a nineteenth century lath and plaster ceiling with poured plaster of Paris and hessian reinforcement obscuring structure beneath, adding weight and reducing flexibility.
