OMC Associates

BSi 5837 Tree Survey for Development

| SITE: | R/O 27 Leighton Road, London, NW5 |
| OUR REF: | 1073/CJO/2009 - Rev 1 |

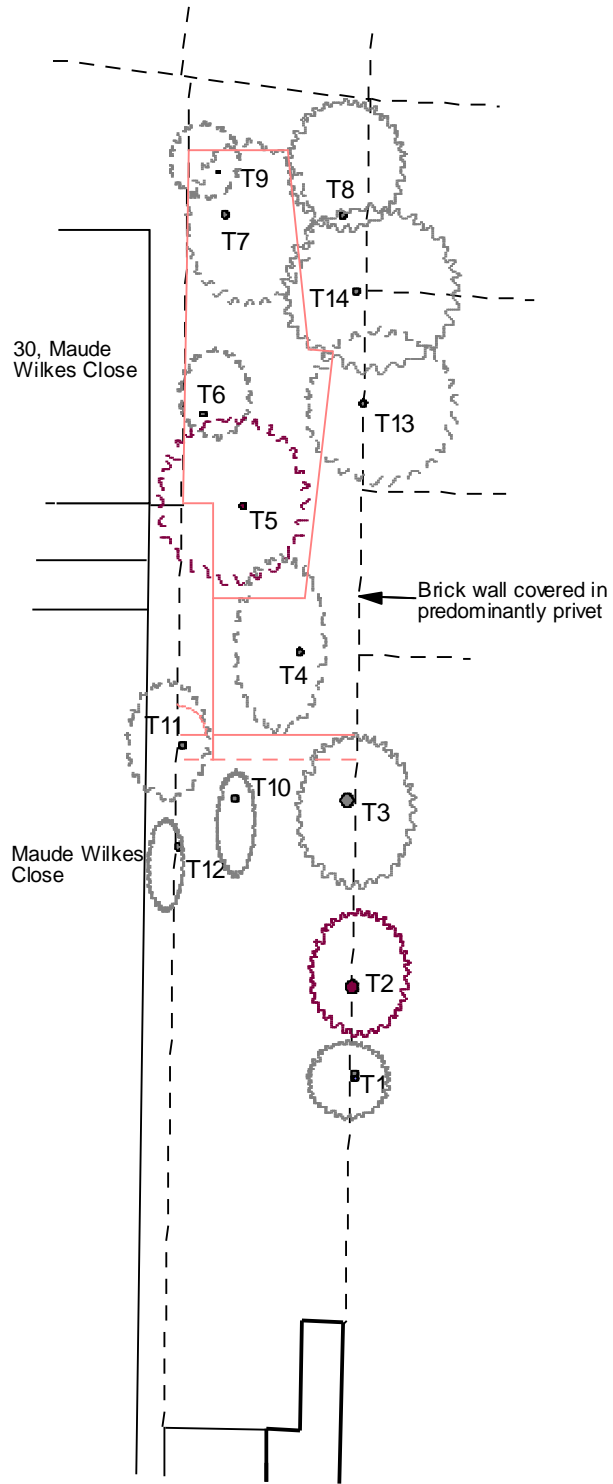
APPENDIX 1

- Proposed layout
- Dripline and stem - colour denotes BS 5837 category
- A
- B
- C
- U
- Where crown line is broken, indicates removal
