# 125 DOC B5 Heritage Statement & Impact Assessment

39 Great James Street, London, WC1 N Rev B - November 2016

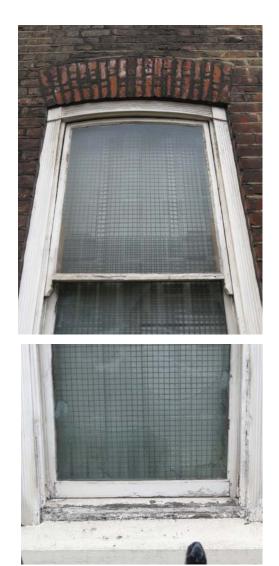
Fig.4e Ground floor windows on front elevation.

The window boxes are positioned to the front of the reveals, as originally designed. The boxes at ground level are fluted – a regency period detail found on most of the other ground floor windows on the street, which indicates a street wide early upgrade. The boxes on the remaining levels are plain.

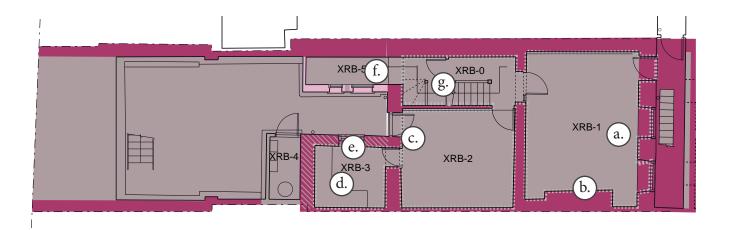
The windows (a) and door to the front of the house are boarded up and propped with scaffold bars and boards, making them difficult to assess.

The door (c) to the back of RB-2 has a square lintel, suggesting the opening is not original. The door itself is certainly modern and in poor condition.

- a. Boarded window in front room
- b. Bricked over chimney.
- c. Narrow entrance to closet extension and
- modern exit to garden.
- d. Kitchenette
- e. Sash window in poor condition. f. Long narrow WC extension g. Modern stair to ground floor.

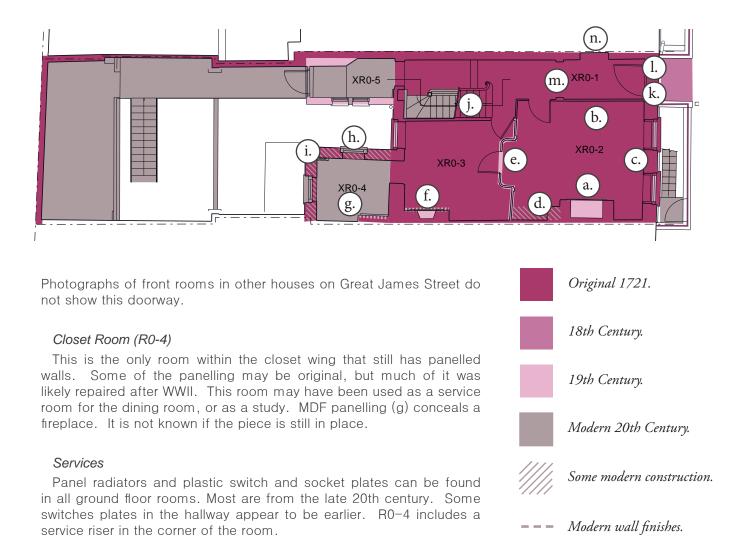
The rear reception (R0-3) may have been the morning room or library. It is plain panelled. It includes a Rococo revival fireplace (f).

The wall between the front and rear room (e) is not original, evidenced by the fact that it obstructs the entrance from the hallway. This wall also has a door that cuts through the panelling.

a. Chimney piece is early 1800s. The top section appears to have been altered.b. Regency/Edwardian cornice.

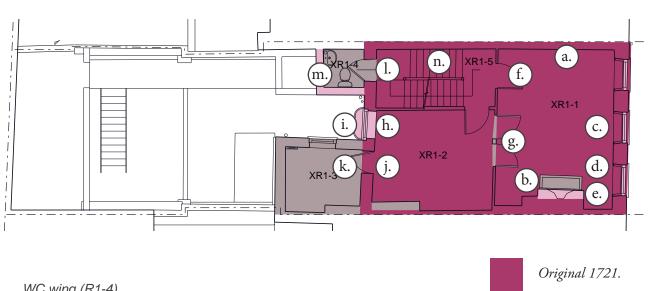
The panelling does not extend into the room and instead the walls are all painted plaster and plasterboard. There is also a painted panel (probably plasterboard) over what is presumed to be a fireplace. It is unclear whether the chimney piece is still in place behind. There is no shutter box around the sliding sash window.

The lack of heritage features tallies with the presumed post war repairs to the exterior of the building

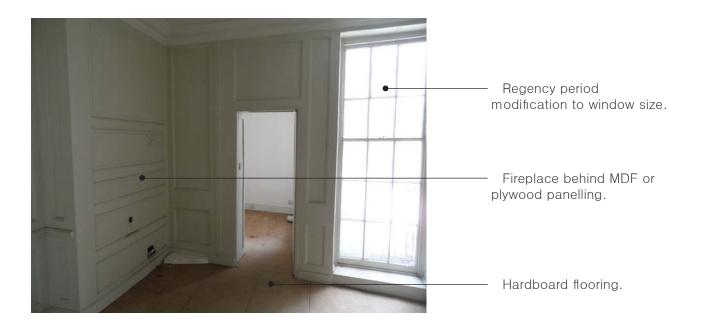
## Drawing Room (R1-1)

The drawing room would have been the principle room of the house, located on the principle floor. It is lined with painted, raised and fielded panelling. The sash boxes and shutters appear original. Some of the shutters retain their original L-hinges and cast iron nails.

The twin doors to the parlour room (R1-2) were constructed following planning permission in 1971 to 'unite the two premises'.

Modern services have been added to some walls.

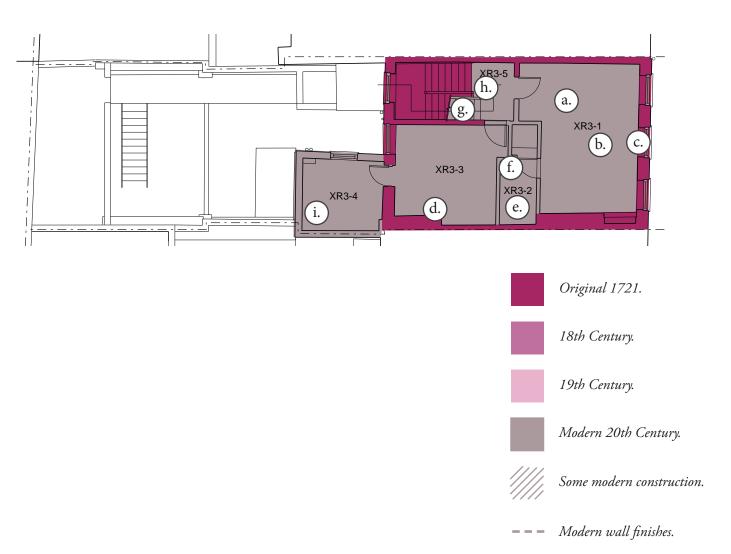
There are modern services throughout. In the closet wing, the services riser from below continues up through R3-4.

h. Stair from second to third have closed stringers and balustrades appears to be later reworking.

i. Closet wing from ground/first to roof appears to be post war.

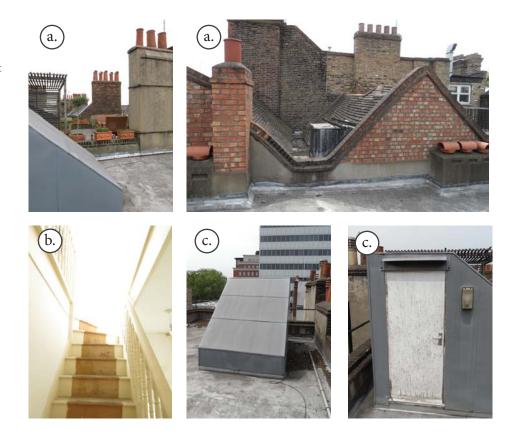
a. New roof to replace original double pitched roof - as found at Number 40 Great James Street - built in 1960s.
b. Modern stair to roof built in 1960s.
c. Access structure built in 1960s.
