# Arboricultural Appraisal Report

## Subsidence Damage Investigation at:

31 Heath Hurst Road  
London  
NW3 2RU

CLIENT:	Crawford & Company
CLIENT REF:	1308651
MWA REF:	SUB161104-830
MWA CONSULTANT:	David Williams (N.D.Arb MArborA)
REPORT DATE:	17-11-2016

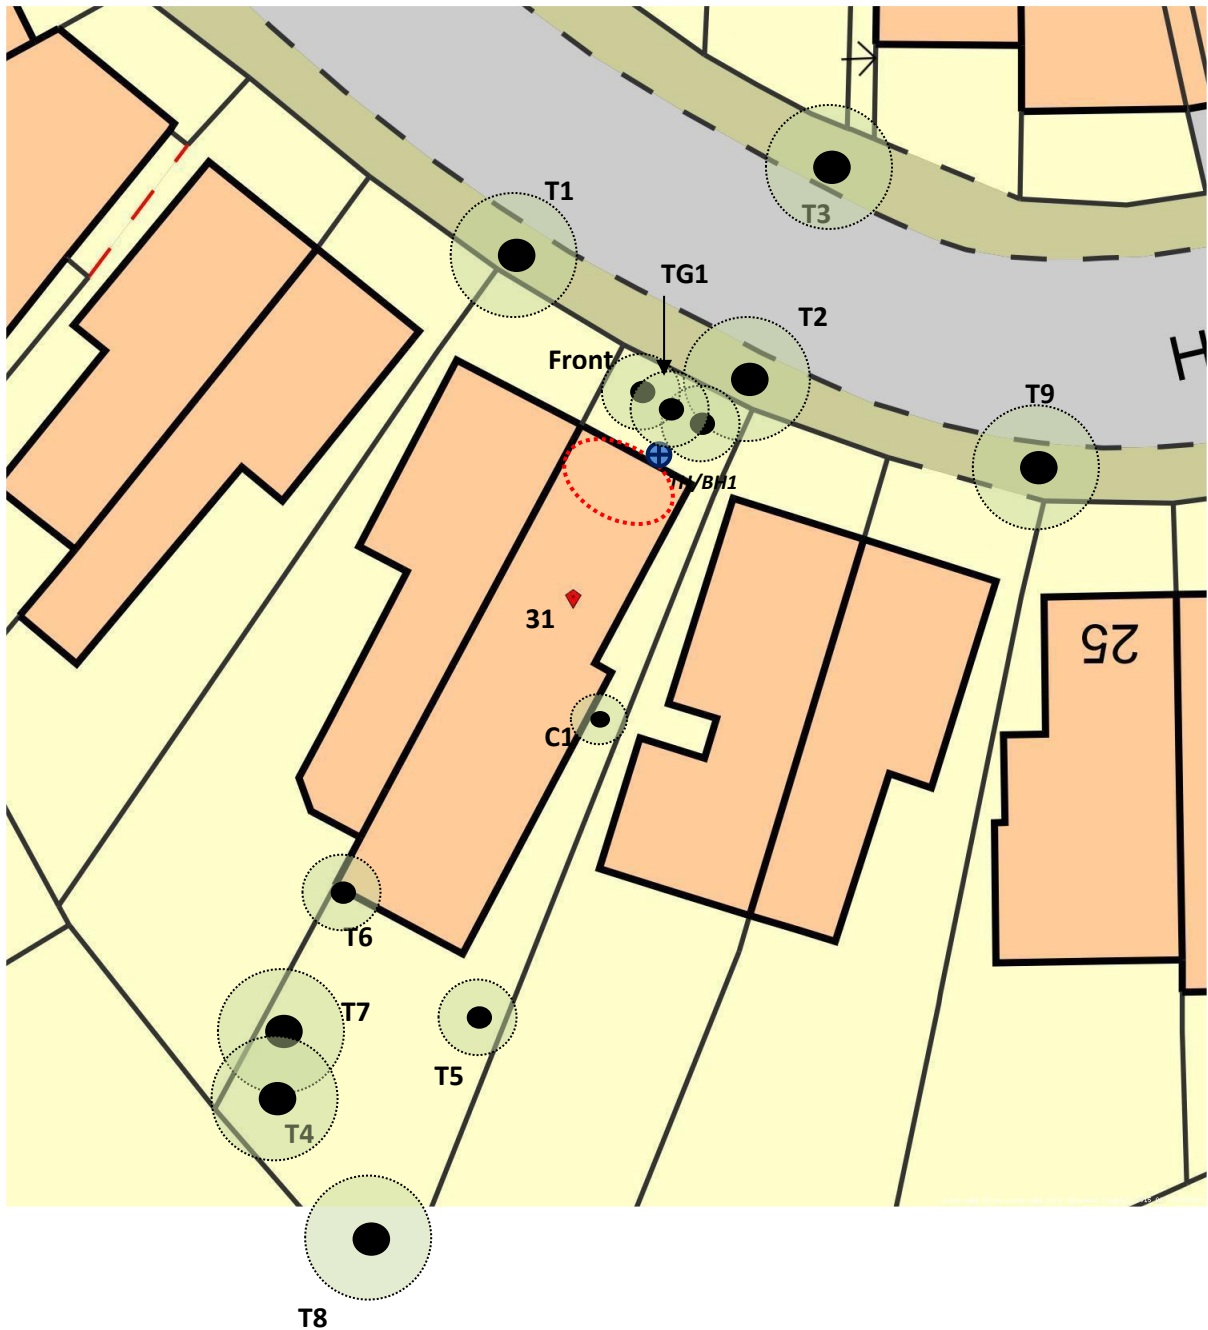
SITE PLAN

Roots were observed below the foundation underside confirming the drying action of TG1 below the front elevation. No roots were recovered from T2 which should not be relied upon to discount the causative role of this tree. *Cupressaceae spp* roots are assumed to originate from tree(s) removed some time in the past.

Based on the technical reports currently available, engineering opinion and our own site assessment we conclude the damage is consistent with shrinkage of the clay subsoil, the cause of which will be the combined drying impact of T2 and TG1 on soil volumes below the front elevation. We are confident of the causal role of T2; however, the LPA may insist on evidence of root trespass despite the trees close proximity to the dwelling.
