**St Katherine's The Danish Church  
Structural Appraisal of Pinnacles**

**Prepared for  
The Danish Church  
November 2015**

This structural engineering appraisal has been prepared by Alan Baxter Limited (ABA) and relates to the two masonry pinnacles on the west elevation of the St Katherine's, The Danish Church in London (see photo 01).

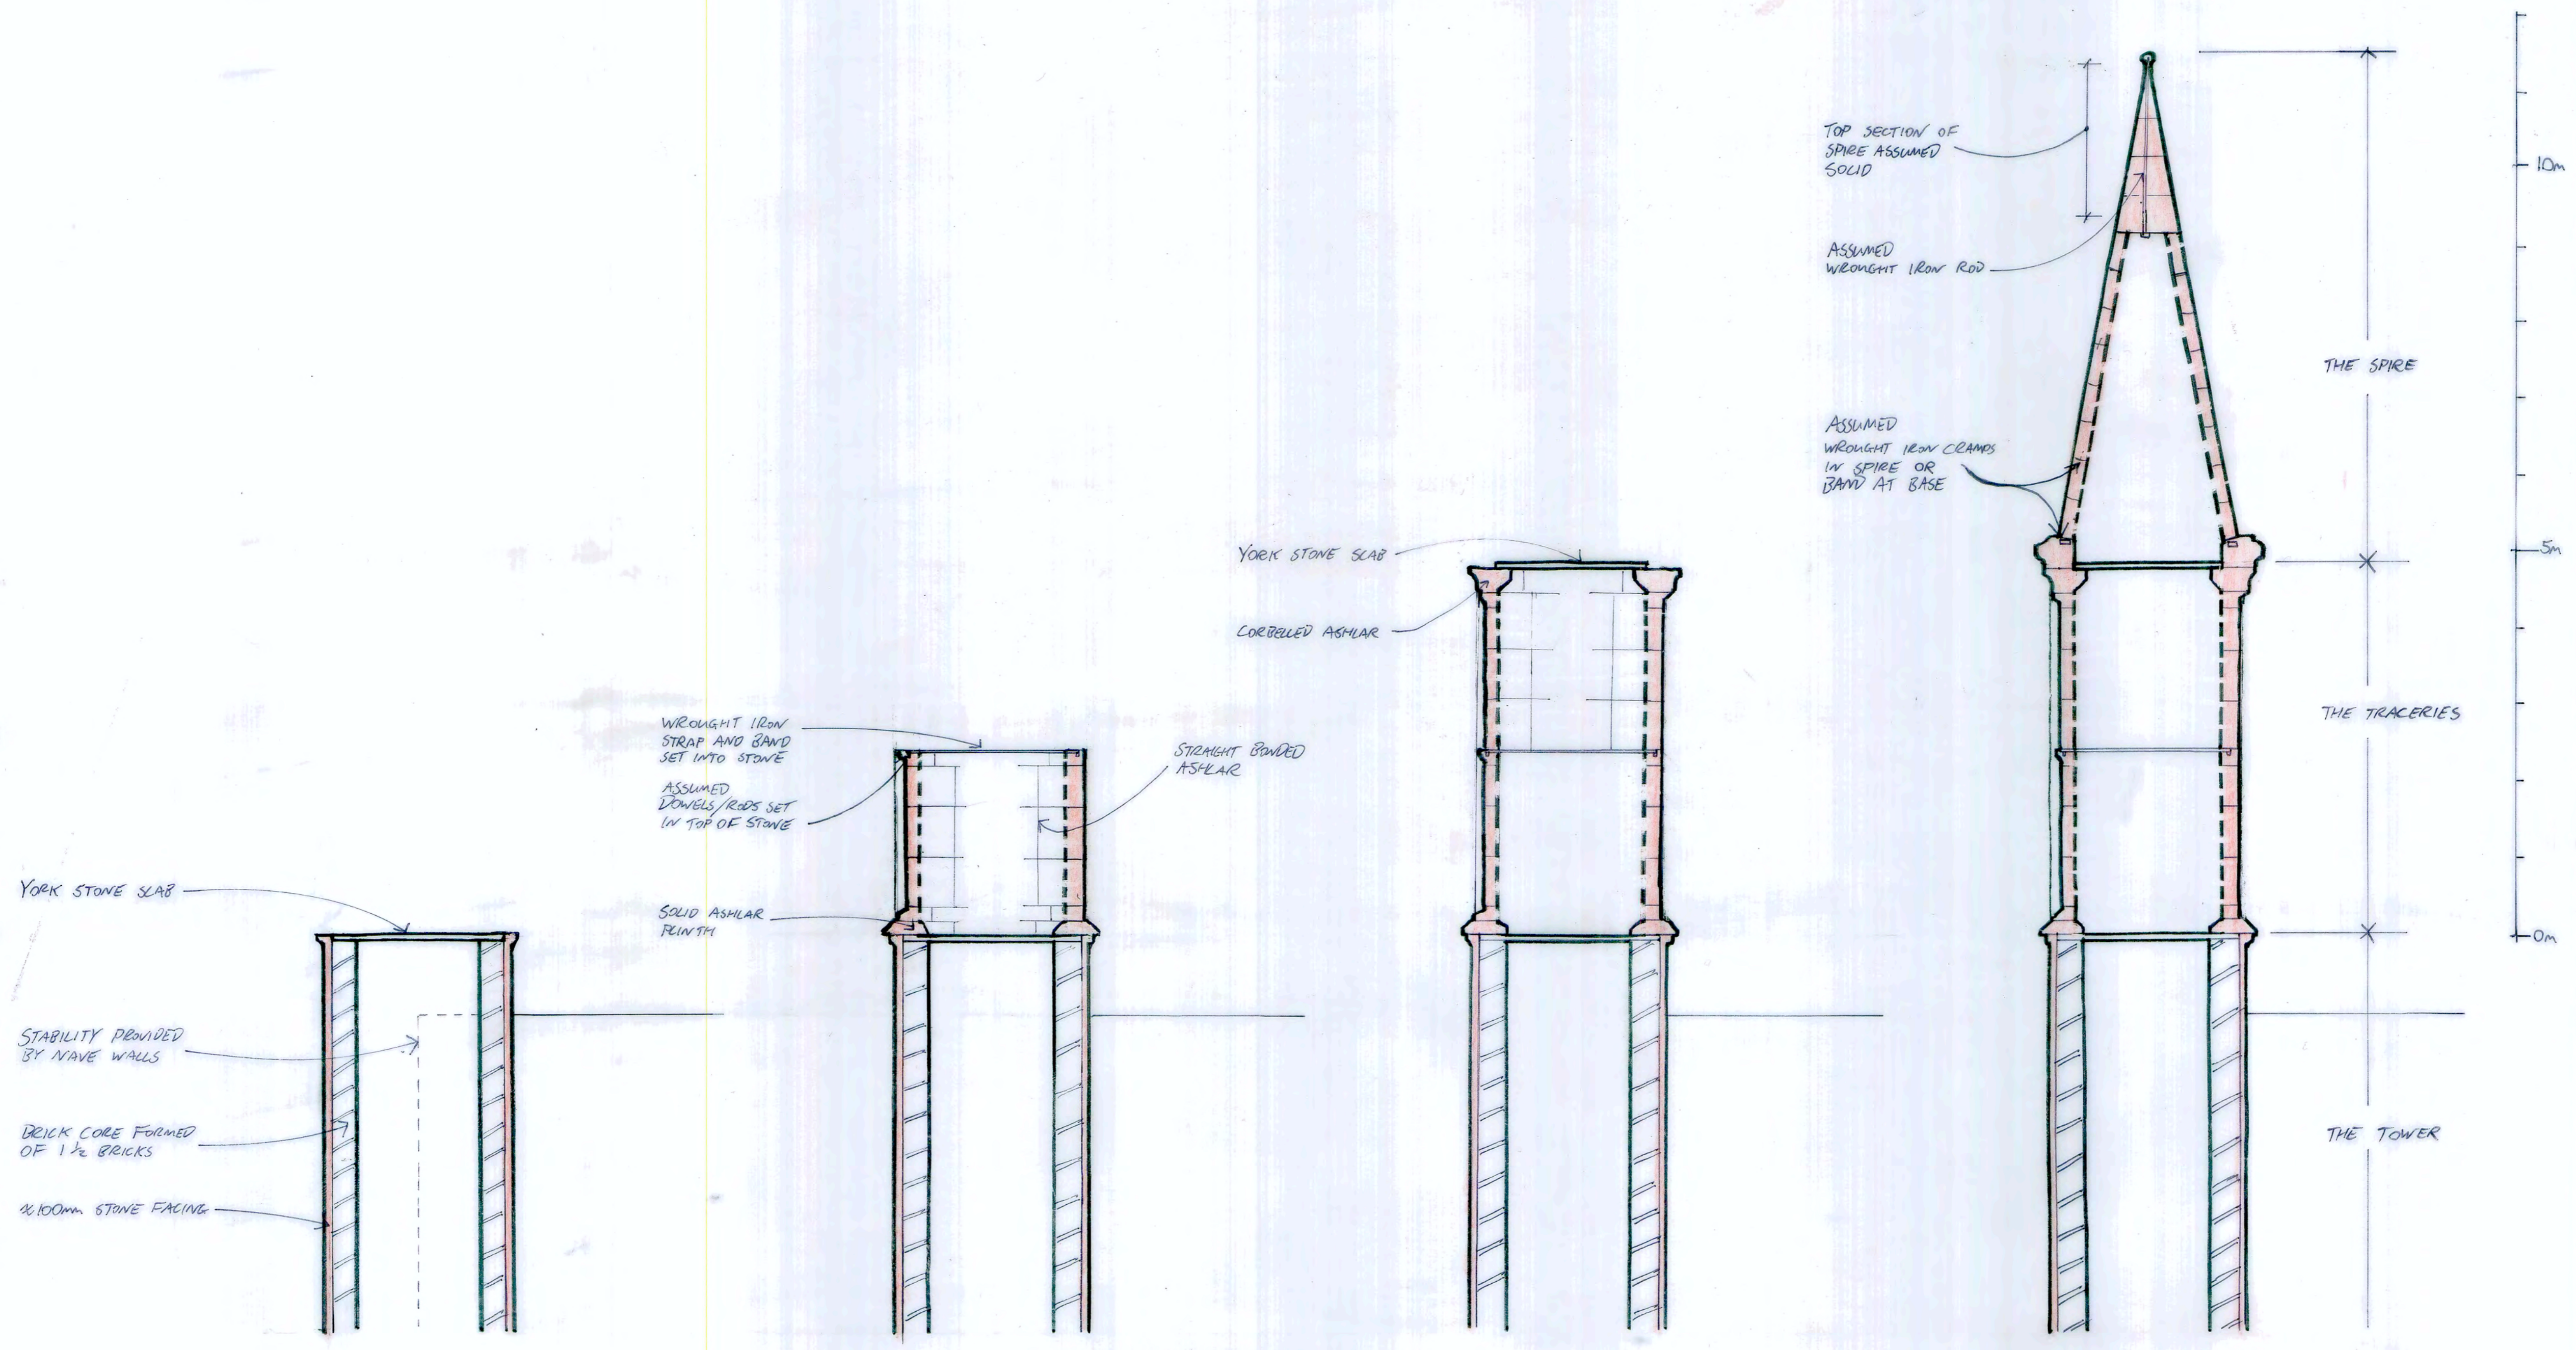
dep. no. <b>1601/212/01</b>	rev. <b>A</b>
--------------------------------	------------------

ASSUMED CONSTRUCTION SEQUENCE OF EXISTING TOWER

- 1/ Construct new internal platform
- 2/ Pack out parting in stonework around pinnacle, inside and outside
- 3/ Install 2 No new stainless steel ring beams, above and below existing wrought iron band, anchored to each stone. Ring packed tight to stones and to be erected in sections
- 4/ Cut out existing wrought iron brace

- 1/ The following sequence is to be carried out one stone at a time or in max 300mm wide sections (whichever is the smaller):
  - i/ Cut out existing stone immediately above existing wrought iron band. Height of stone to be agreed.
  - ii/ Remove wrought iron embedded within stone
  - iii/ Replacement stone to be laid
  - iv/ Pin up tight to masonry above
- 2/ Suggested sequence of stones to be replaced:
  - v/ Non-decorated solid ashlar rear face
  - vi/ Panel sections
  - vii/ Mullion sections
  - viii/ Rear corner/column sections
  - ix/ Corner/column sections
