## SEQUENCE OF DESIGN

Reference: STRUCTURAL REPAIRS TO WALKWAY, CHALK FARM BUILDING  
Stables Market, Chalk Farm Road, London NW1 8AH

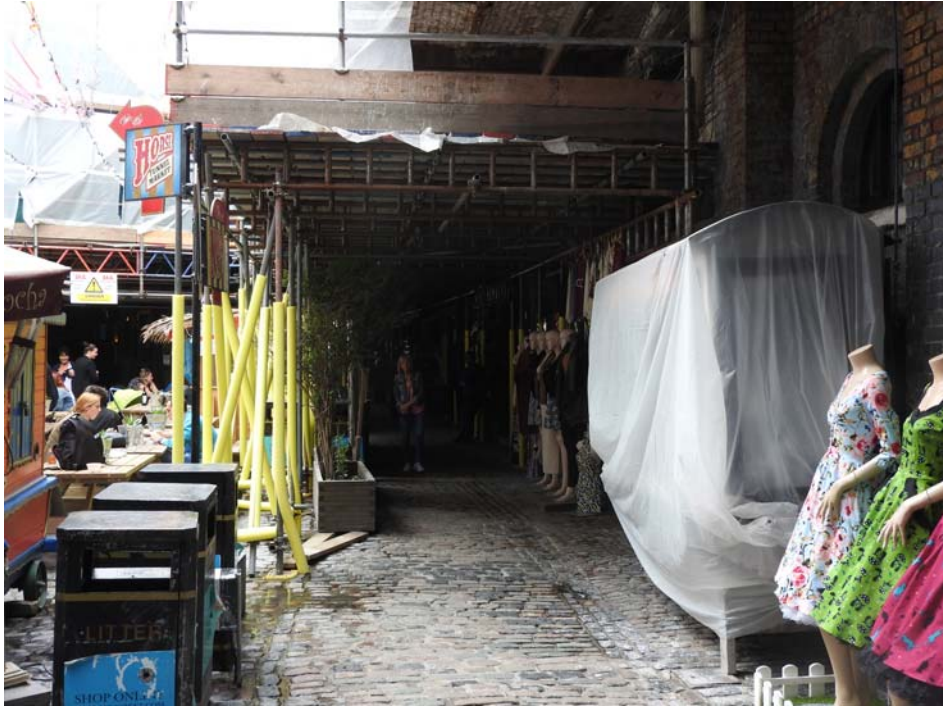
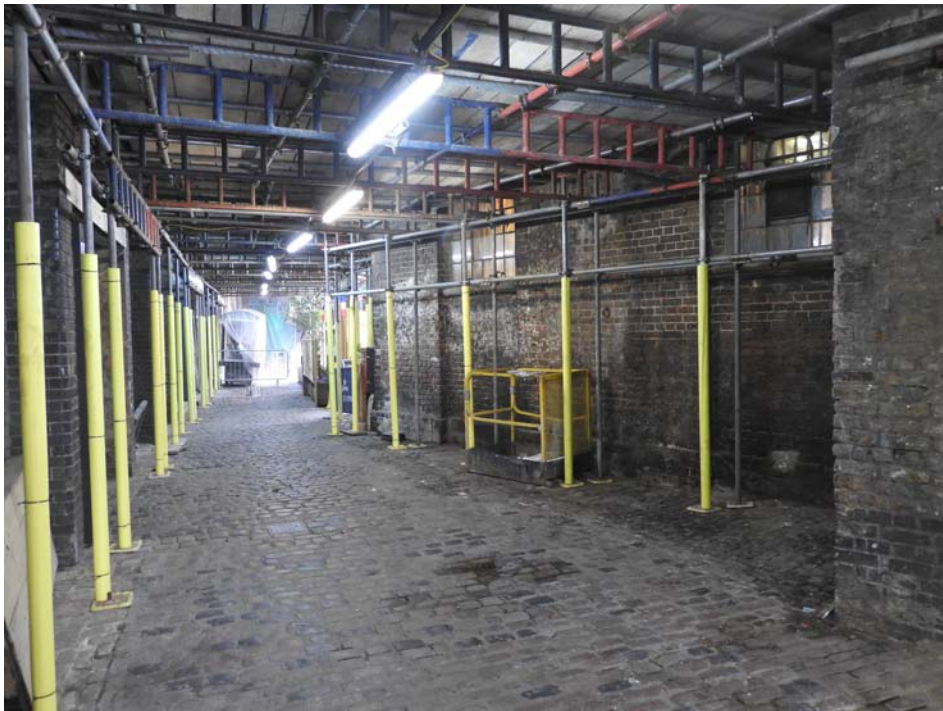
## 1. CRASH-DECK AND SCAFFOLDING ERECTED – JUNE 2016

The below crash-deck and scaffolding was erected as part of the previously approved conservation and alteration works to the Chalk Farm Building walkway. The completion of this work enabled the condition of the existing steelwork to the underside of the walkway to be inspected more closely than before by the Structural Engineer and metal-work specialist for the project.
