THE COCK TAVERN, 23 PHOENIX ROAD, LONDON,
NW1 1HB

REPAIR & RENEW SCHEDULE

OCTOBER 2016, Rev A

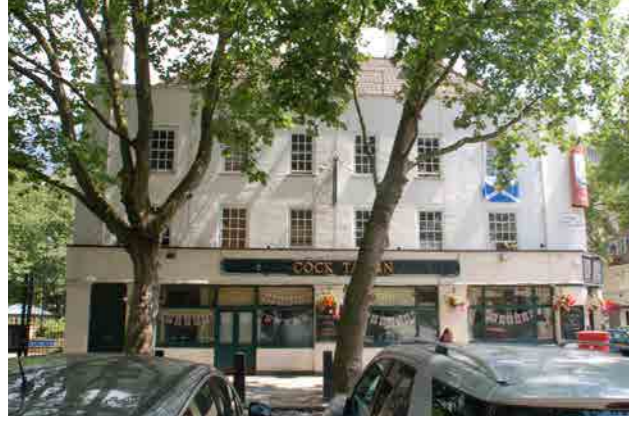
First and second floor sash windows south west façade

Original sash windows with timber boxes and cills. 12 no. on south west elevation facing Chalton Street. Refer to Window Condition Survey for details.

2 No. replacement sash windows proposed in new listed building application to match existing with timber single glazed sashes. All existing sash boxes to be replaced with new timber boxes to match existing to allow the existing sash windows to be restored and correctly mounted, weighted and preserved. Existing catches and handles to be salvaged and preserved, new brass window pullies, ropes and weights to be installed.

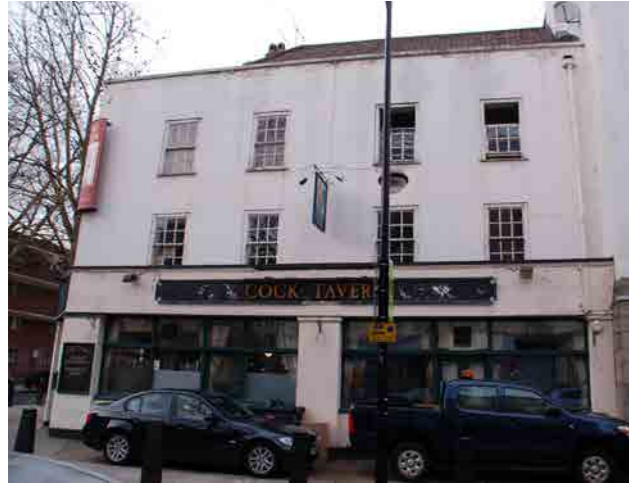
Original sash windows with timber boxes and cills. 8 no. on south east elevation facing Phoenix Road. Refer to Window Condition Survey for details.

4 No. replacement sash windows proposed in new listed building application to match existing with timber single glazed sashes. All existing sash boxes to be replaced with new timber boxes to match existing to allow the existing sash windows to be restored and correctly mounted, weighted and preserved. Existing catches and handles to be salvaged and preserved, new brass window pullies, ropes and weights to be installed.

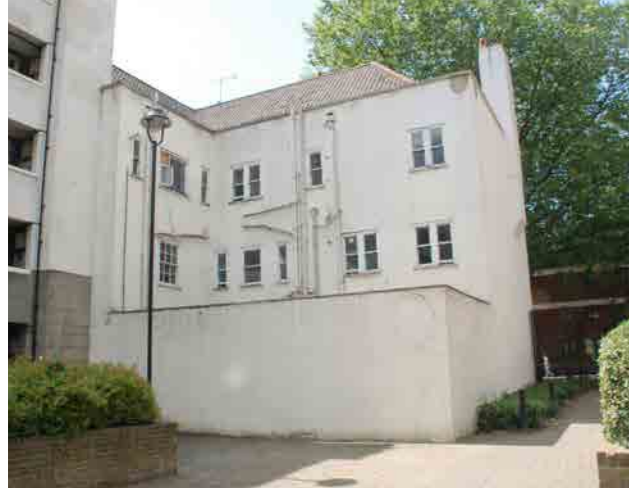
Original sash windows with timber boxes and cills. 5 no. of various sizes at first floor level. Refer to Window Condition Survey for details.

All existing sash boxes to be replaced with new timber boxes to match existing to allow the existing sash windows to be restored and correctly mounted, weighted and preserved. Existing catches and handles to be salvaged and preserved, new brass window pullies, ropes and weights to be installed.

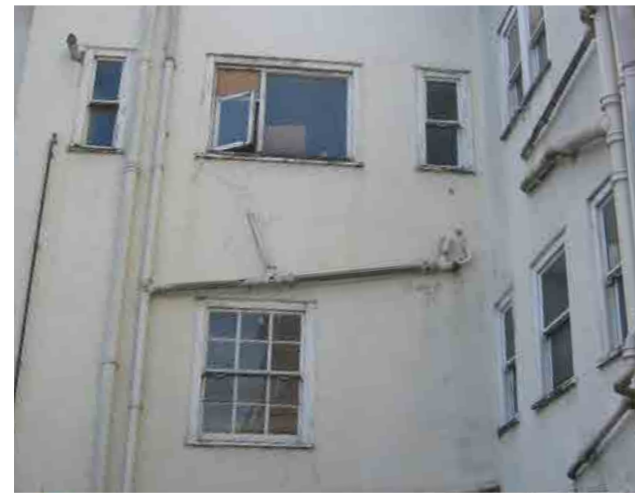
Original sash window Ref: W1 14 with timber box and cill. 1 no. at first floor level. Refer to Window Condition Survey for details.

Sash window to be repaired and retained refer to WD/308 with new stud work compartmentation installed behind to apartment. Existing sash box to be replaced with new timber boxes to match existing to allow the existing sash windows to be restored and correctly mounted, weighted and preserved. Existing catches and handles to be salvaged and preserved, new brass window pullies, ropes and weights to be installed.

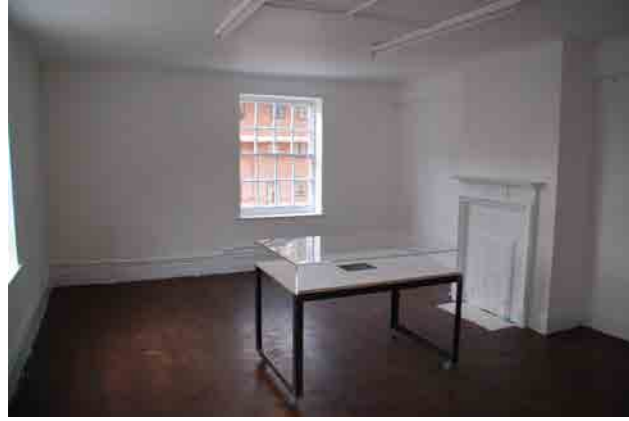
First floor ceilings in poor condition and in need of repair.
