Arboricultural Consultancy for Aviva

1. Case Details

Insured	Mr Anthony Dworkin	Address	62 Albert Street, London, NW1 7NR		
Client	Infront Innovation	Contact	Arif Khalifa	Claim No.	IFS-AVI-SUB-14-0048840
MT Ref	NL/2301141643/TP-REV1	Consultant	Thomas Peppiatt	Contact No.	08702 416 180
Report Date	13/02/2014 <i>Revised 13/07/2016</i>

3. Technical Reports (Revised)

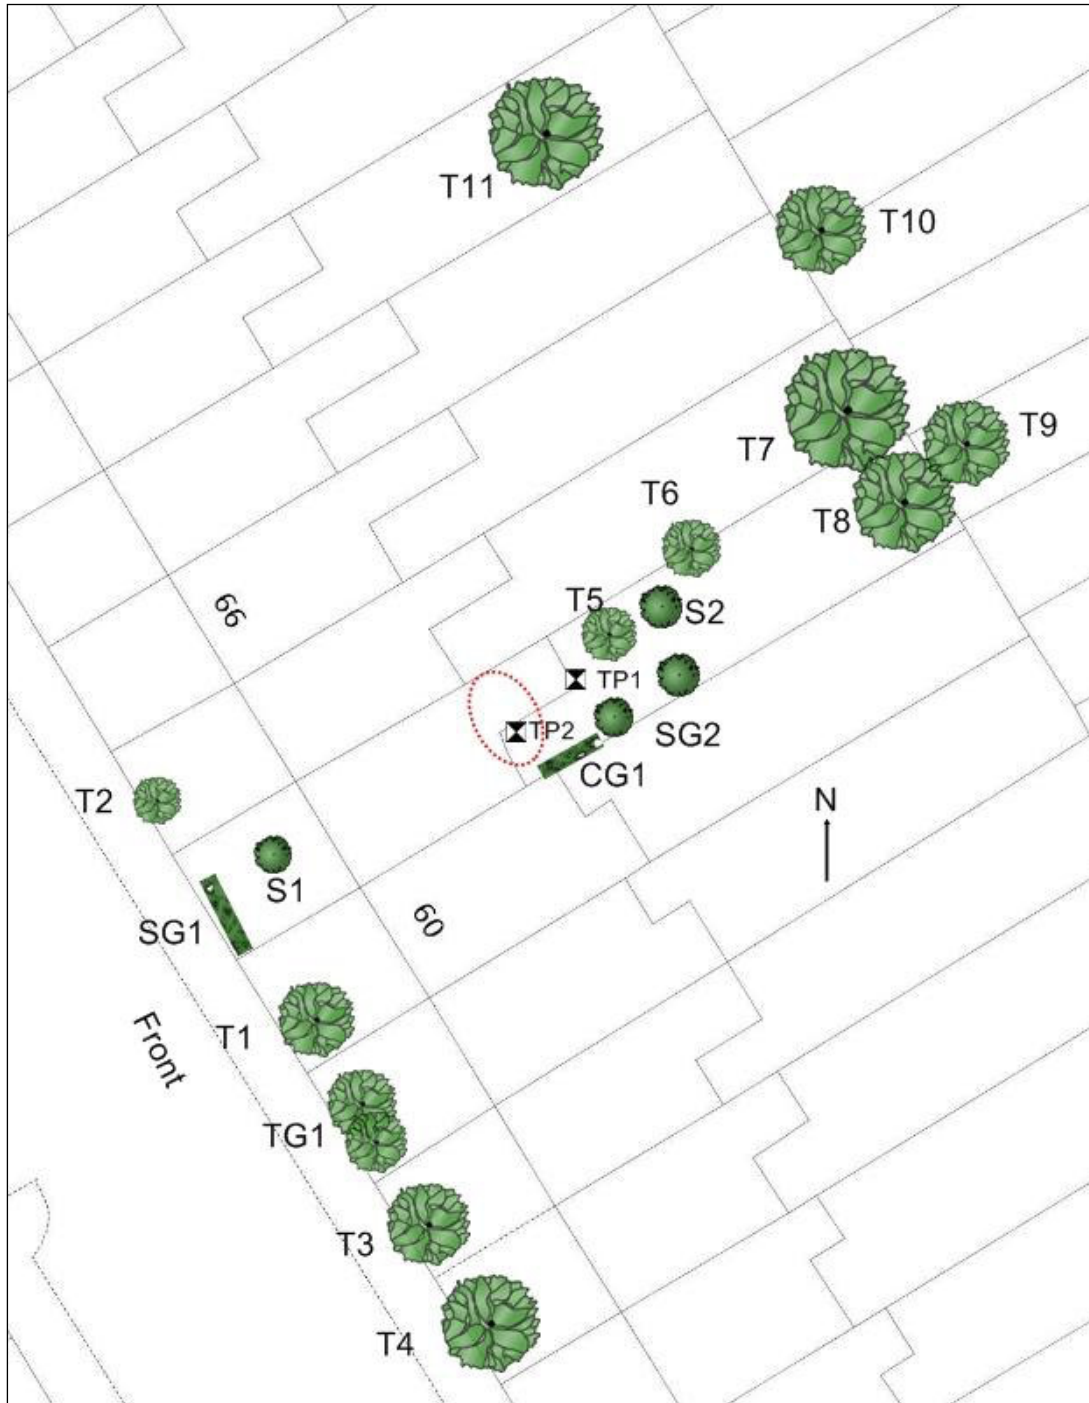
7. Site Plan

In assessing the extent of damage and the potential drying influence of the vegetation on site, T7 (Plane (London)) is judged to be the dominant feature and accordingly we have identified it as the principal cause of the subsidence.

In order to mitigate the current damage and allow soils beneath the property to recover to a position such that an effective engineering repair solution can be implemented we recommend a program of removals as listed by this report.
