Manhattan Loft Corporation St Pancras Booking Hall

Ticket Office Mezzanine – Phase 2 of Structural Feasibility Study

Final | 24 June 2016

Appendix A: Intrusive Column Survey Report

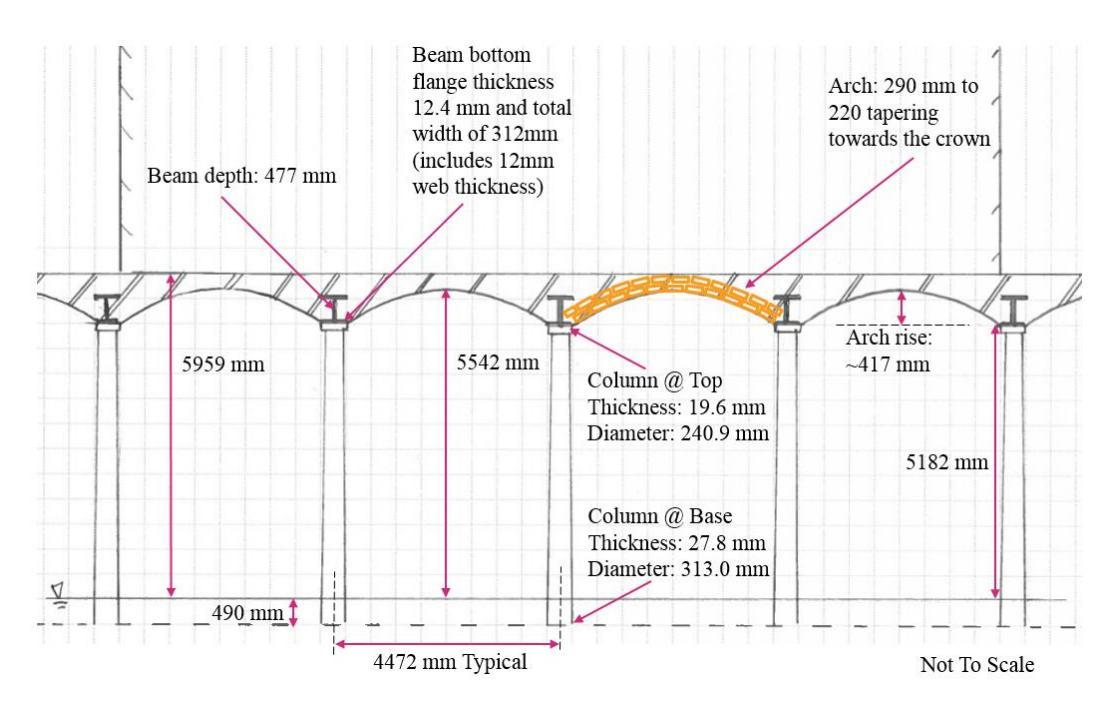
Figure 1: Dimensions of existing structure assumed for feasibility study

The existing structure beneath the Booking Hall consists of masonry arches spanning between wrought iron beams. The beams bear on cast iron columns. Based on existing drawings the foundations appear to be square concrete footings. The key dimensions of the existing structure are given in Fig. 1.

The flooring consists of non-structural fill and a brick voussoir resting on wrought iron beams. The existing drawings and laser survey confirm that the span of this arch is about 4472mm between beam centrelines. The intrusive survey data suggests that the rise of the arch masonry barrel is 471mm (May 3rd 2016 report).

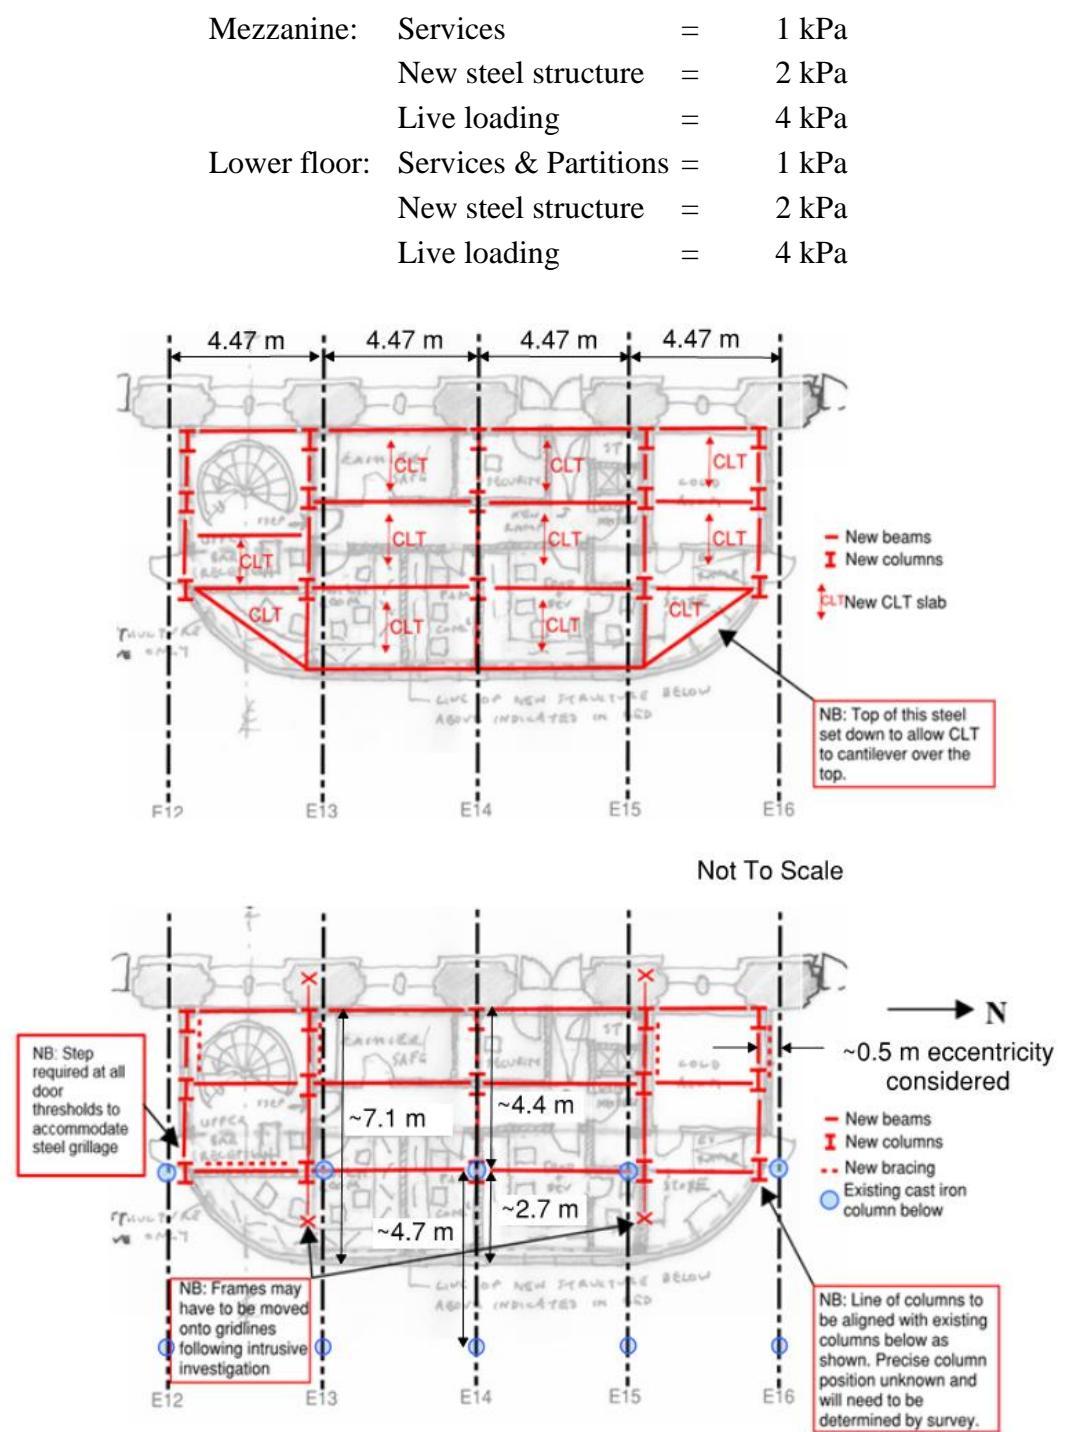
Figure 2: Dimensions of mezzanine and lower floor assumed for feasibility study

The proposed structural solution from the 22^{nd} July 2015 report is reproduced in Fig. 2. Approximate dimensions, valid for this feasibility study are included and used in calculating the dead and imposed loadings. The loadings assumed over the mezzanine and lower floor areas are:

An analysis using the dimensions in Figs. 1 and 2 and unfactored loadings in Sect. 3 was conducted. Various loading cases were considered to give the worst case. A large point load with little uniformly distributed load gave the most critical condition. Fig 3 illustrates the analysis for the case where there is point loading at each end of the beam with a 500mm eccentricity from the support of the arch. It shows that the compression thrust line is within the voussoir, hence is stable, but only has a geometric factor of safety of 1.4 (within the middle 70%). Since this line of thrust goes outside the middle third of the voussoir depth, cracking will occur in the arch. Furthermore, to achieve this line of thrust requires a large horizontal thrust which may make the neighbouring arch unstable if that arch has little vertical load acting on it. Thus our study indicates that the existing masonry arch is not suitable to carry the large eccentric point loads from the new mezzanine columns.

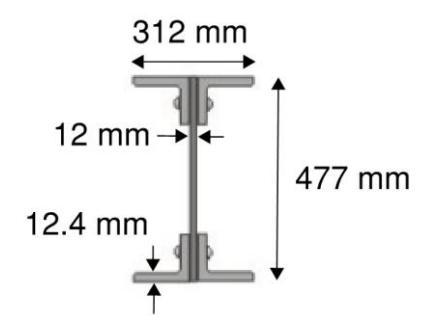
Figure 4: Assumed dimensions of the built-up wrought iron beam

It is assumed that the beams are made of wrought iron (instead of cast iron) as the beams are a built-up section made of plates and angles- a common characteristic for wrought iron. The beams are embedded in the brick flooring, with only the bottom flanges able to be observed. By drilling from above we were able to determine the depth of the beam. This drilling also indicated that there is a top flange to the beam. The dimension assumed for this study are given in Fig. 4

The proposed new structure in Fig. 2 was devised so that the loadings from the new mezzanine level are not imposed on the existing beams. Thus the existing beams are not envisaged to be loaded significantly more than their current state.
