**STATEMENT OF HERITAGE SIGNIFICANCE
10 REGENT'S PARK TERRACE, LONDON NW1**

**For
Mr Godeau & Ms Gastaldo
December 2016**

G R Bennett BA MA DipTP IHBC

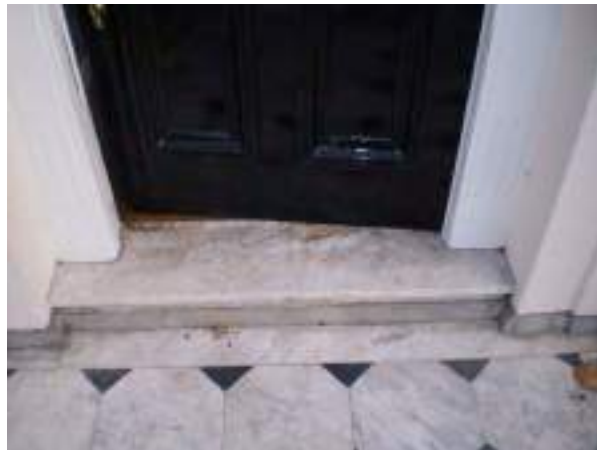
Non-original marble door step. No Significance. Harmful modern alteration.

- On the pavement vaults' wall, rerun the white plastic plume pipe and the condensate pipes internally to reduce their visual impact and paint their outlets to match the wall.
- Remove the marble cladding and tiling from the front entrance steps and landing and reinstate the steps in Portland stone and the landing in York stone using large slabs to the original design.
- Remove the basement build-out of the kitchen area under the front entrance bridge and reinstate the wall in line with the bridge. Replace the front basement entrance door with an appropriately detailed four-panelled door with flush panels with butt and beaded edges externally and flat recessed panels with no mouldings internally.

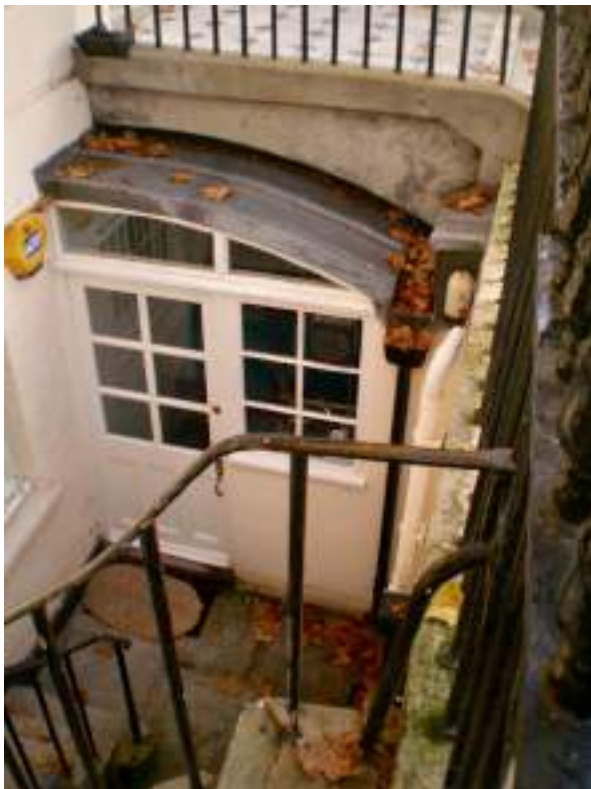
Front Basement Lightwell Non-original door & window infill under bridge - No Significance. Harmful modern alteration

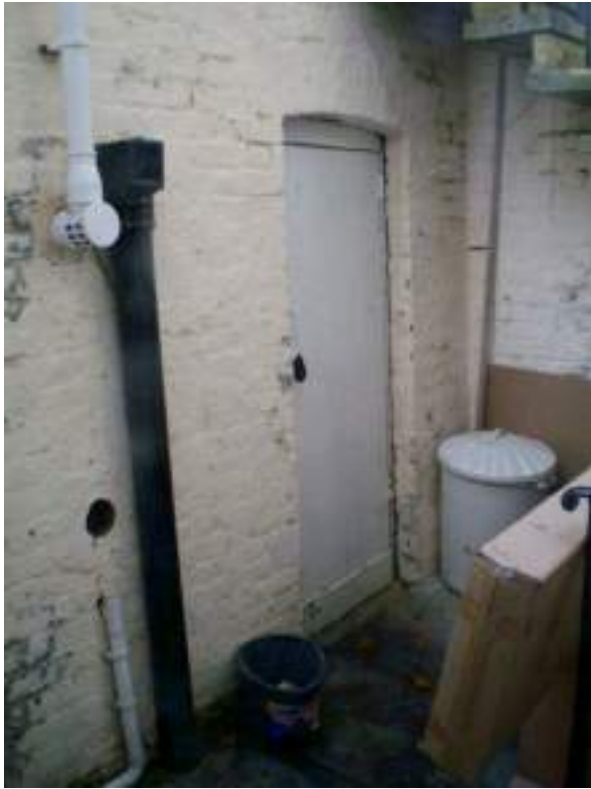
- 5.14 The basement front window has metal bars over it as protection against intruders. This is a harmful modern alteration.
- 5.15 The lightwell is paved in York stone. There are plain-boarded doors to two vaults under the pavement. An unattractive white plastic boiler flue with a plume pipe extension and a white plastic condensate pipe protrude through the wall of the vaults. The vaults have lost the coalhole plate in the pavement above.

Front basement lightwell. Original door to vault - Low Significance. Modern boiler flue - harmful modern alteration.

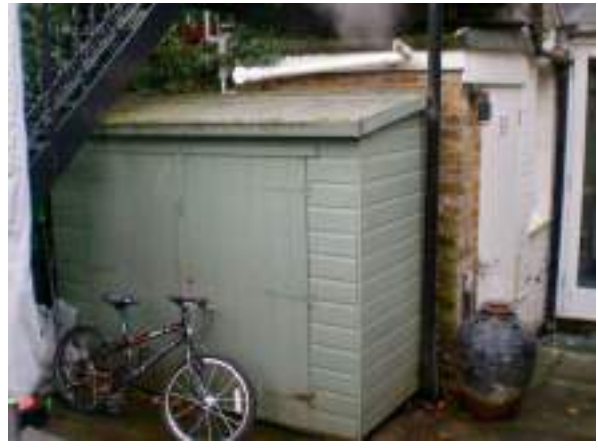
Modern single-storey brick extension and boiler flue and modern shed. No Significance. Harmful modern alterations.

- Remove the single-storey rear extension's fascia boards and felt roof and construct a parapet wall with a stone coping to conceal the roof.
- Replace the rear wing's ground floor door with a more appropriate four-panelled one, with flush bottom panels having butt and beaded edges and glazing in the upper panels with bull-nosed glazing beads.

- Remove the concrete lintel above the rear wing's ground floor door and construct a segmental curved brick on end arch.
- Replace the single-storey rear extension's modern flush door with a traditional boarded door with butt and beaded tongue and grooved boarding.

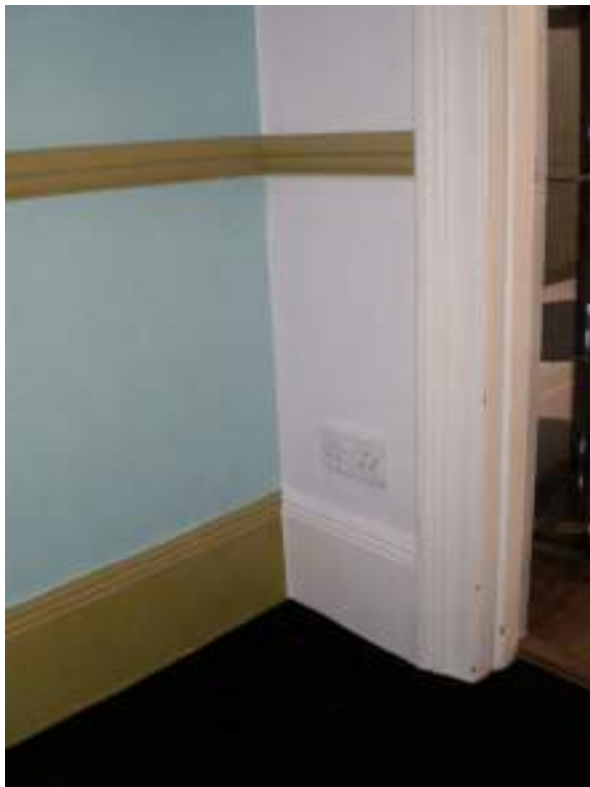
Detail of first floor landing original skirting board, door architrave - High Significance.
Dado rail, later alteration - No Significance.

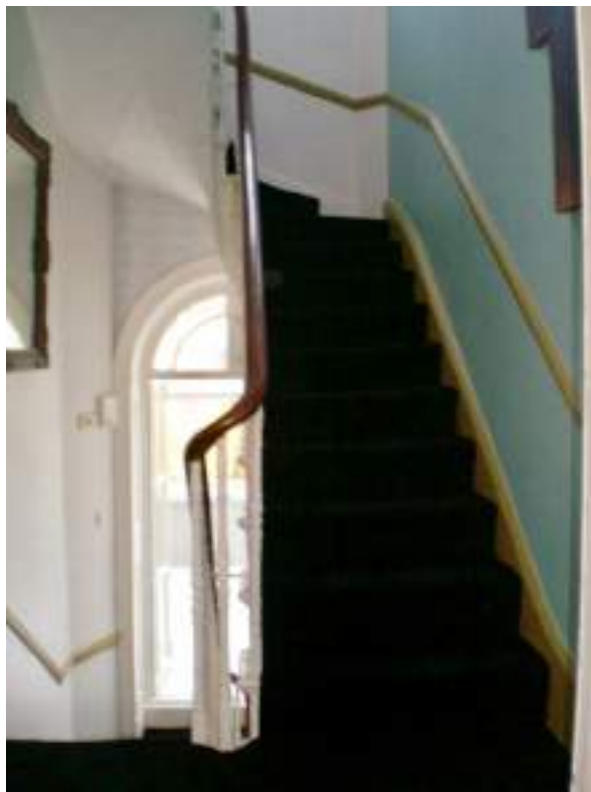
First flight from first to second floors. Original feature - High Significance.

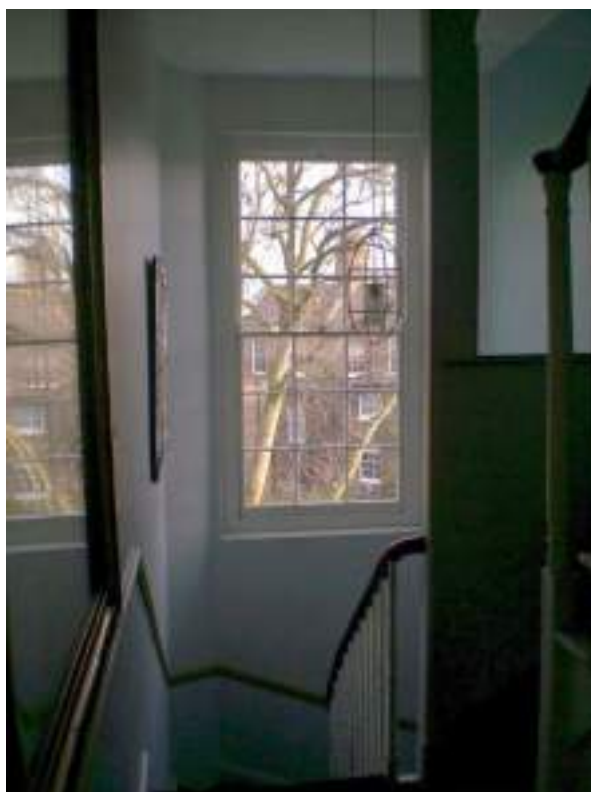
Second floor level staircase window. Enlarged by lowering Cill - No Significance. High architectural merit.

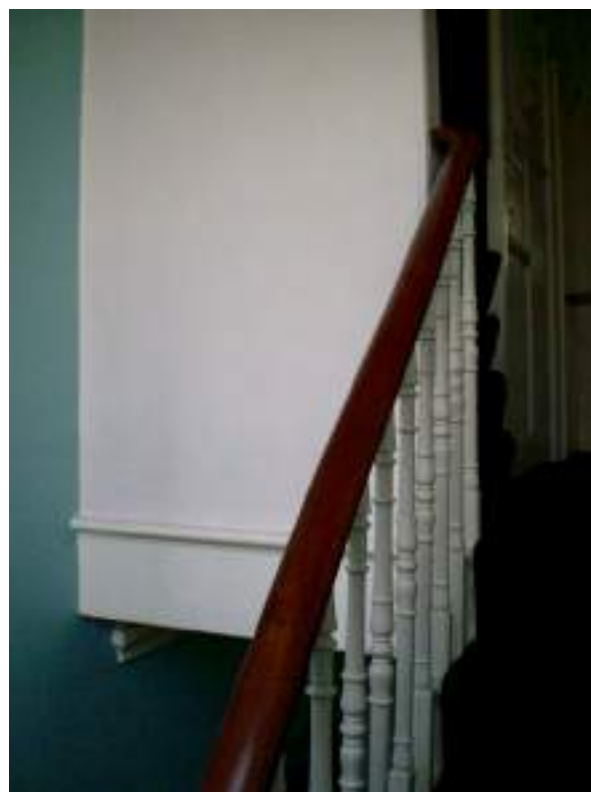
Handrail and bannisters terminating at second floor level. Original feature - High Significance.

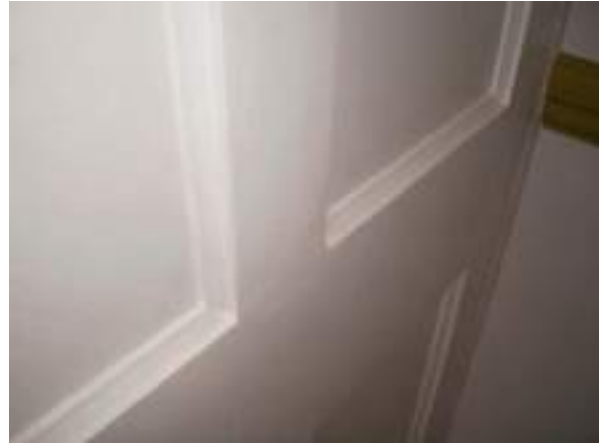
Detail of airing cupboard door - inappropriate panel moulding.

- Generally replace inappropriate none-matching off-the-shelf skirting boards, door architraves and doors with appropriately designed bespoke joinery suitable to the hierarchy of each floor and to match the originals.
- Generally remove stone flooring and timber over-boarding of floors and re-expose and restore, restain and wax polish the original floorboards on the ground and upper floors.
- Generally remove recessed ceiling spotlights from the more important rooms at ground, first and second floors and the third floor front rooms and replace with central pendant lights and appropriately positioned wall lights.
- Generally reinstate appropriate period fireplaces to all chimneybreasts currently lacking them, with priority given to the ground and first floors.

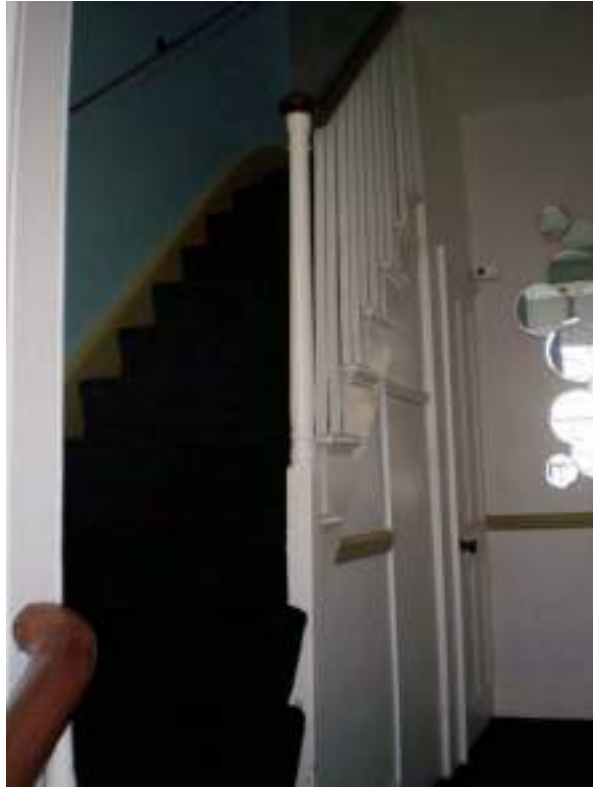
The Secondary winder stairs to third floor. Original feature - High Significance

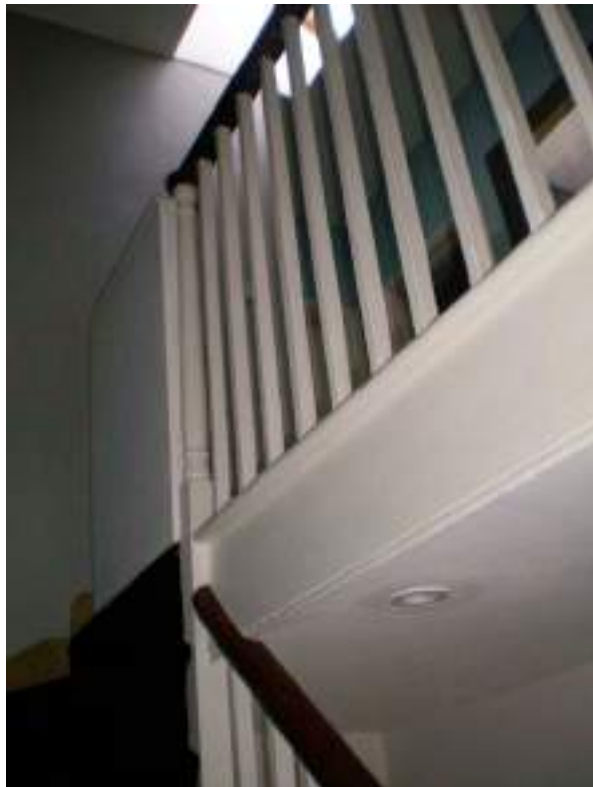
Third floor landing. Original balustrade with turned newel post and stick bannisters - High Significance.

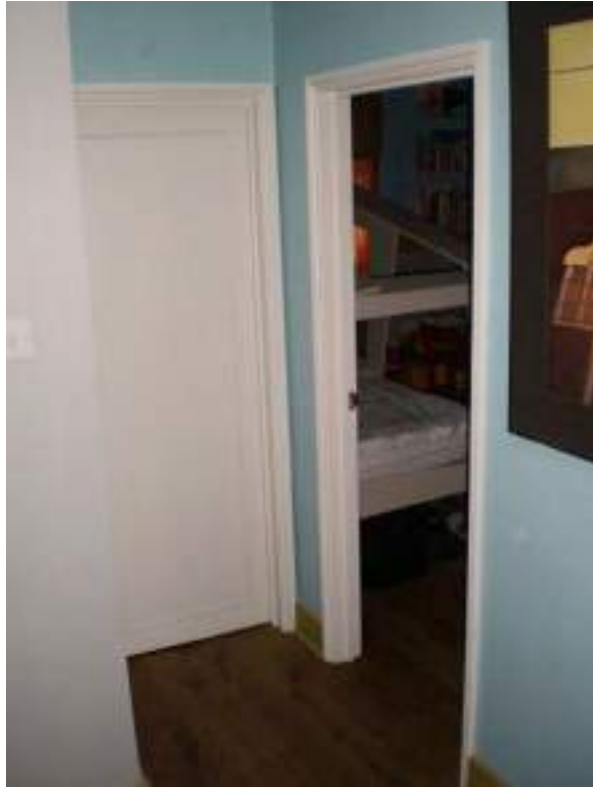
Third floor landing. Overall, Low Significance. Non-original doors and partitions - Harmful modern alterations.

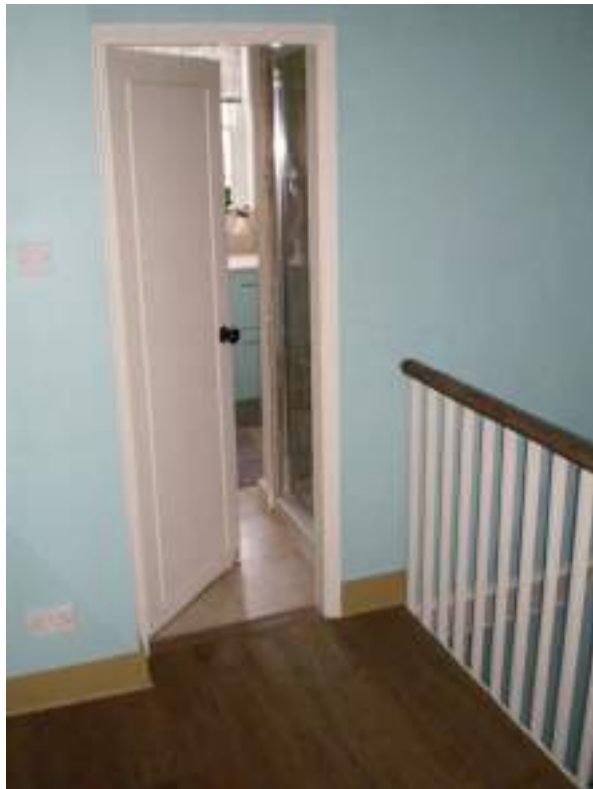
Third floor landing. Non-original door and partition wall to left - Harmful modern alterations. Original balustrade - High significance.

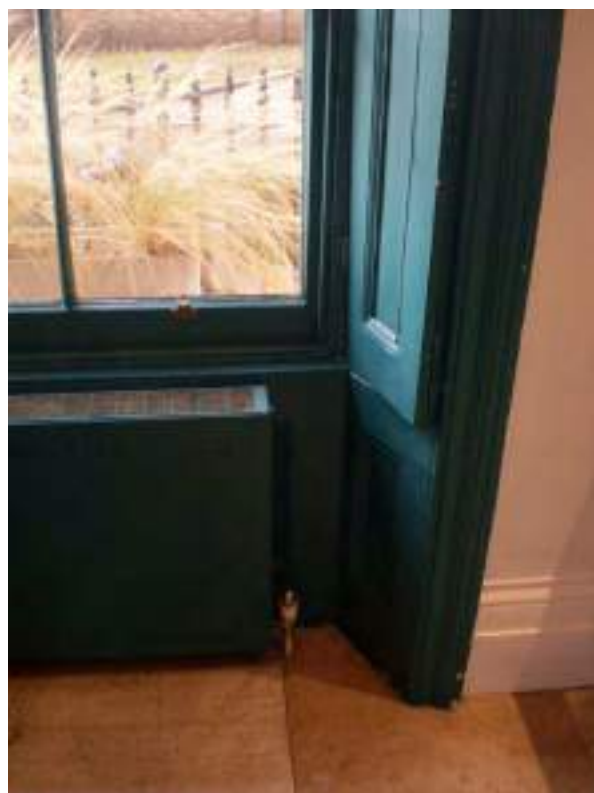
Ground floor front room. Detail of original window, shutters and architrave - High Significance.

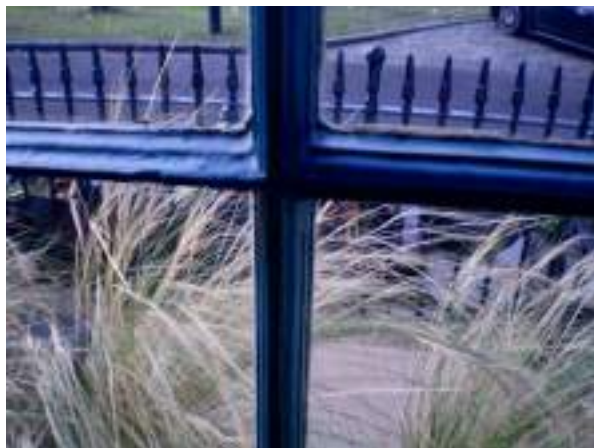
Ground floor front room. Detail of window joinery. Original lamb's tongue moulding glazing bar on left, later long ovolo replacments in centre and right.

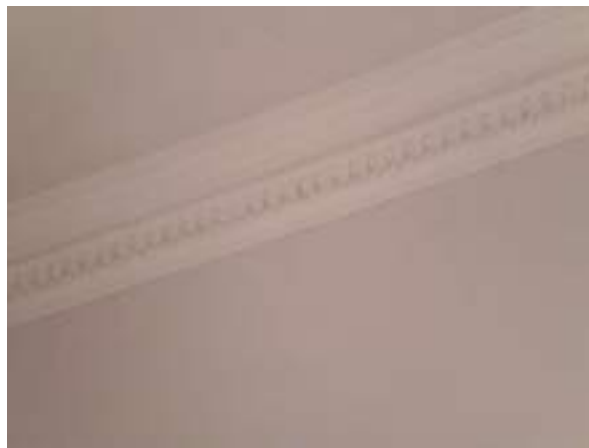
Ground floor front room. Non-original period cornice - No Significance. Medium architectural merit. Worthy of retention.

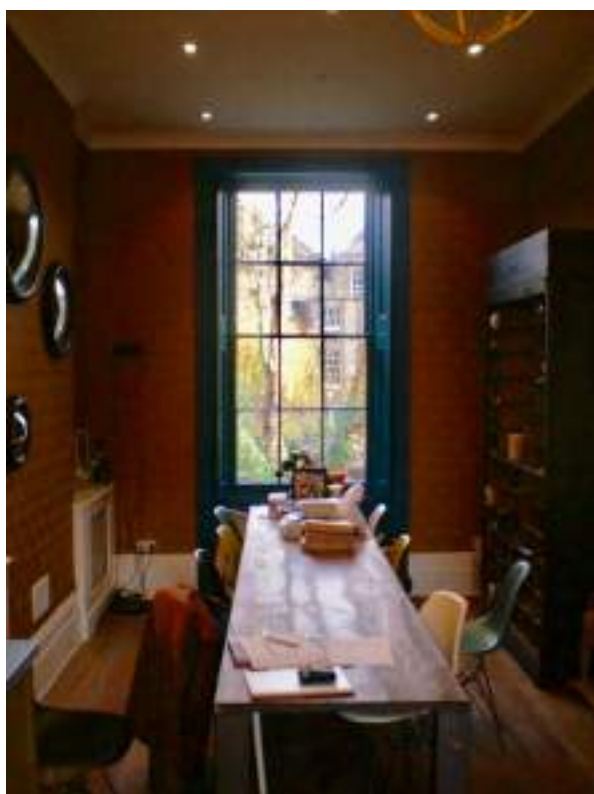
Ground floor rear room. Overall, High Significance. Original window shutters, panelling and architrave - High Significance.

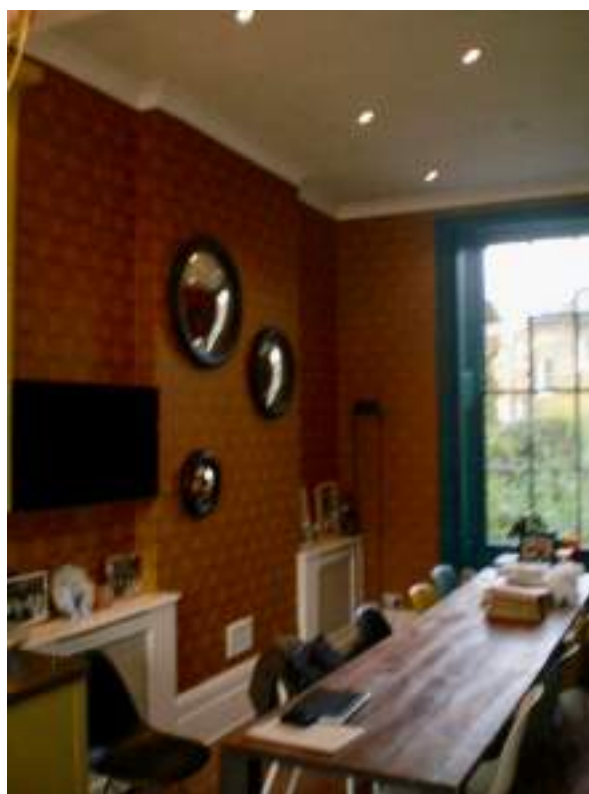
Ground floor rear room. Fireplace removed - harmful modern alteration. Modern radiator cabinets in recesses - No Significance.

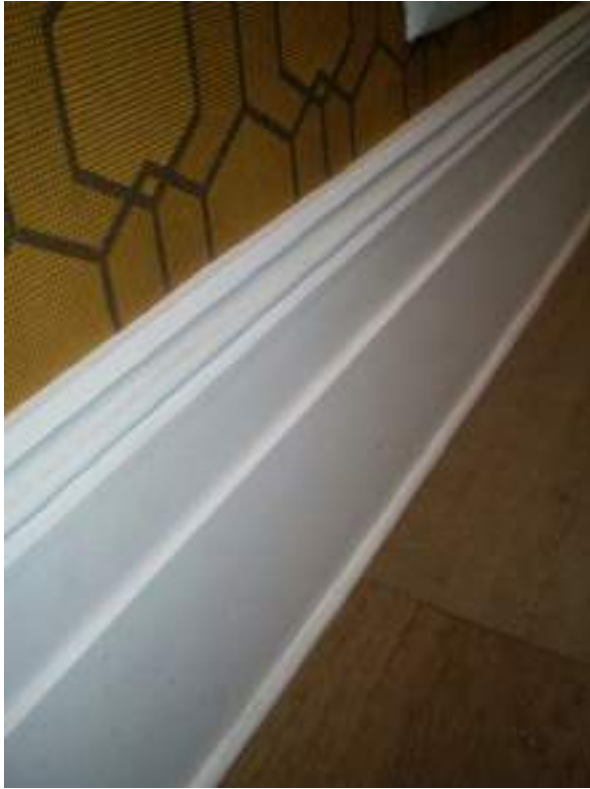
Ground floor rear room. Modern replica skirting board not an exact match. No Significance.

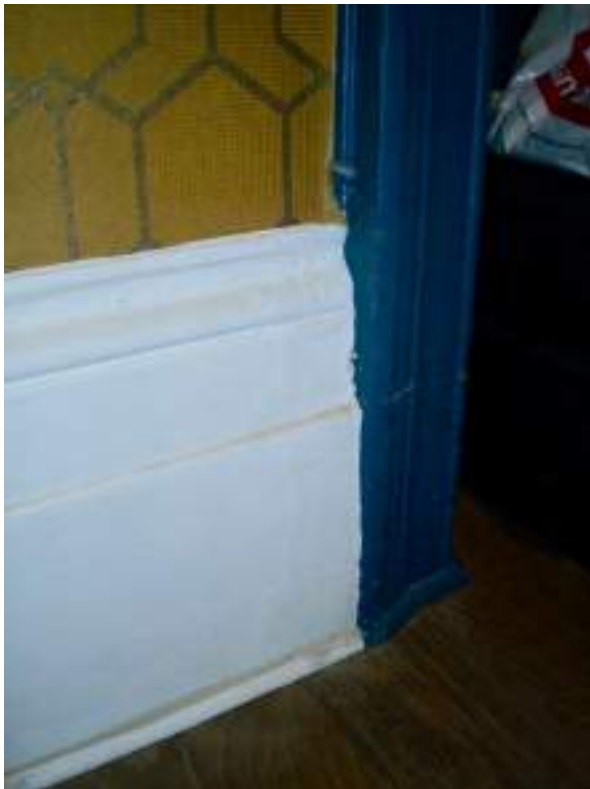
Ground floor rear room. Detail of original skirting board - High Significance.

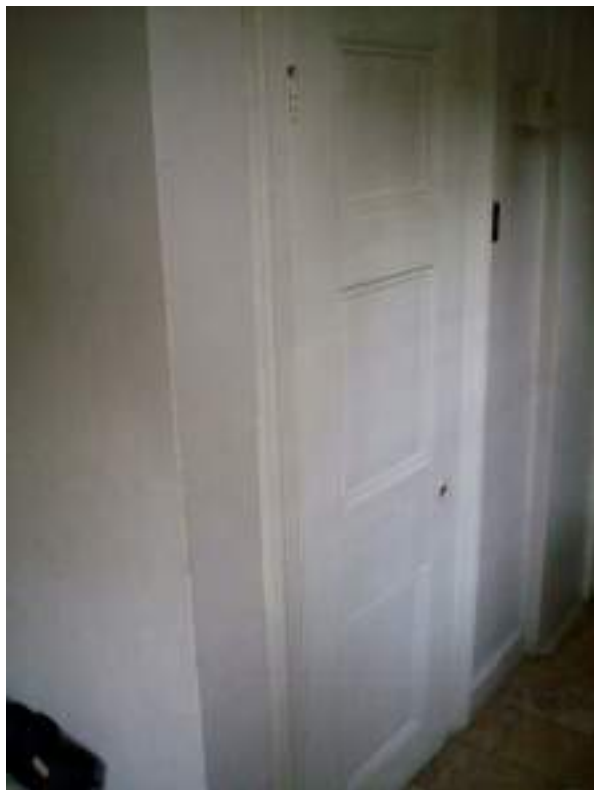
Ground floor rear wing. WC. Original door - Medium Significance.

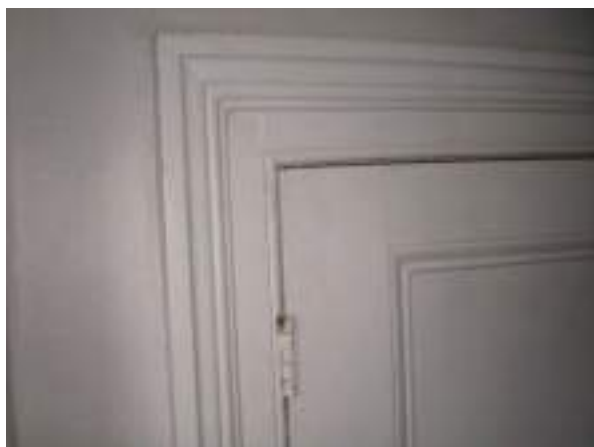
Ground floor rear wing. W.C. door architrave and panel details. Original - Medium Significance.

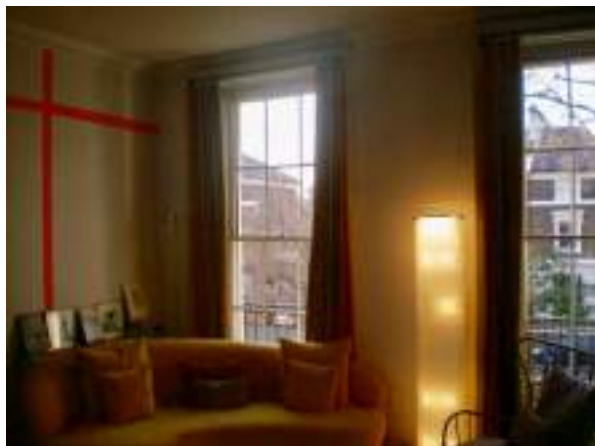
First floor front room. Overall - High Significance.

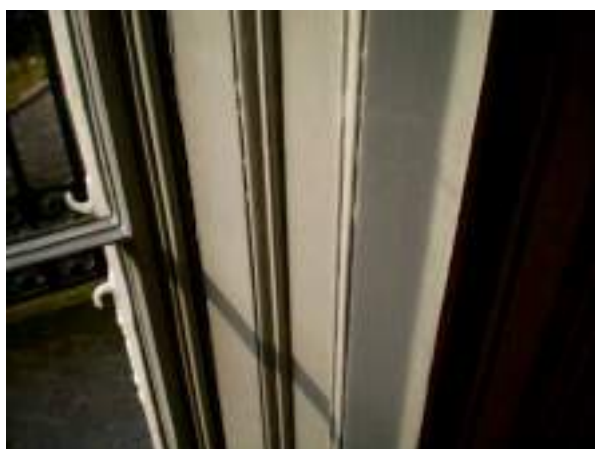
First floor front room. Original lamb's tongue window frame and shutter joinery details - High Significance.

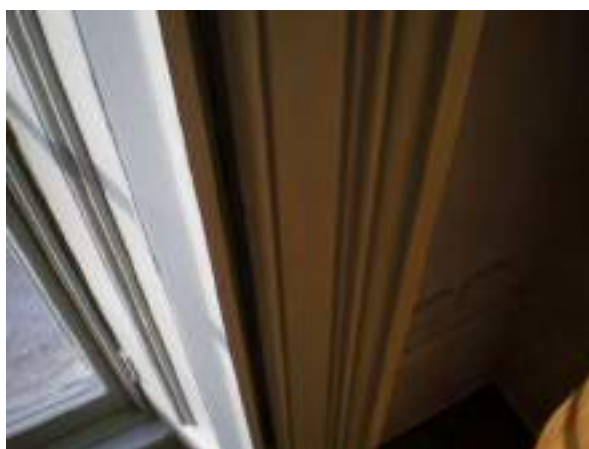
First floor front room. Original window shutter and architrave detail - High Significance

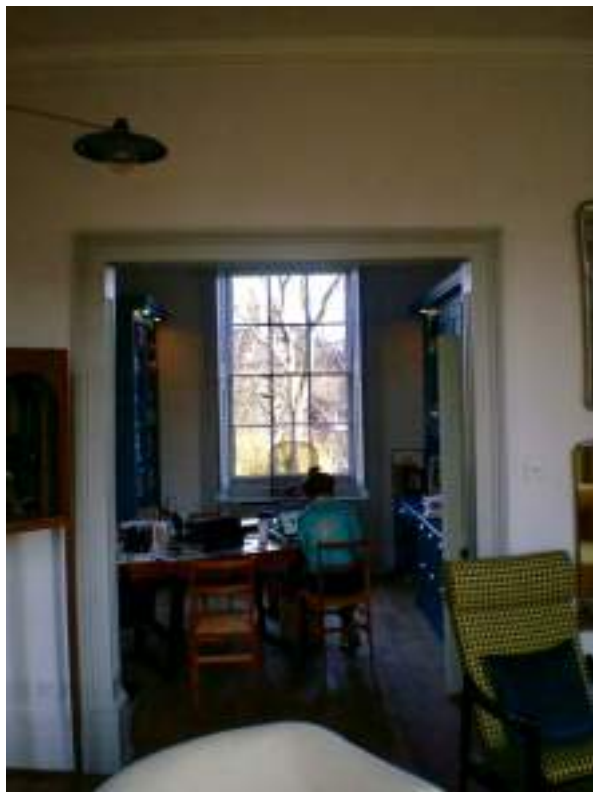
First floor front room. Original Archway - High Significance.

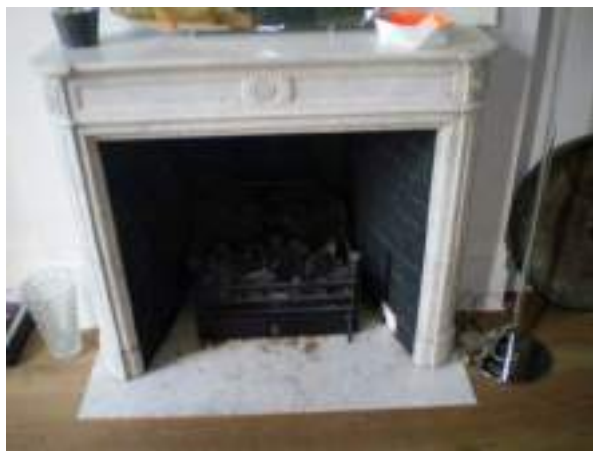
First floor front room. Non-original marble period mantelpiece and hearth with free-standing grate - No Significance. High architectural merit. Good quality and worthy of retention.

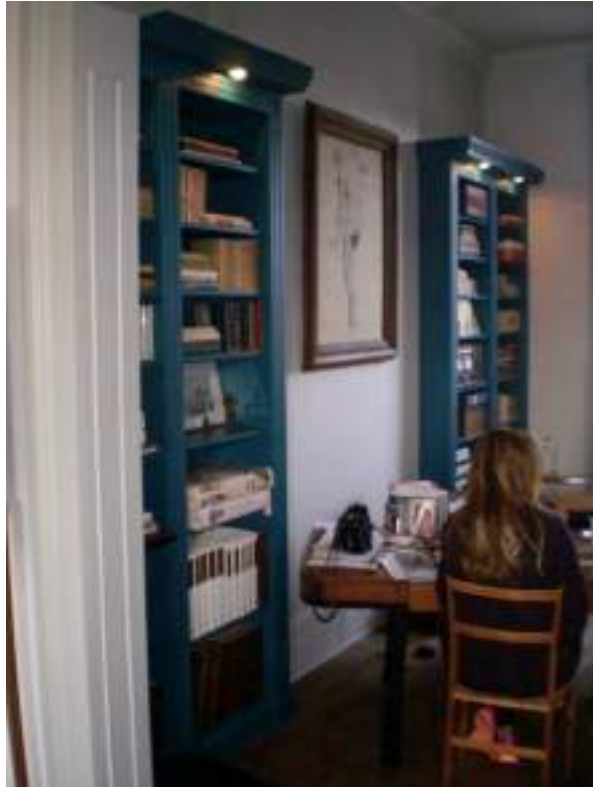
First floor rear room. Fireplace removed - Harmful modern alteration. Non-original period cornice - No Significance. Overall - High Significance.

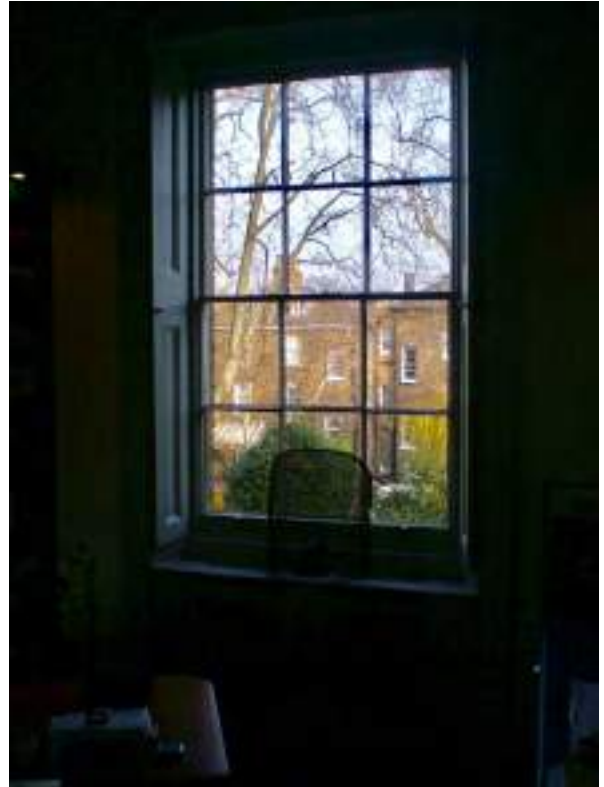
First floor rear room. Original window and shutters - High Significance.

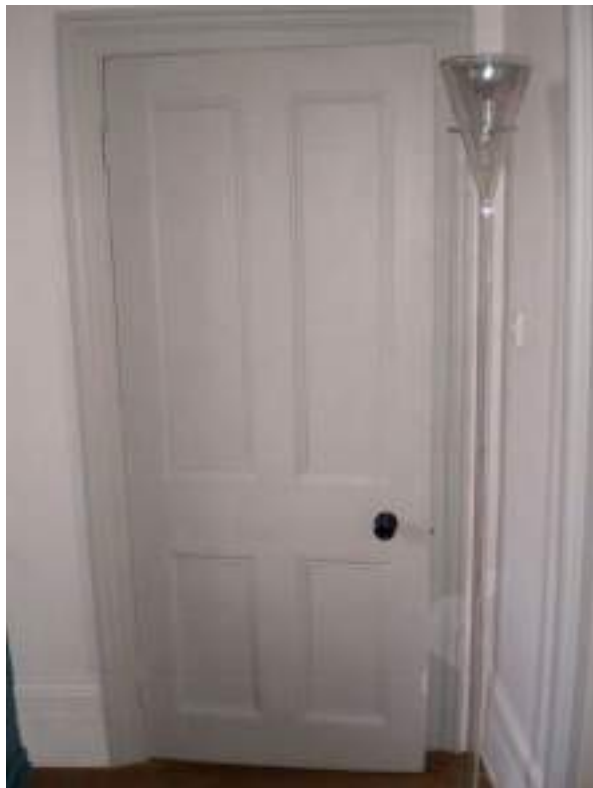
First floor rear room. Original four-panelled door - High Significance.

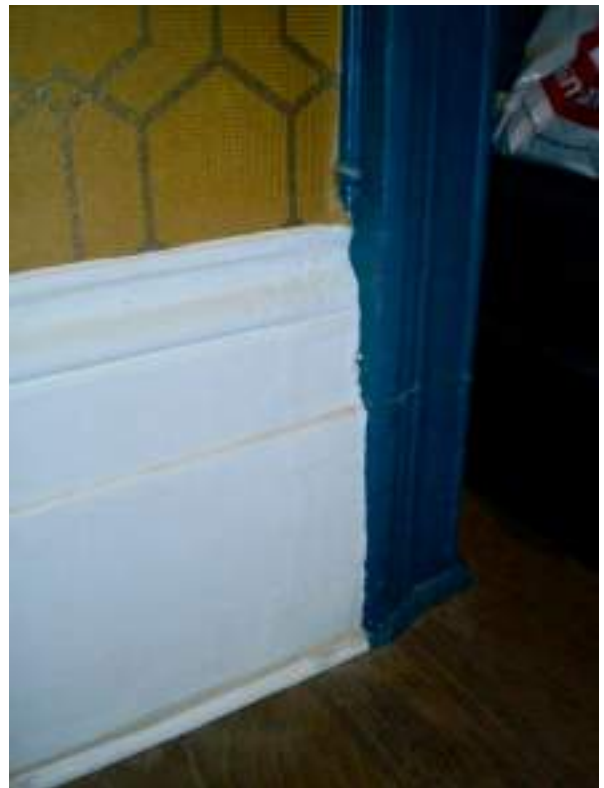
First floor rear room. Detail of original window architrave and skirting board - High Significance.

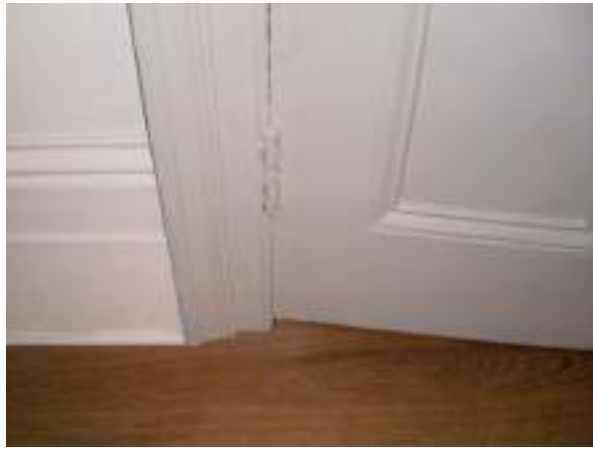
First floor rear room. Detail of door architrave and panels. - High Significance.

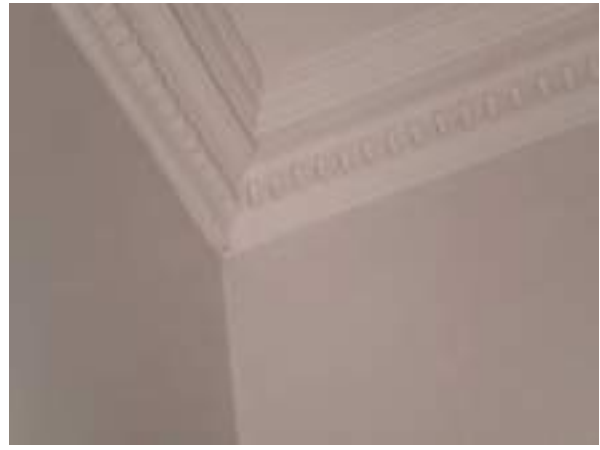
First floor rear room. Non-original period ceiling cornice - No Significance. Medium architectural merit. Good quality and worthy of retention.

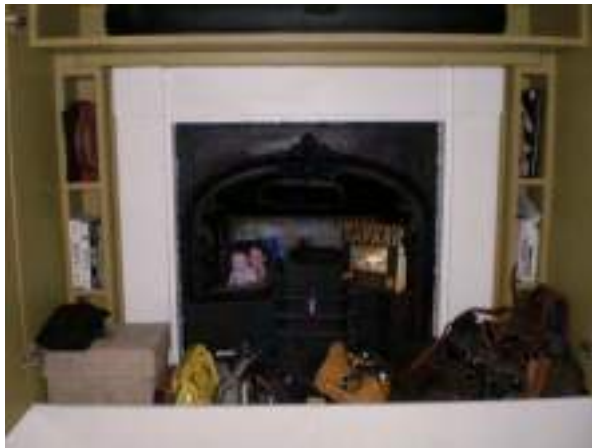
Second floor front room. Original fireplace mantelpiece and register grate hidden inside wardrobe- High Significance.

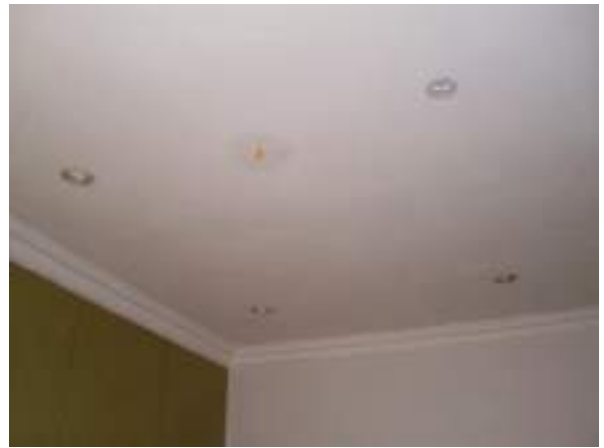
Second floor front room. Modern period ceiling cornice - No Significance. Medium architectural merit. Recessed spotlights - Harmful modern alteration.

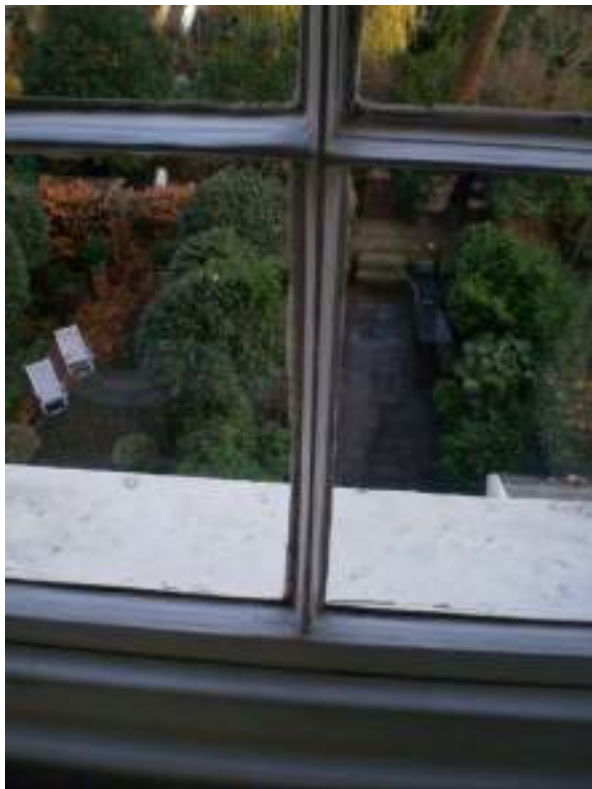
Second floor rear room. Original sash frame with lamb's tongue mouldings - High Significance.

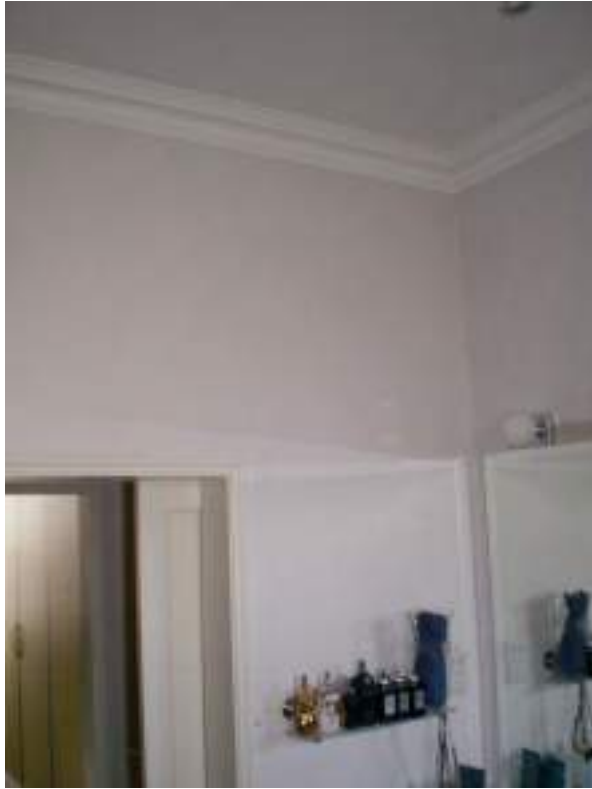
Second floor rear room. Modern partition and sliding door - harmful modern alteration. Modern period ceiling cornice - No Significance. Medium architectural merit.

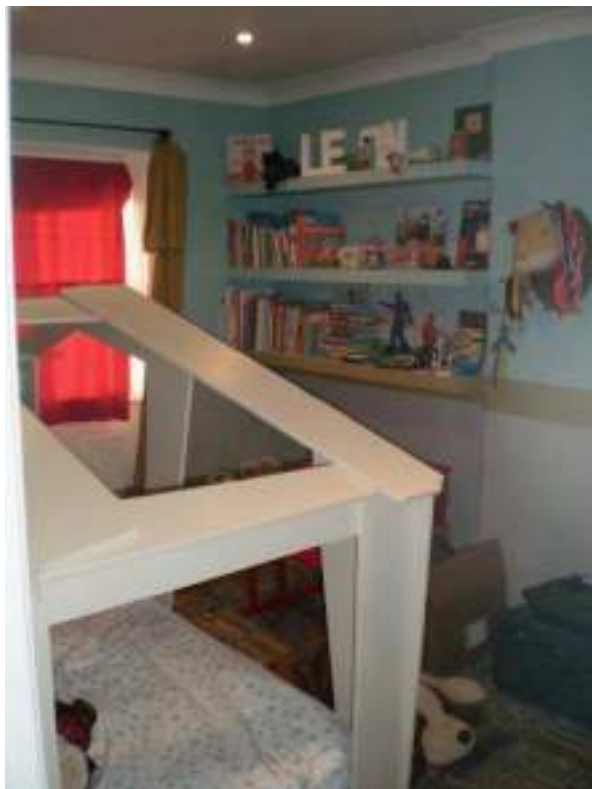
Third floor front north room. Overall - Low Significance. Ceiling coving - harmful modern alteration.

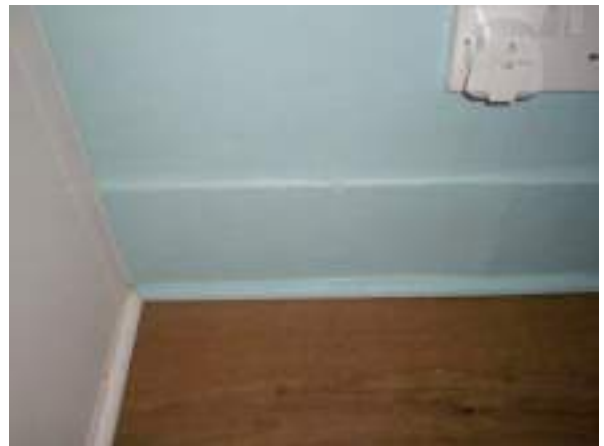
Third floor front south bedroom. Original skirting board - Low Significance.

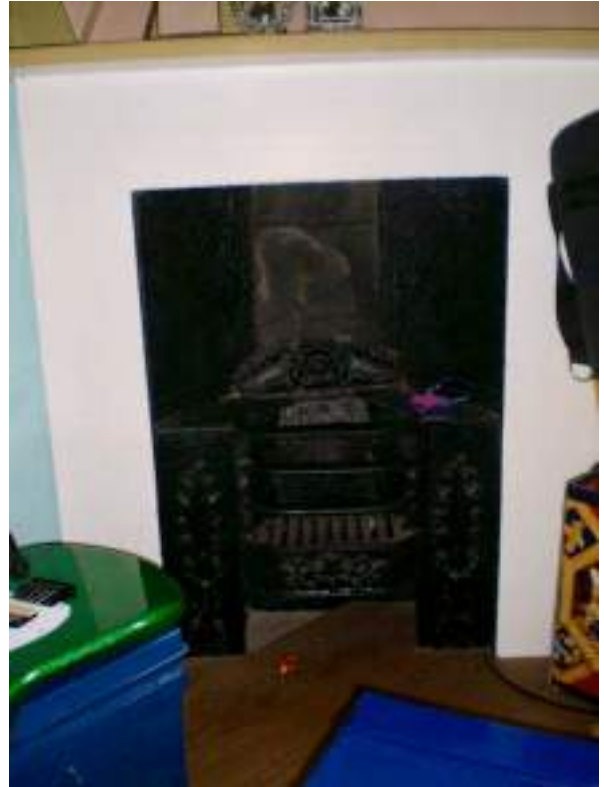
Third floor rear north bedroom. Original corner fireplace with hob grate - High Significance.

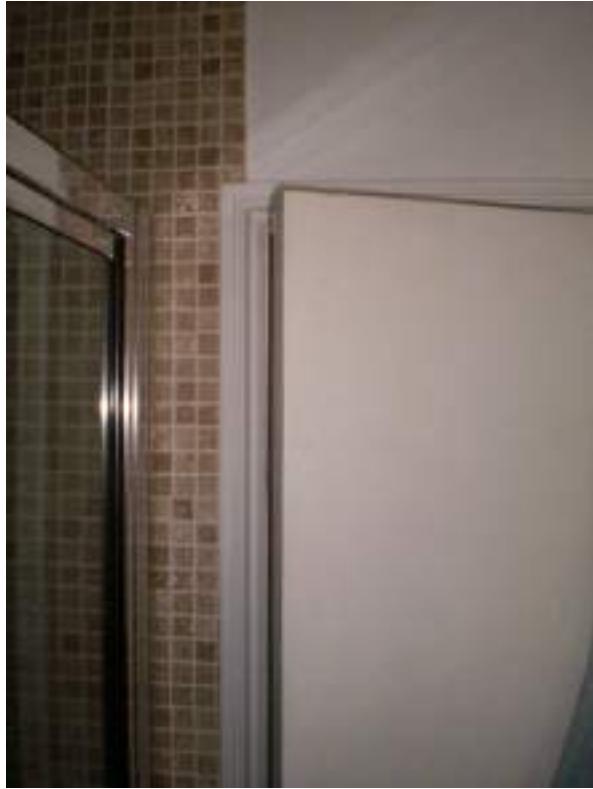
Third floor rear south bathroom. Modern architrave - No Significance. Flush door - harmful modern alteration.
