CONSERVATION STRUCTURAL ENGINEER'S ADVICE

REPAIRS TO DEFECTIVE BRICKWORK

**94 HAVERSTOCK HILL
LONDON, NW3**

JULY 2016

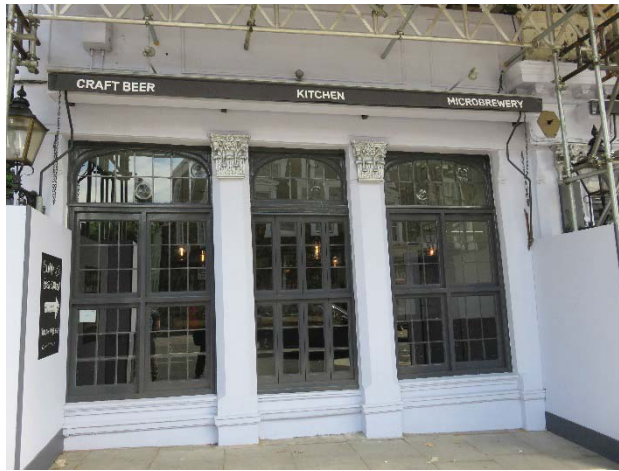
Photo 7280 – Front Elevation

- 2.2 The exterior at upper levels, as examined, would seem to be fairly much as built without significant alterations. The ground floor elevation too, may well be original. See photographs 7280 and 7281.

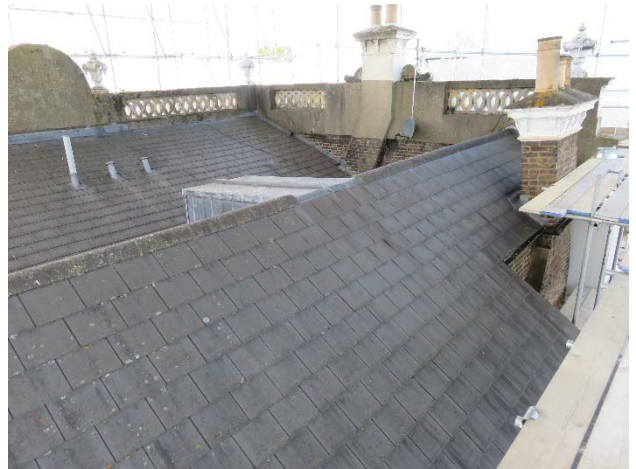
Photo 7282 - Roof

- 2.6 The roof is timber framed, covered in slate with a central valley parallel to the front elevation. (Photographs 7272).
- 2.7 The left flank and front elevations have numerous decorative elements. These are mostly stock items simply added to ornament the yellow London stock brick façade. They mostly survive intact except where ruptured by structural movement over certain windows as described in section 3 of this report.

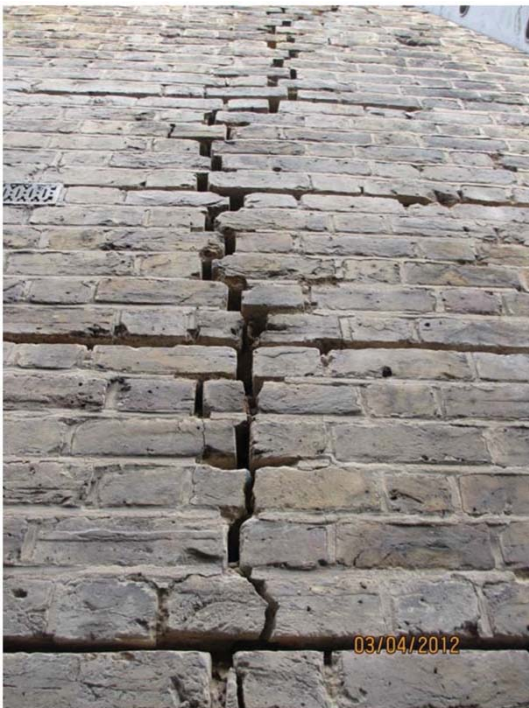
Bed joints in stock brickwork recessed to 40mm depth, staggered each side of fracture

Bed joints carefully cut out with hand tools only to minimise disturbance.
