Ref:15027/AKn/005

**RE: CENTREPOINT – HISTORIC STAIR TREADS**

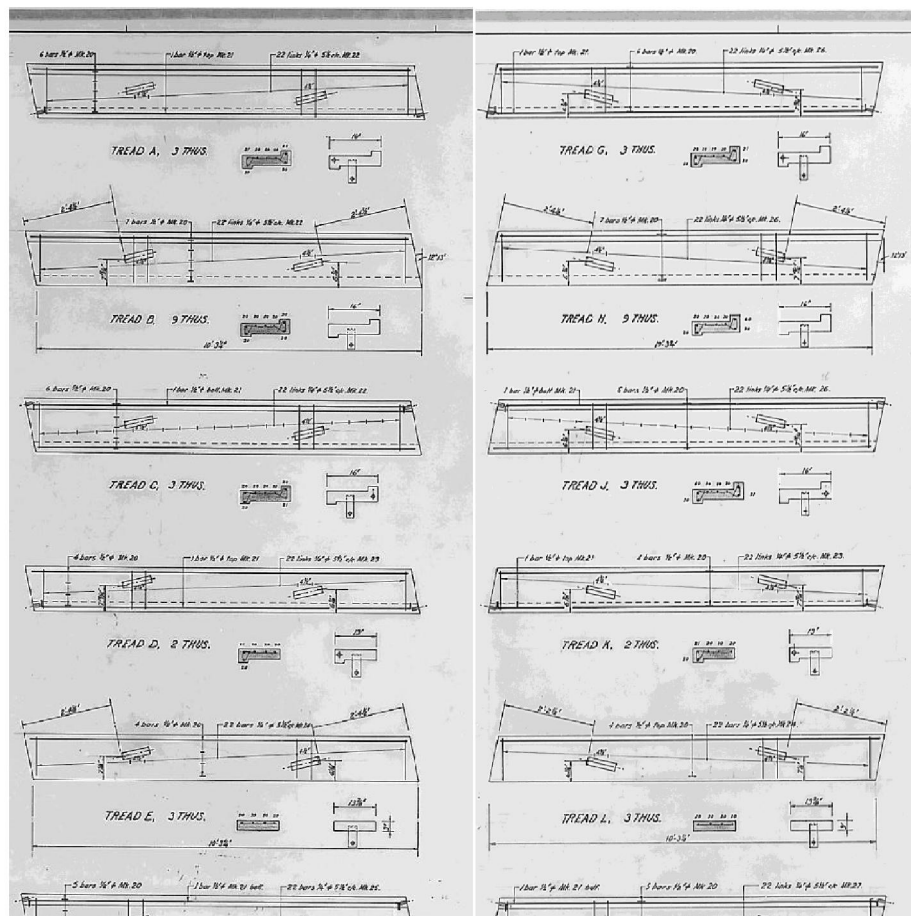
A classification of the existing treads into original types was conducted after the defect - repair surveys. The Pell Frischmann's archive drawings made it simple to identify each tread against its design type as key information is provided: dimensions, position on the staircase, type of fixing to the tread, location of the fixing within the tread and the location of the balustrade fixings. These details can be seen on an extract from the archive drawings shown below: See figure1.
