**34 John Street, London**

**Decorative Plaster Survey**

February 2017

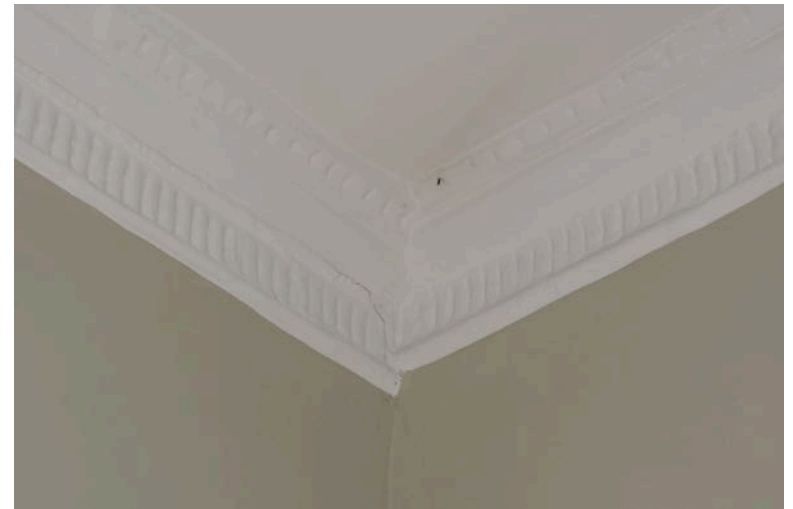
3.5 The cornice is original and in good order, except the internal mitre above the front door. Possibly a section has fallen, and the repair has not re-aligned the mitre detail.
