ARBORICULTURAL ASSESSMENT REPORT

For:	Client:	Cunningham Lindsey (Leeds)
	Insurer:	
Site:	Policyholder:	
	Risk Address:	Flats 1&2, 108 Greencroft Gardens, London,NW6 3PH
Refs:	OCA Ref:	69755
	Client Ref:	6332780
	Insurer Ref:	TBC

Arborist Name:	Sorrel Kiamil	Date:	10/04/2017
QC:	William Argent	Date:	10/04/2017

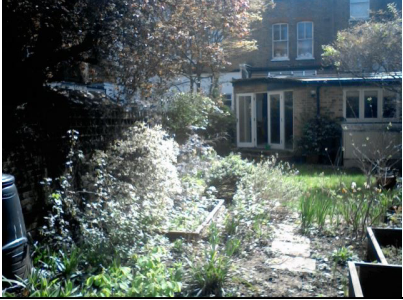
<p>SG1 - Mixed species group</p>	<p>T6 - Oak</p>

T6	Oak	Mature	Fair	9.1	10	500	6	management. Subject to past management.	Fell and treat stump.	London, NW6 3PH 110 Greencroft Gardens, London, NW6 3PH	P3P
SG1	Mixed species group	Semi-Mature	Fair	1.5	1.0	80	1	Subject to recent management. Managed Shrub group. includes rose, acer, yacca	No work required.	Flats 1 and 2, 108 Greencroft Gardens, London, NW6 3PH	PH
SG2	Mixed species shrubs	Semi-Mature	Fair	4	2	80	1	Subject to past management.	No work required.	110 Greencroft Gardens, London, NW6 3PH	P3P
