DR. FRANK HOPE

Forensic & Planning Arboricultural Consultant

ARBORICULTURAL IMPACT ASSESSMENT REPORT RELATING TO THE PROPOSED DEVELOPMENT AT NUMBER 15 LYNDHURST TERRACE, LONDON, NW3 5QA – REVISION 1: FEBRUARY 2017.

FH-Mond-15-Lyndhurst-Terrace-London-NW3-5QA

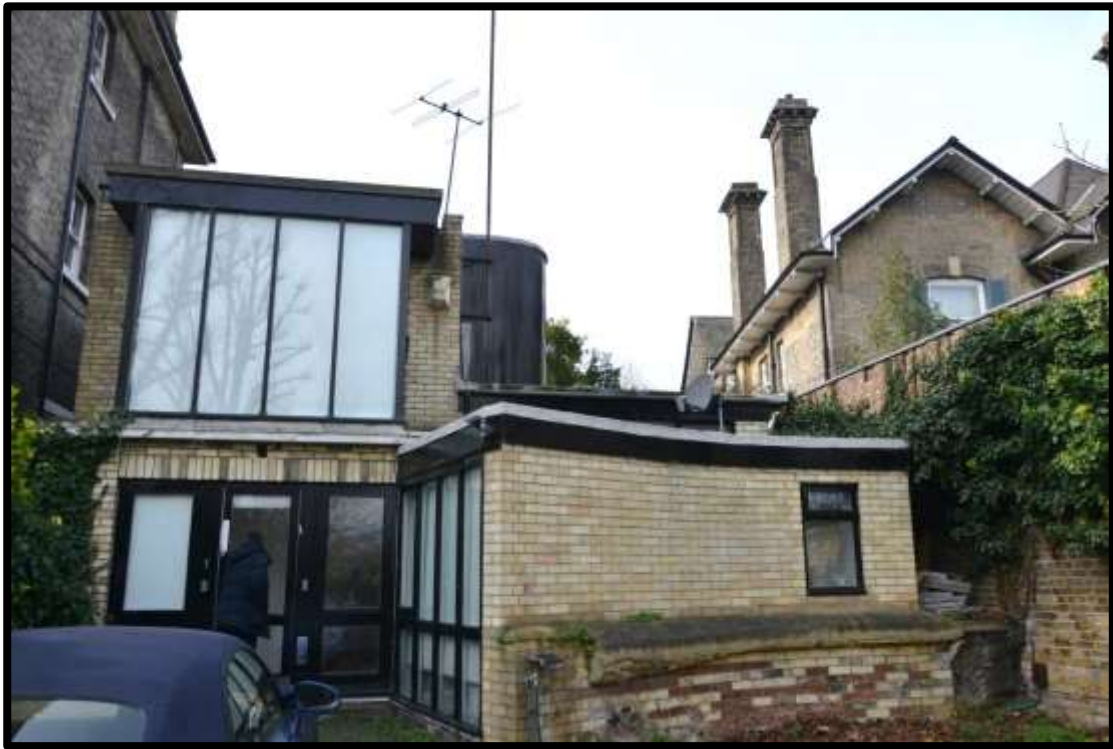
- 3.1 Number 15 Lyndhurst Terrace is relatively small, modern, single-storey and two-storey, detached residence located on a generally level site, on the western side of the road, between numbers 13 and 17/19 Lyndhurst Terrace, London (See the picture below).

Picture taken on the 26th of February 2016 showing the front of number 15 Lyndhurst Terrace.

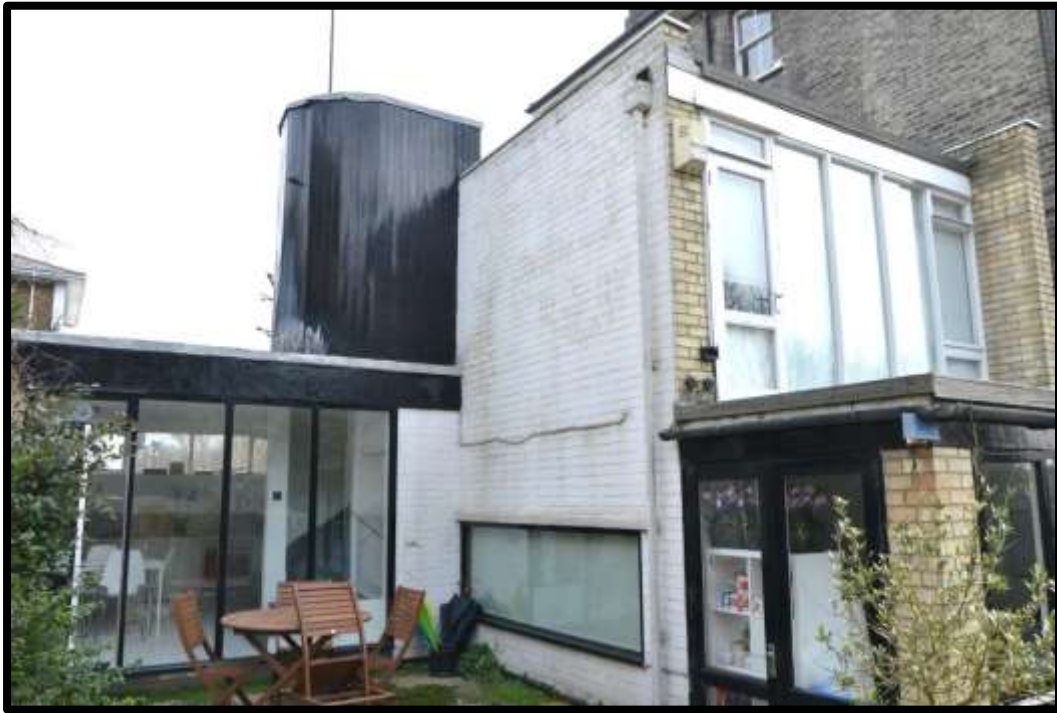
Picture taken on the 26th of February 2016 showing the rear of number 15 Lyndhurst Terrace.

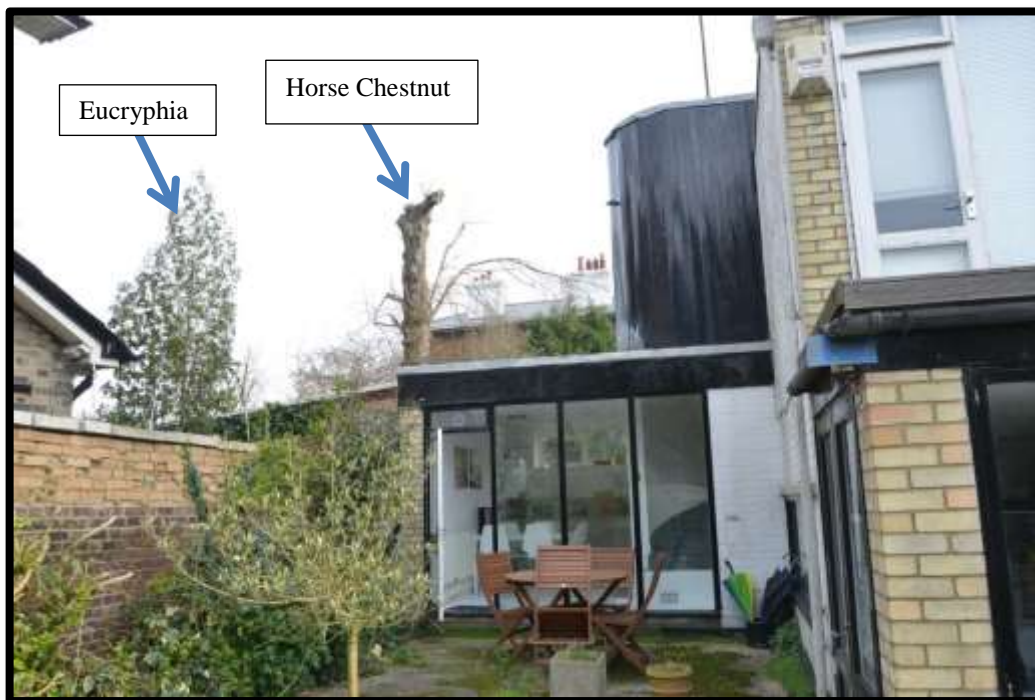
- 3.5 There is an extremely poor-quality Horse Chestnut (*Aesculus hippocastanum*) tree located in the front garden of number 17/19 Lyndhurst Terrace, and a relatively small *Eucryphia* shrub is located in the rear garden of that property. A mature Lime is located to the front of number 13 Lyndhurst Terrace.

Picture taken on the 26th of February 2016 showing the Horse Chestnut in the grounds of number 17/19 Lyndhurst Terrace.

Tree T1: This is an over-mature Horse Chestnut (*Aesculus hippocastanum*) located in the grounds of number 17/19 Lyndhurst Terrace, approximately 3.0 metres away from the brick-built boundary wall with number 15 Lyndhurst Terrace. The tree is in an extremely poor condition, and it is in terminal decline (See the picture above).

The basal trunk of the tree contains a large, decaying, open cavity, which is irremediable, and will continue to develop for the remainder of the tree's life. However, there are no current signs to indicate that the tree is potentially unstable at the present time.

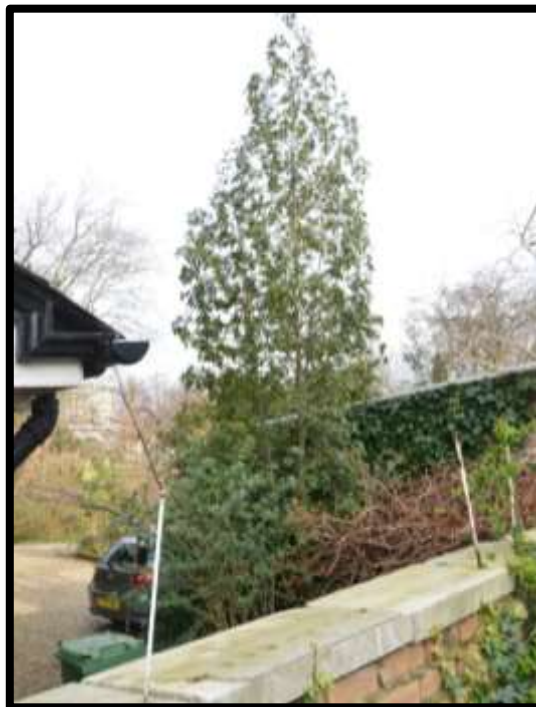
Picture taken on the 26th of February showing the young Eucryphia.

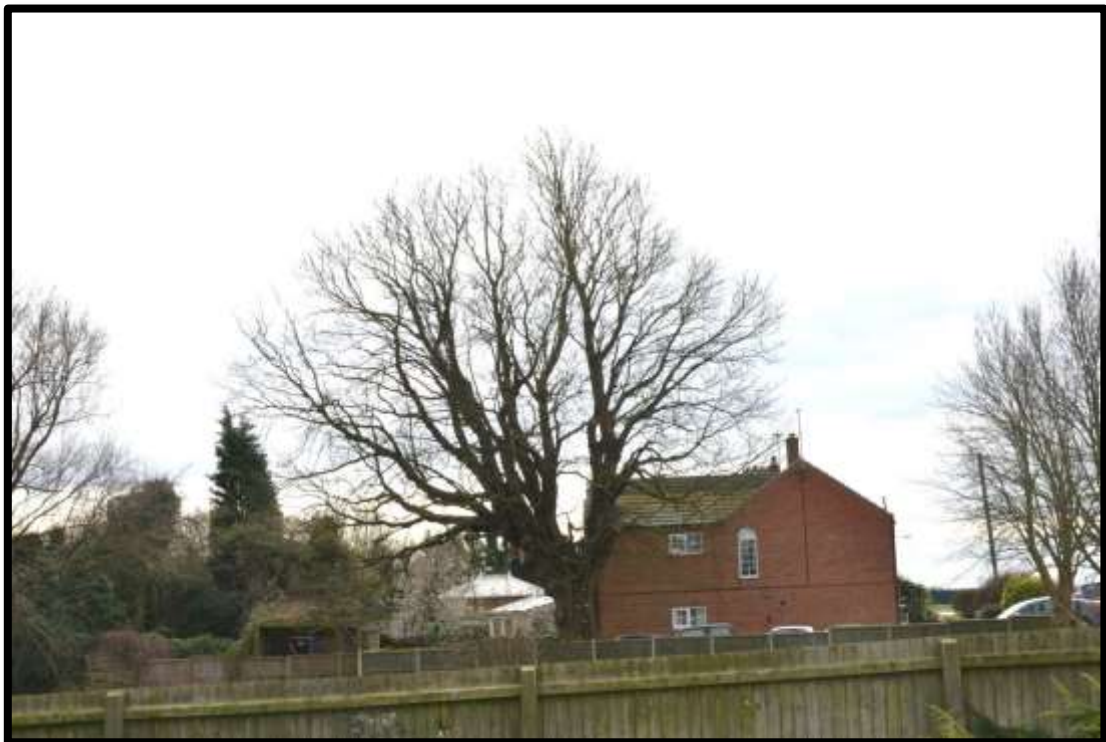
Picture taken on the 28th of February 2016, showing a large Horse Chestnut of a similar aged to the one in the grounds of number 17 Lyndhurst Terrace.

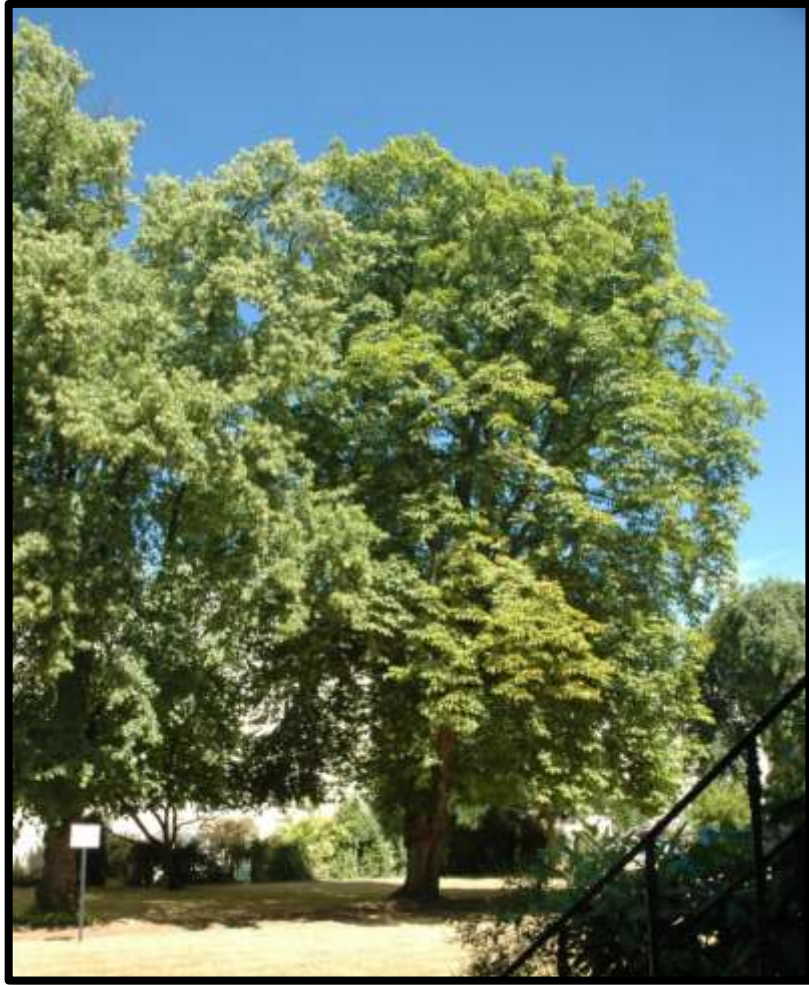
Picture taken in summer showing a large, mature Horse Chestnut in full leaf.

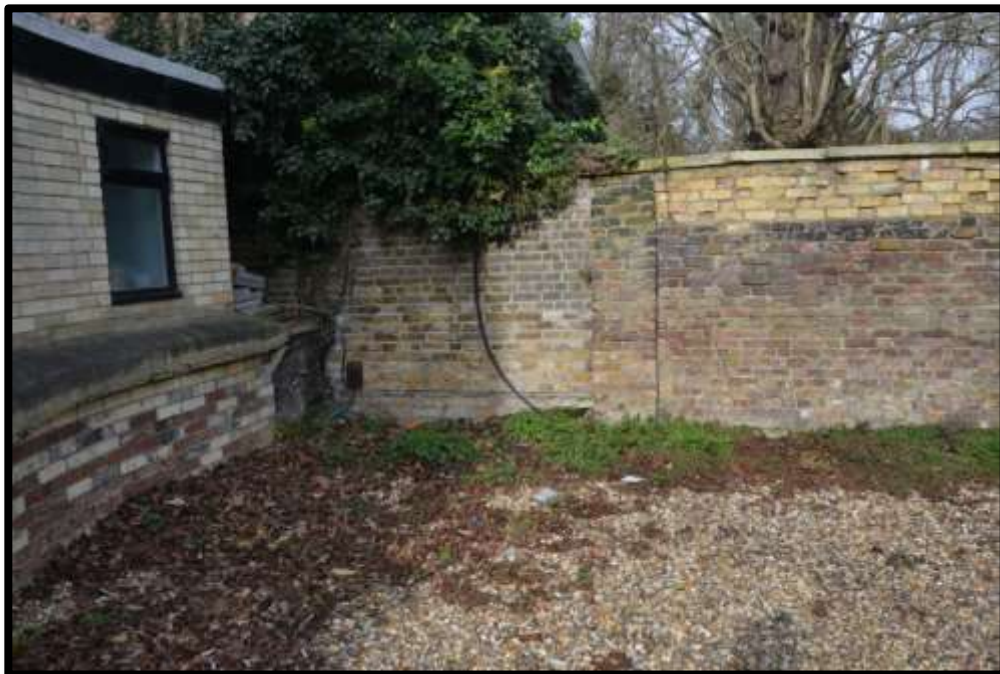
Picture taken on the 26th of February 2016 showing the boundary wall between the Horse Chesnut and area of development.

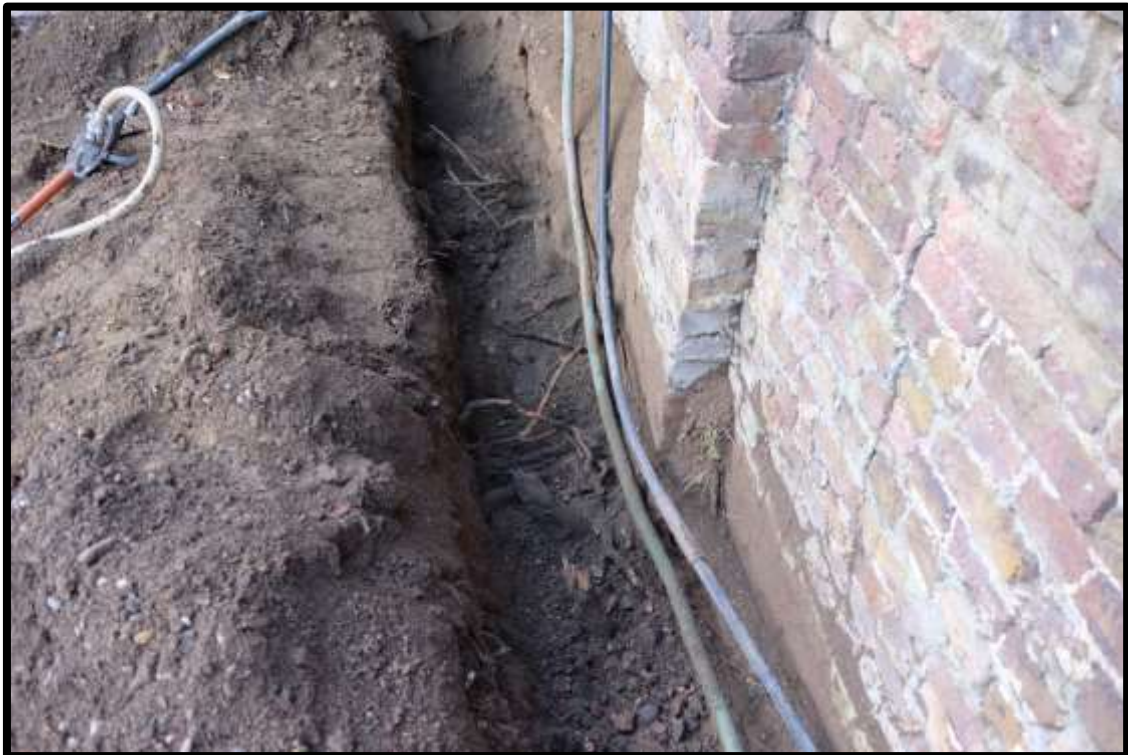
11.7 On the 29th of February 2016 an “Air-Spade” test was carried out by Ruskins Trees and Landscapes, in the grounds of number 15 Lyndhurst Terrace, i.e. up against the boundary wall. The excavation confirmed that the foundations of the wall were 400mm deep, not including the depth of two recently uncovered layers of bricks being taken into account.

Picture taken on the 29th of February 2016, showing the location of the Air-Spade trench.
