Your ref: 0ur ref: 1-38-3816

Re: 5 Templewood Avenue, London, NW3 7UY

SAFETY APPENDIX

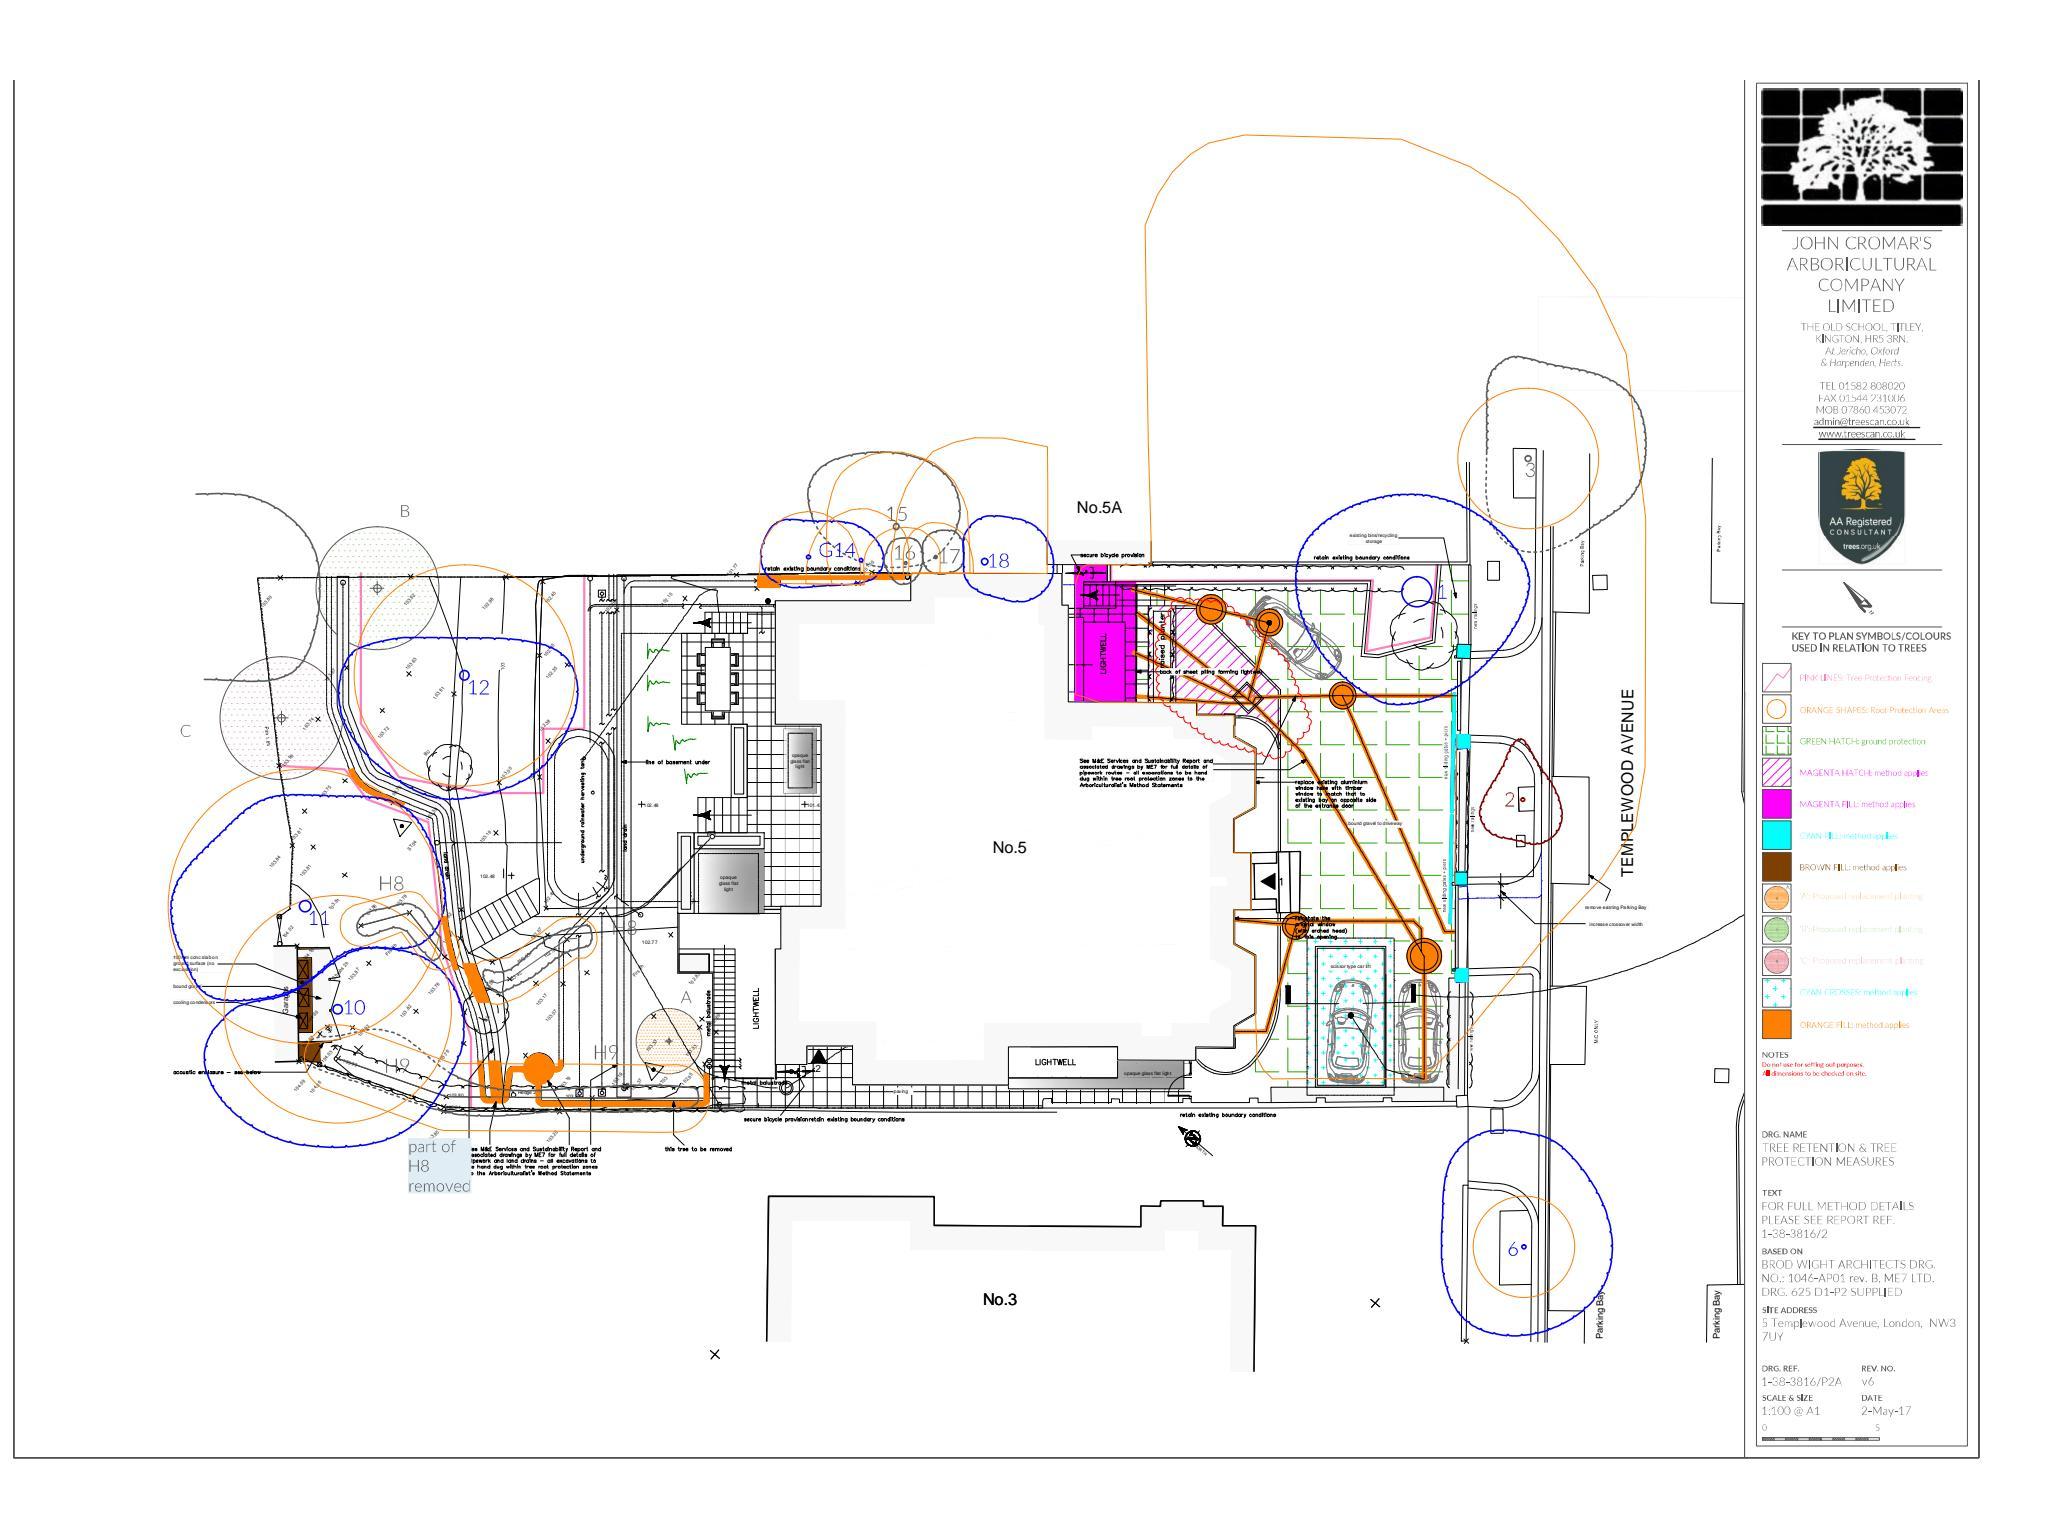
PLAN 1-38-3816/P2a v6

This method shall apply within any RPA (orange shapes around tree locations), for example in the magenta fill zone (proposed steps/lightwell at front) and the eyan cross zone (car lift at front). Any roots encountered shall be trimmed to the edge of excavation using a sharp edge tool such as handsaw or secateurs; the cuts shall be made at right angles to the long axis of the root, and in accordance with BS3998:2010, 8.6. Any soil removed shall be replaced with 'Carbon Gold' mixed with dry clay loam. The relative amount of 'Carbon Gold' to dry clay loam will be 5% by volume - this equates to 20 kgs of product per cubic metre of topsoil (to BS3882 : 2015 topsoil). Two products (Carbon Gold 'Tree Growth Enhancer / Tree Protector') shall be mixed in equal amounts. 10 kgs of each, thus, shall be applied in every cubic metre of topsoil. An HDPE membrane shall be placed between any root-bearing soil and any wet concrete to be poured. Impermeable sheeting (to exclude wet concrete) shall be laid and secured locally by temporary weighting as required. Any concrete casting shall take place without disturbing this protective layer.

The existing hard surface shall be lifted by hand tools or hand-held power tools only. No 'scraping up' with a mechanical excavator shall be carried out. No excavation below the underside of the existing sub-base shall take place. De-compaction measures shall consist of lightly hand-forking over to 250mm depth, or using a pinch bar to loosen the ground surface. The ground surface once exposed shall immediately be protected : a 2D geotextile membrane, such as 'Treetex T300' type shall be laid; 100mm of green-source woodchip; continuously abutted scaffold boards or manufactured boards so as to completely cover this area. This area may be used for pedestrian access. Scaffold erection shall take its bearing directly off the ground surface via spreader plates/scaffold boards. At landscaping phase, this protection layer shall be removed.
