**Rose Cottage, Vale of Health, Hampstead , London.**

### **Structural Overview**

On May 8 2017 I visited this cottage and, together with the help of a builder, I was able to determine the sizes of most of the main structural elements, and see some of the defects.

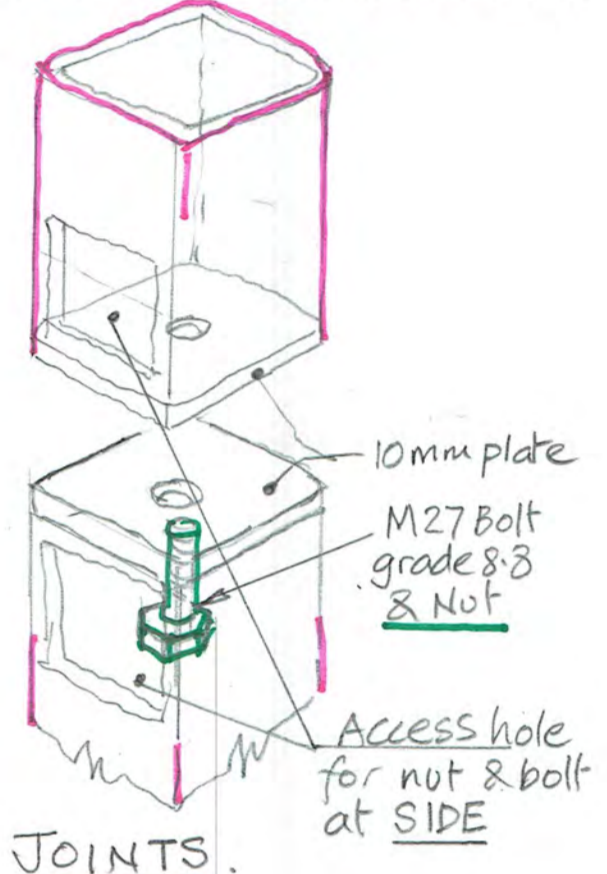
③ Pair of steel Portals

2 No Portal Frames Like This  
 All members 100x100x6.3 RHS

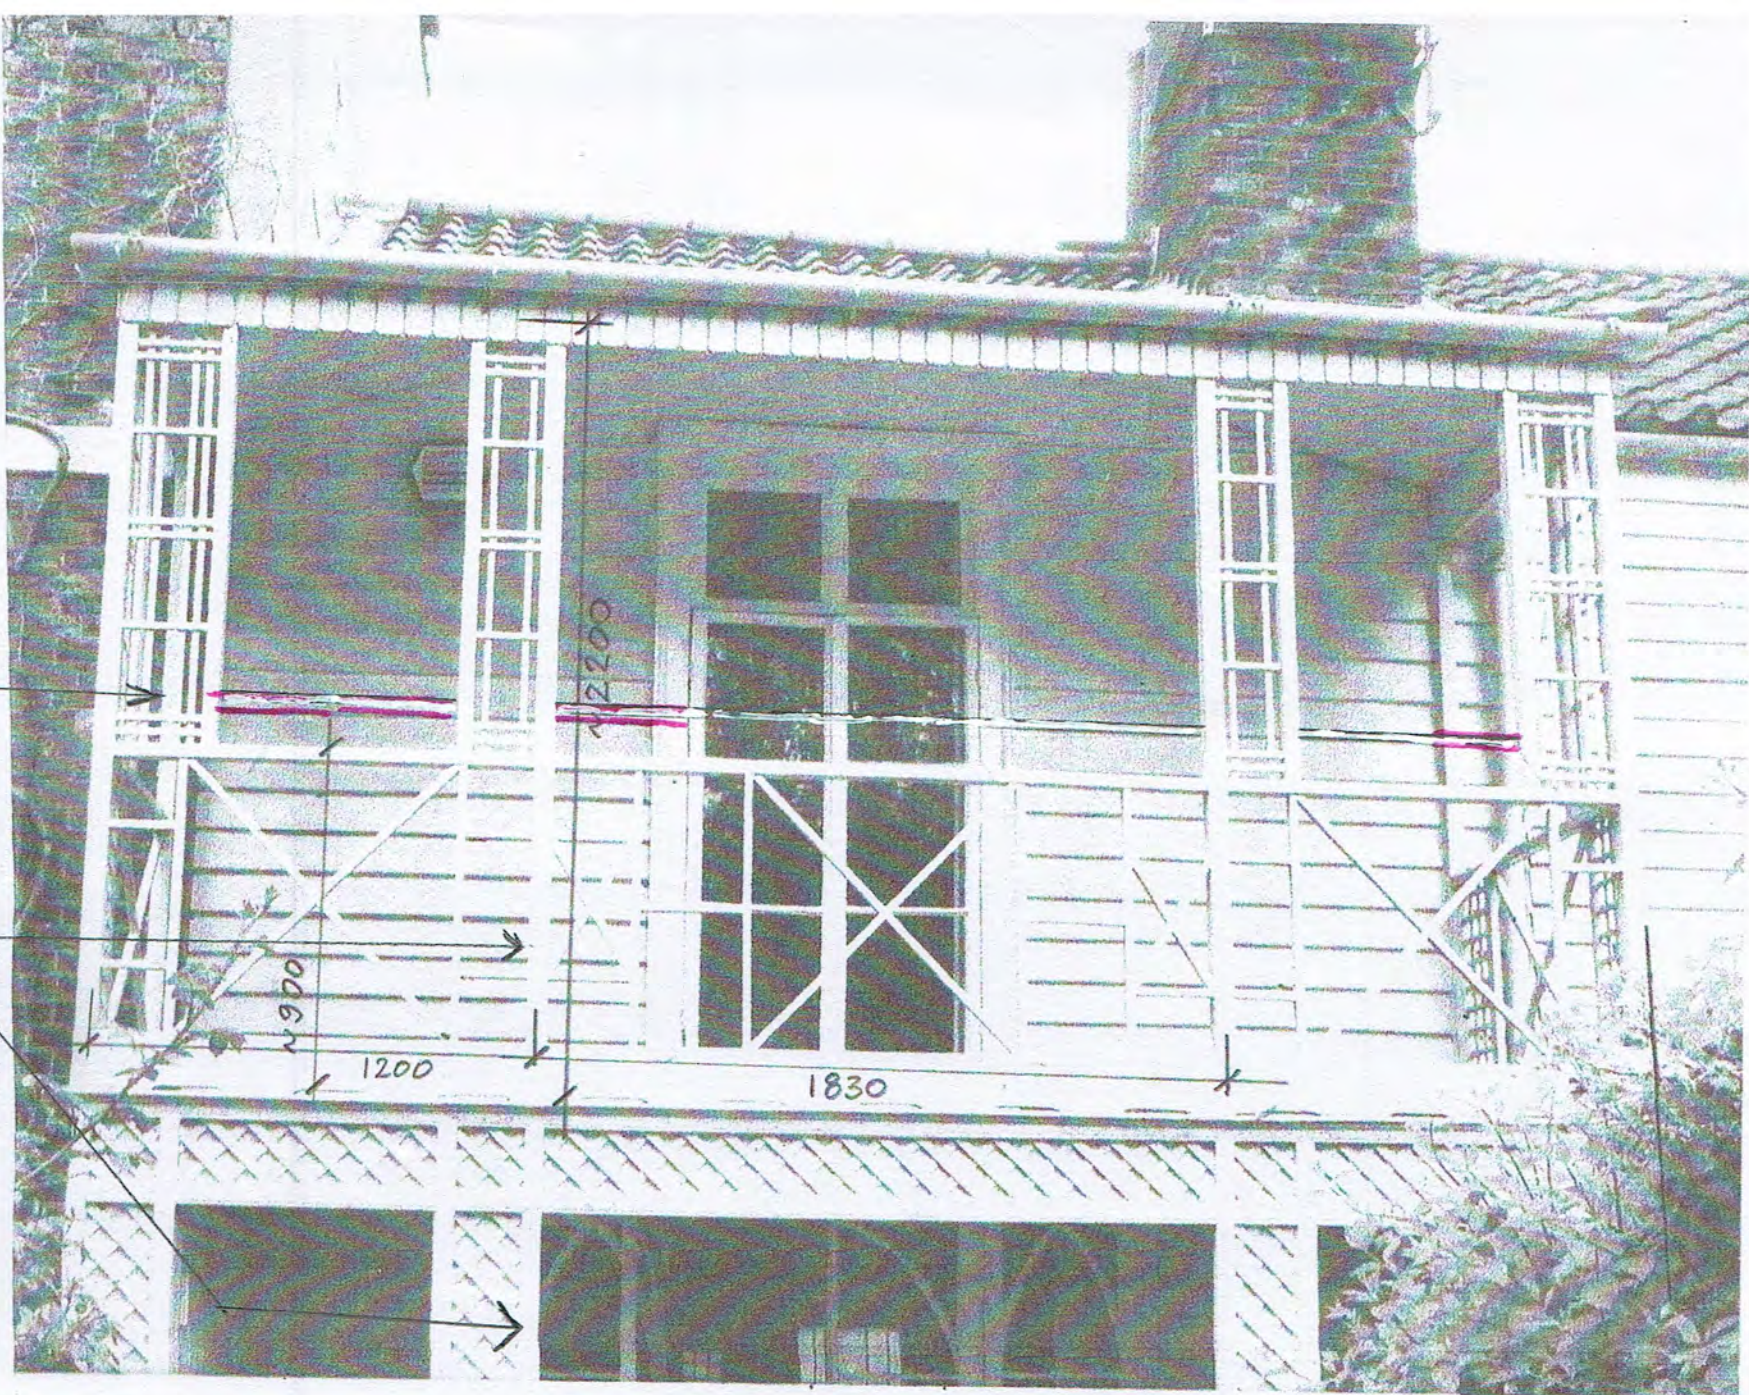
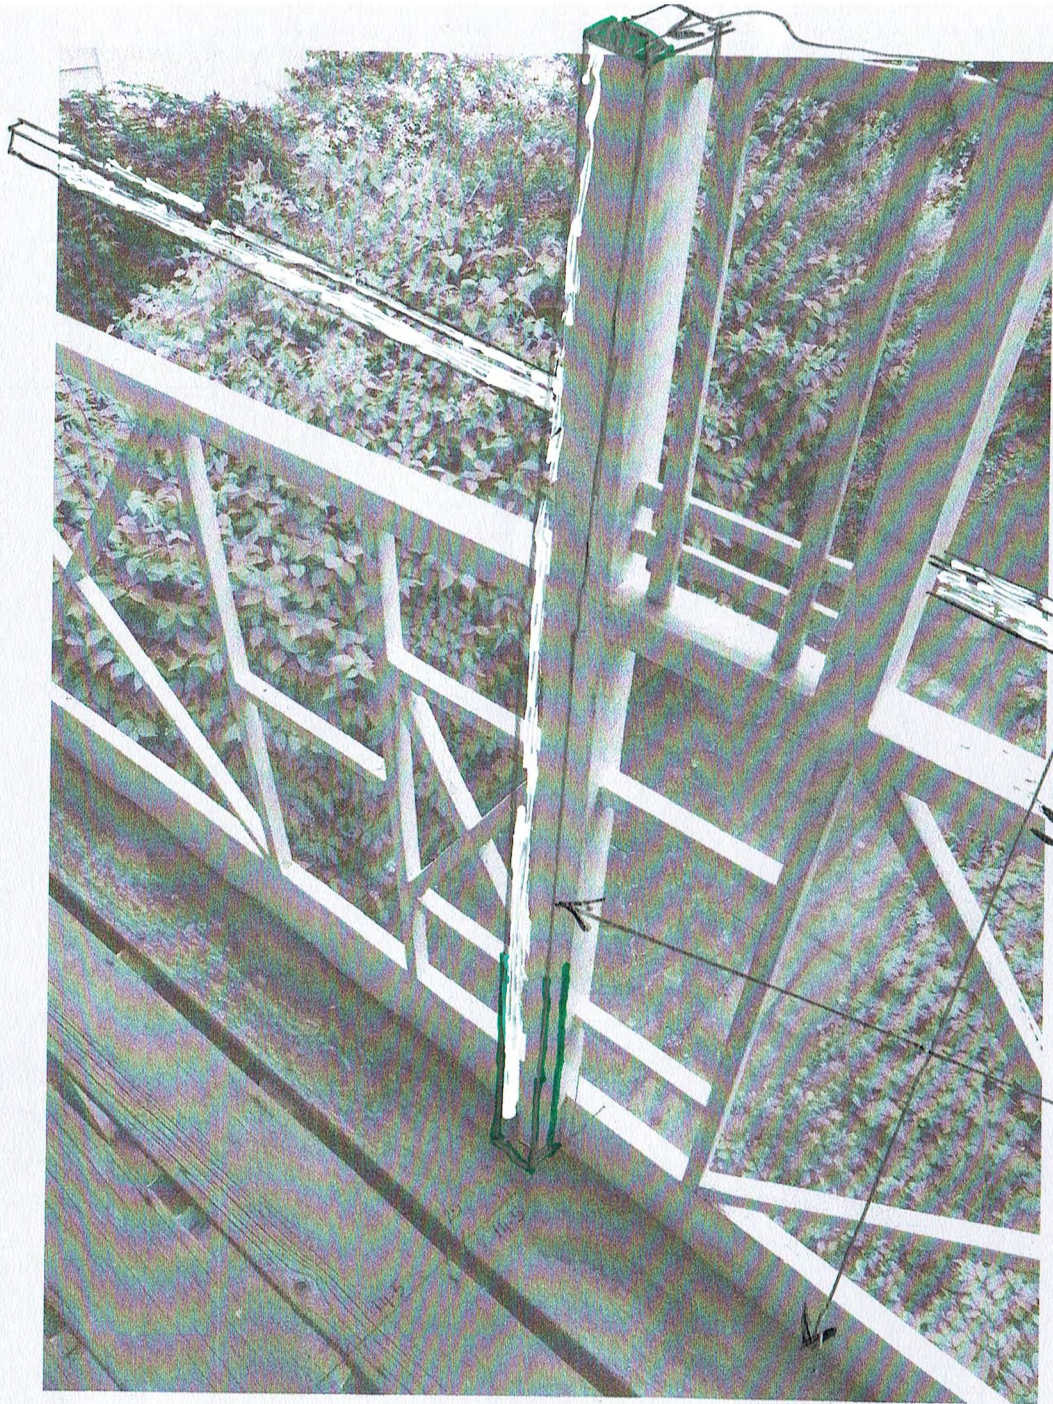
$$\frac{M}{Z} = \frac{0.618 \times 10^6 \times 6}{45 \times 62^2} = 21.4 \text{ N/mm}^2 \text{ Fails}$$

New 25x25 steel  
handrail white  
at 1100 above deck

Extra 45x45 timber  
(taper if desired)  
glued & screwed to  
inside (back face) of  
2 vertical posts at  
both ground to 1st  
and 1st to Roof.

45 x 45 or tapered wood inside

New addition 25 x 25 steel white
