St Giles Circus

26 Denmark Street

Temporary Removal of Timber Panelling

July 2017

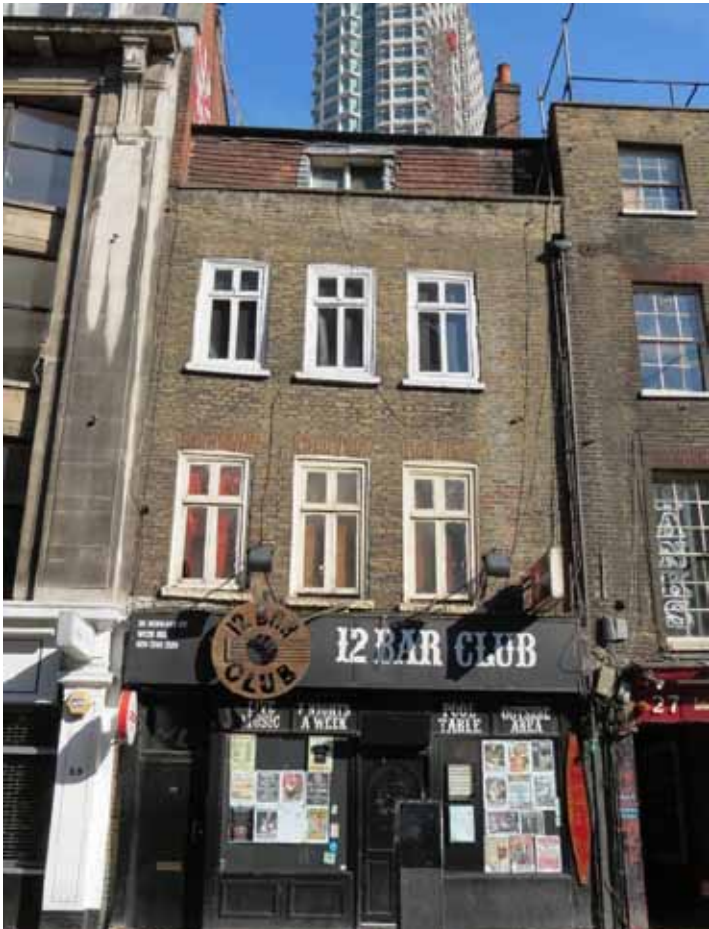
- 2.1 As noted in Alan Baxter's report on No. 26 Denmark Street, the front facade of No. 26 Denmark Street is thought to have been previously rebuilt to provide today's shop front.
- 2.2 On the recent removal of a contemporary back panel to a cupboard at first floor level, the interface between the front facade and the perpendicular Party Wall was exposed. At this location a crack of approximately 50mm width was observed, with free view in to the adjacent property.

- 2.3 Directly adjacent to this, the chimney breast to the Party Wall was also observed and seen to be separated from the wall.
- 2.4 This movement and separation of the masonry is a cause of serious structural concern. Should the defect be shown to be general to the front façade and not just local, the front façade will in effect be unsupported by flank walls and therefore reliant on the very limited structural restraint of the floor joists, or central bressummer beam.

- 2.5 Historically, this wall has shown a great deal of movement, as expressed in the slopping of the front lintels. This delamination could be the reason for this movement. Although no new movement has been recorded from the monitoring of the façade over the past few years, the lack of restraint of the masonry wall could lead to its ultimate and catastrophic failure.

- 2.6 Both the front façade and the chimney breast will be required to be tied back to their adjacent Party Walls, without this repair the wall is potentially unstable.

- 2.7 However, prior to repair, the full extent of this issue should be surveyed. To do this, the historic panelling to the walls must be removed to provide full access and view.
