Arboricultural Impact Assessment

Gloucester Lodge, Gloucester Gate, Regents Park,
London, NW1 4HA

Iconic Properties Limited

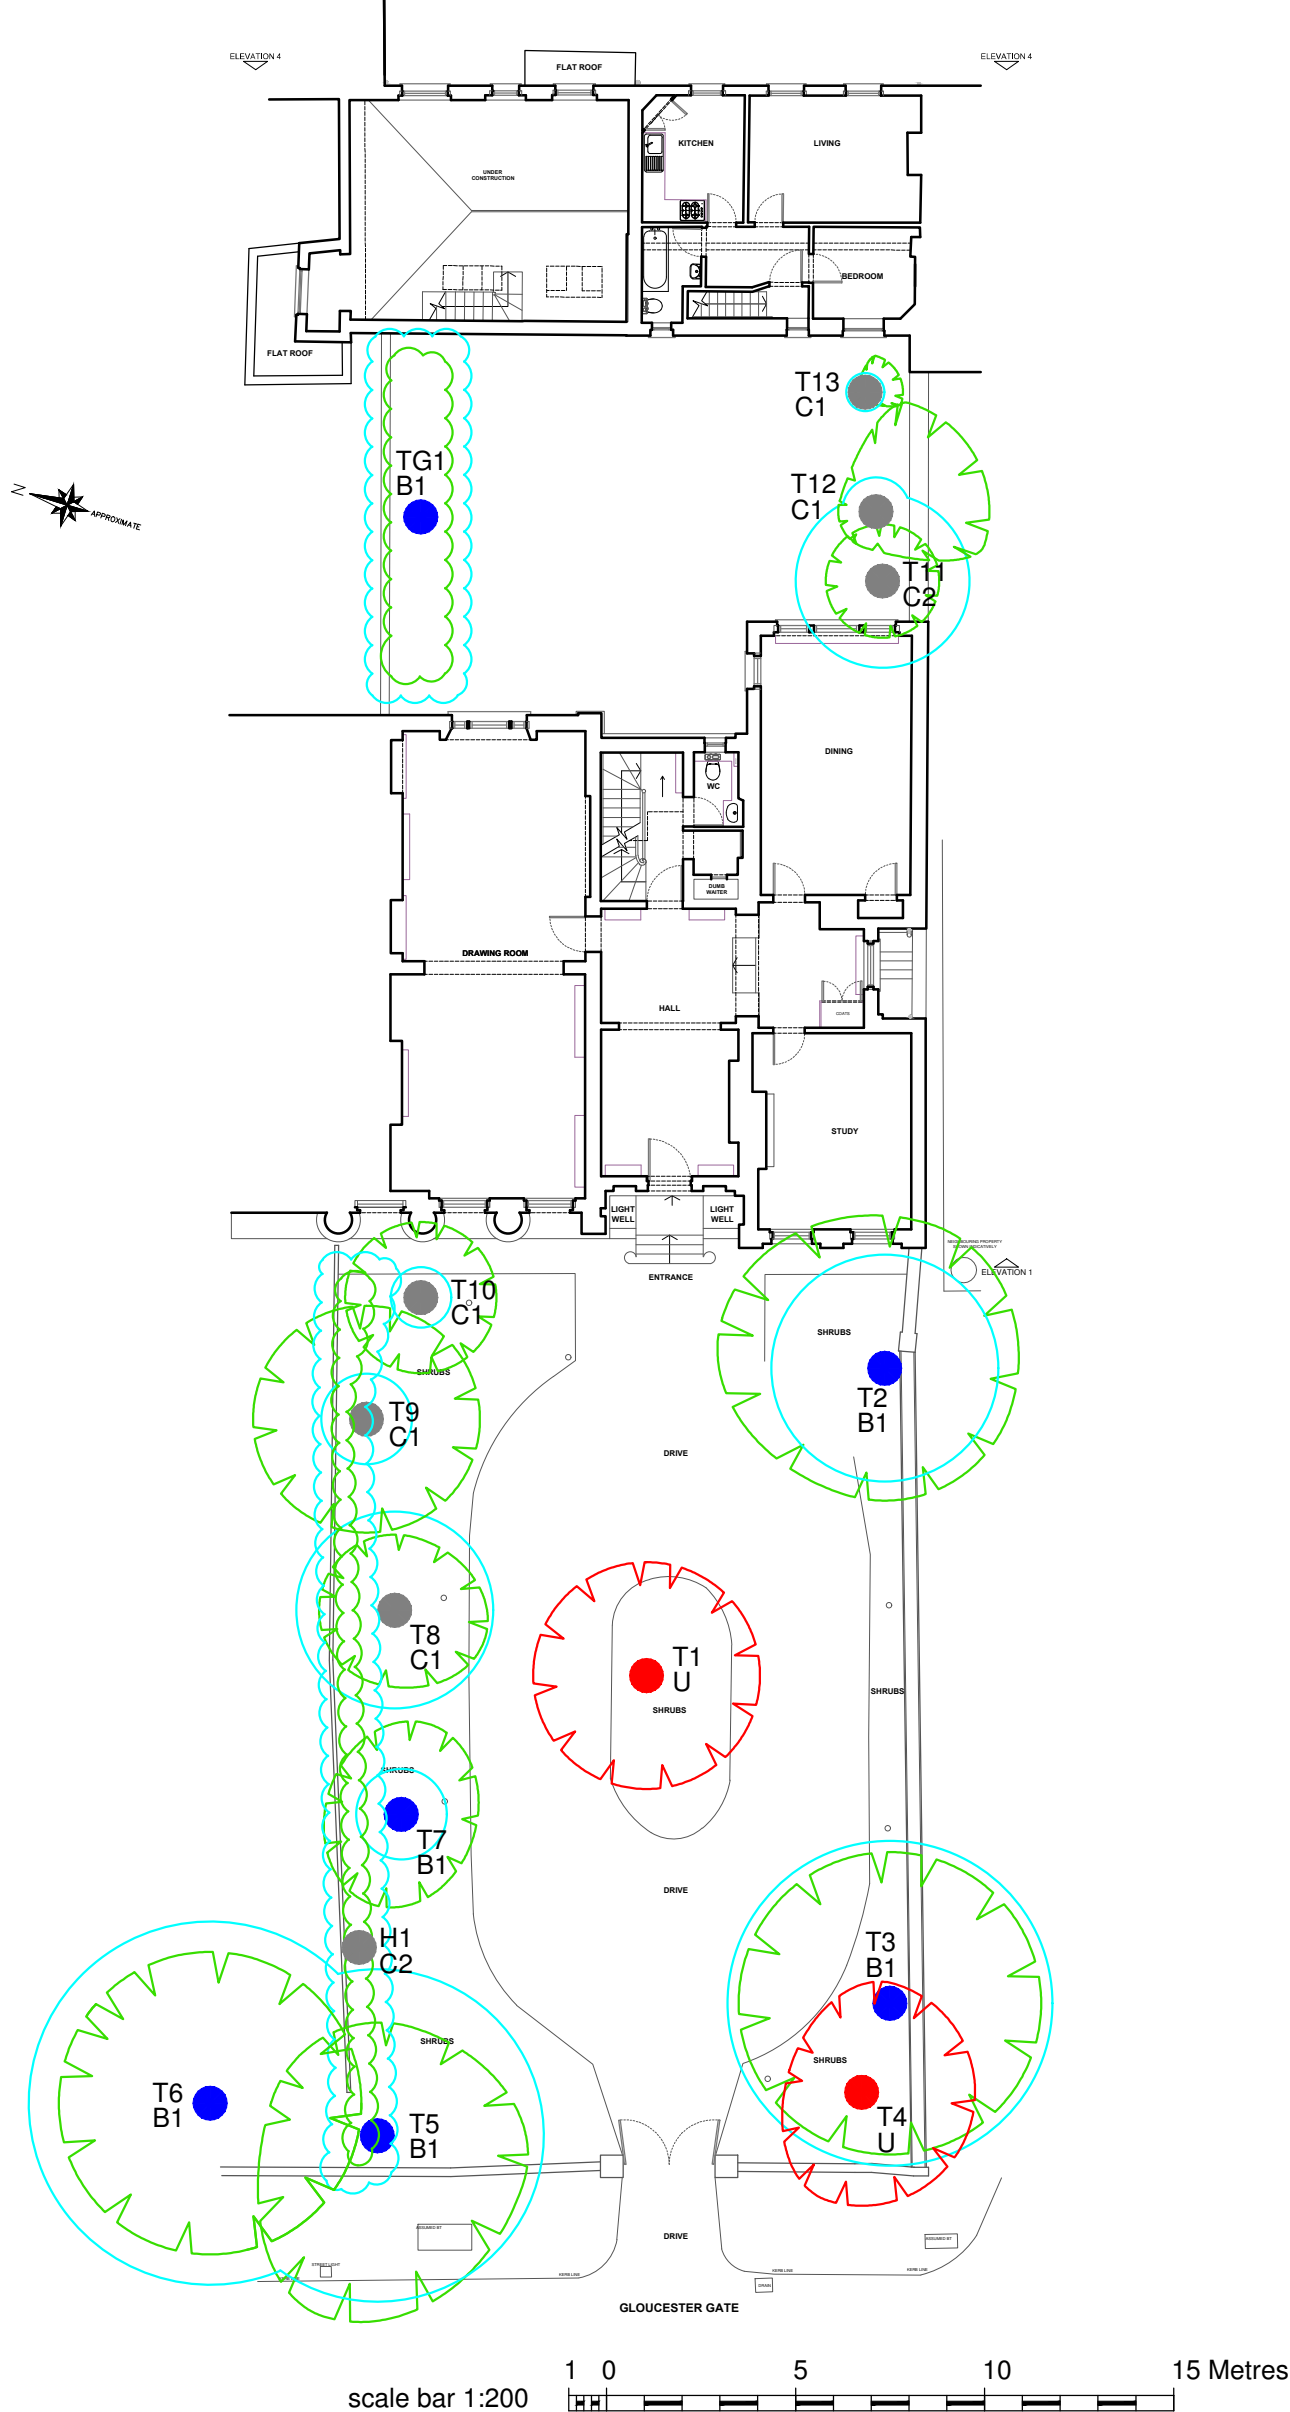
Appendix 3 – Tree Constraints Plan

Tree No	Species	DBH(m)	No of Stems	Ht (m)	BS Cat
T1	Weeping Ash.	0.65	1	8.7	U
T2	Magnolia.	0.25	1	7.6	B1
T3	Ash.	0.36	1	12	B1
T4	Cherry.	0.27	2	4.7	U
T5	False Acacia.	0.37	1	10.4	B1
T6	Oak.	0.4	1	13.7	B1
T7	Japanese Maple.	0.12	M/s	4	B1
T8	Pittosporum	0.26	2	5.5	C1
T9	Lilac.	0.12	M/s	4.6	C1
T10	Cotoneaster.	0.067	1	4	C1
T11	Rhododendron.	0.19	1	8.2	C2
T12	Lilac.	0.09	M/s	3.6	C1
T13	Japanese Maple.	0.04	1	3.4	C1
H1	Yew.	0.08	M/s	3.5	C2
TG1	Hornbeam.	0.19	1	4.5	B1
