Window Schedule

Project: **British Museum Perimeter Projects 1-1A MS : Window Schedule**
 Job No: **P2007246**
 Issue: First Issue
 Date: 17/03/2017
 28/04/2017 Rev A
 01/06/2017 Rev B

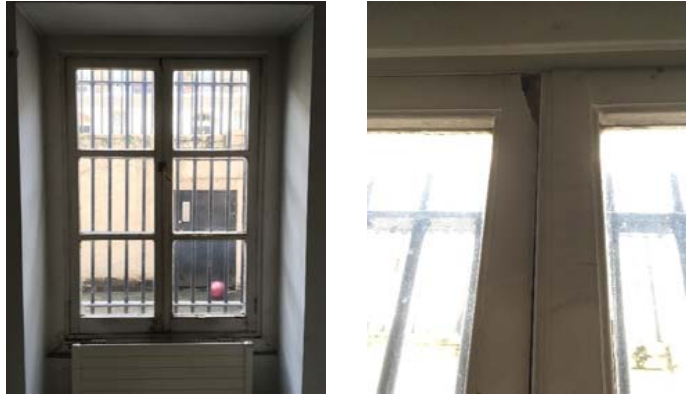
| Window Number | Location | Window Construction | Window Finish | | Nominal Window Size | | Security | Current condition | Notes / Scope of Works |
|---|---|--|---|---|---|---|---|---|--|
| 1-LG-W02 | 1MS/1/014 | Solid timber framed double opening, side hinged casement window | Paint | Paint | Existing | Existing | External security bars | | |

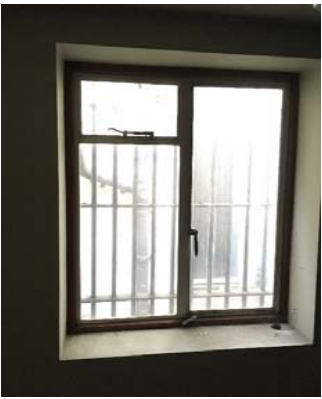
| 1A-LG-W04 | 1AMS/1/004 | Metal framed casement window with side and top hung openings. Fitted within timber frame surround. | Metal | Metal | Existing | Existing | External security bars | | |

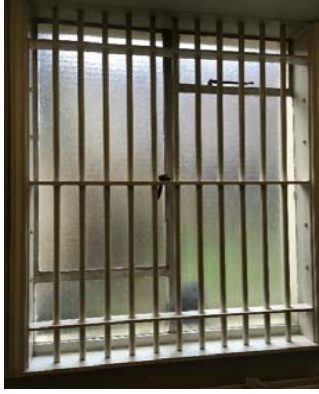
| 1-G-W06 | 1MS/2/009 | Metal framed casement window with side and top hung openings | Metal | Metal | Existing | Existing | Internal security bars | | |

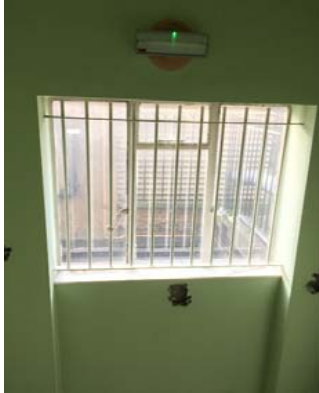
| 1A-1-W05 | 1AMS/3/S01 | Metal framed casement window with two side openings and central top hung opening | Metal | | Existing | Existing | Internal security bars | | |
