<b>Room No. 1MS/2/003 Lobby</b>	
<b>Item</b>	<b>Scope of works</b>
General	<ul style="list-style-type: none"> <li>▪ Existing fittings and services have already been removed;</li> <li>▪ Walls to be redecorated with matt emulsion paint finish -allow for 2 coats. Colour to be agreed with architect and British Museum;</li> <li>▪ Existing ceilings to be redecorated with matt emulsion paint.</li> <li>▪ Existing stairs, skirting, doors and architrave to be retained, repaired where necessary and redecorated;</li> <li>▪ New services provision throughout. Electrical distribution to be recessed.</li> <li>▪ New lighting to be installed</li> <li>▪ External roof light to be retained and cleaned.</li> </ul>
Ceilings	<ul style="list-style-type: none"> <li>▪ Carefully remove all existing services, fixtures and fittings from the existing plaster ceiling together with any friable or loose/live plaster;</li> <li>▪ External roof light to be retained and cleaned, upstand to be redecorated;</li> <li>▪ Areas of existing damaged ceilings and supporting structure to be carefully removed and repaired/ replaced as required;</li> <li>▪ Ceiling to be redecorated with white emulsion paint finish;</li> </ul>

<b>

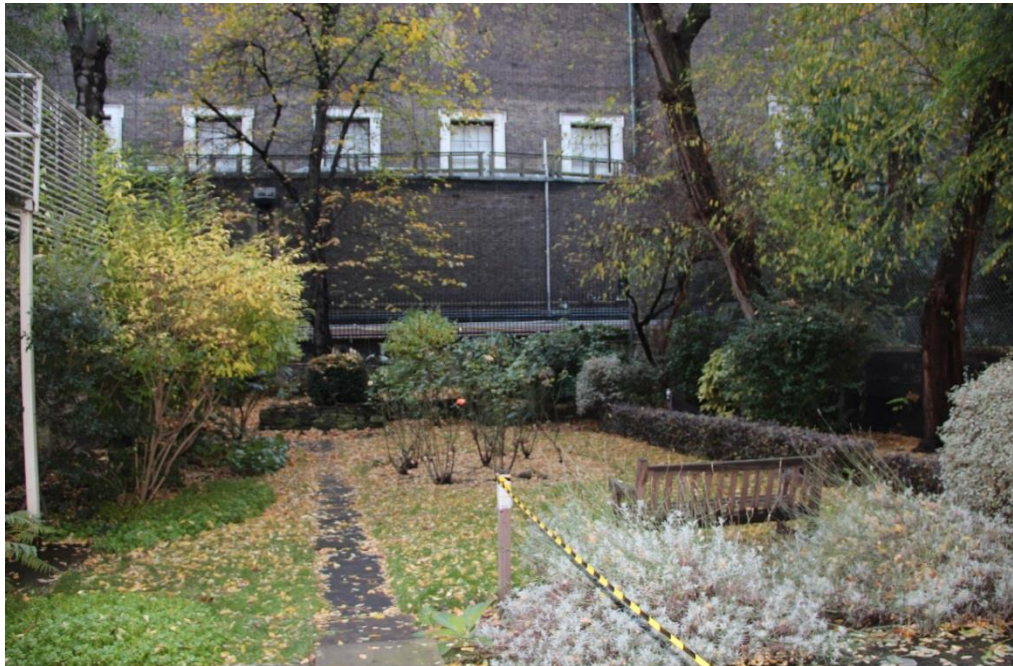
*Existing plants and hedges to be removed from rear garden where required. Refer to drawing (18)AP007*  
*Timber clad enclosure to be created to contain plant. Refer to drawing (41)AD003*  
*Ground to be levelled and prepared with stone base and bedding for new raised garden retreat area at the bottom of the garden using flagstones to match existing seating area. New seating area with 3 x new hardwood tables. Existing fence in rear garden to be redecorated in exterior grade paint.*

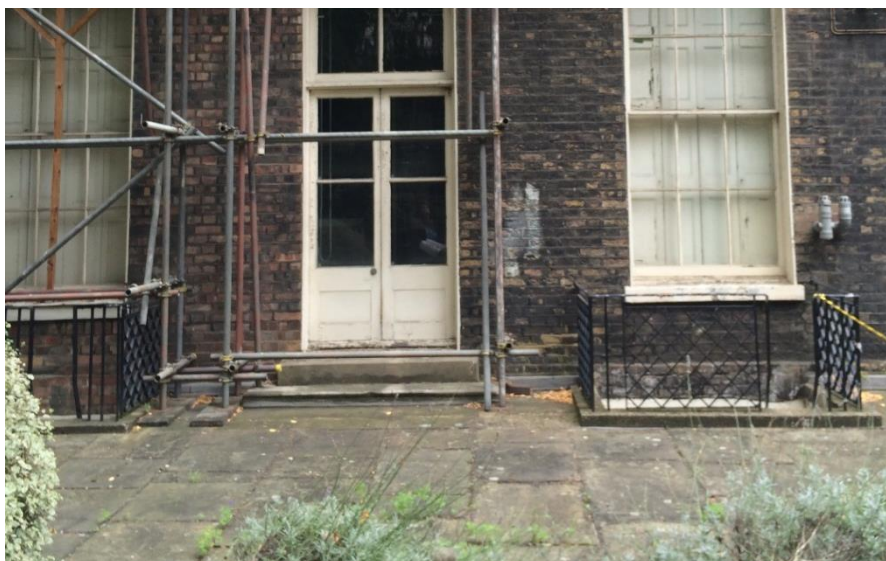
*Existing flagstones to be cleaned and made good where necessary. Refer to BDP drawing 24AD003. Area of existing stone flagstones to be removed and relocated in plant area. See BDP drawing (18)AP007;*  
*Existing balustrades to be redecorated and new section of railing to be added to match existing adjacent. Refer to BDP drawing 24AD002.*
