## ASBESTOS REFURBISHMENT/DEMOLITION SURVEY

Parliament Hill  
Highgate Road  
London  
NW5 1RL

Lantern Services  
Barnet by Pass  
South Mimms  
Potters Bar  
Hertfordshire  
EN6 3NQ

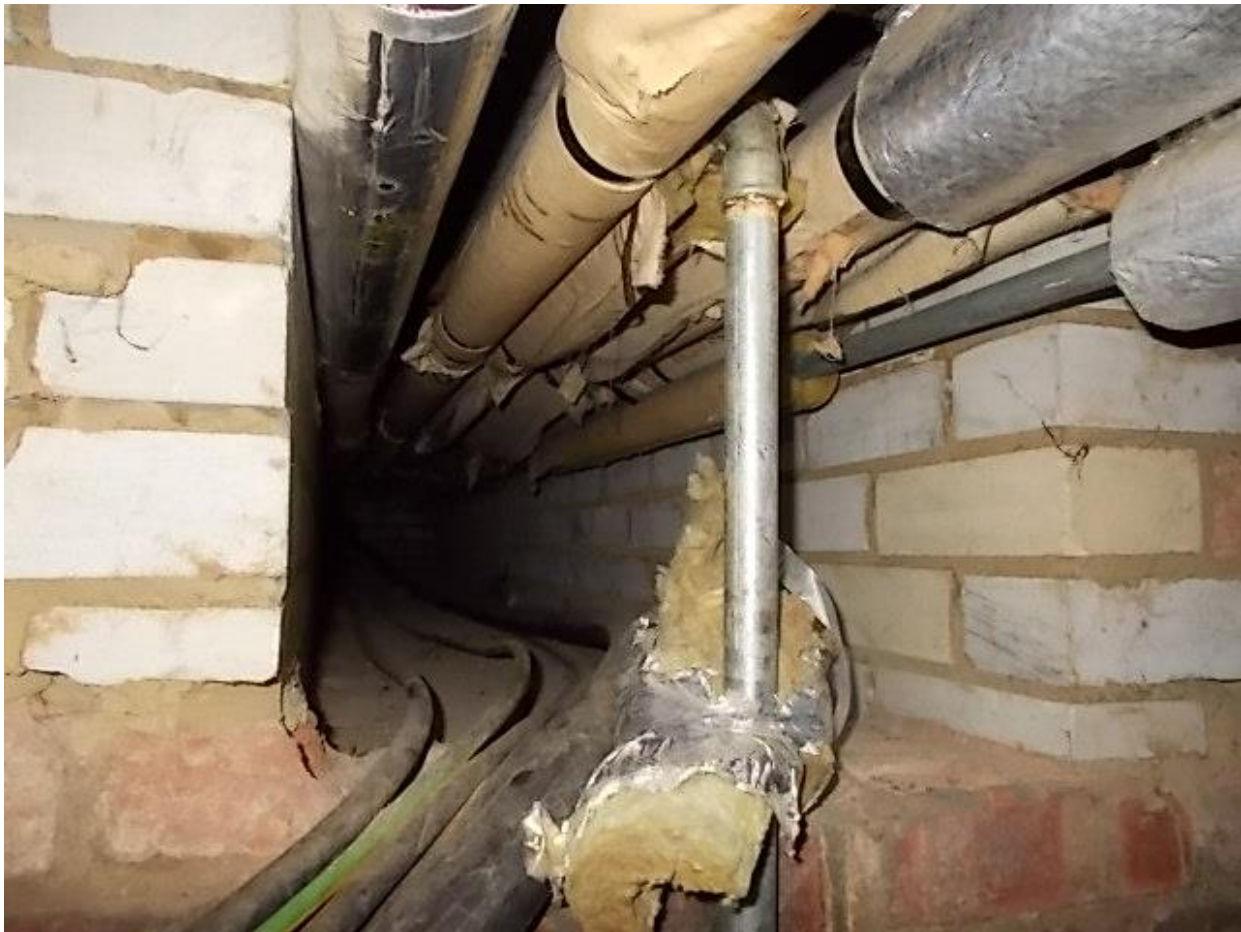
Sample Ref	Description	Location & Extent	Asbestos Type
KA047	Boiler Room - Dust & Debris	Internal Throughout boiler room	Chrysotile Amosite
Material Assessment Score	Priority Assessment Score	Recommendation	
10	2	Remove under fully controlled conditions by a licenced contractor prior to demolition works

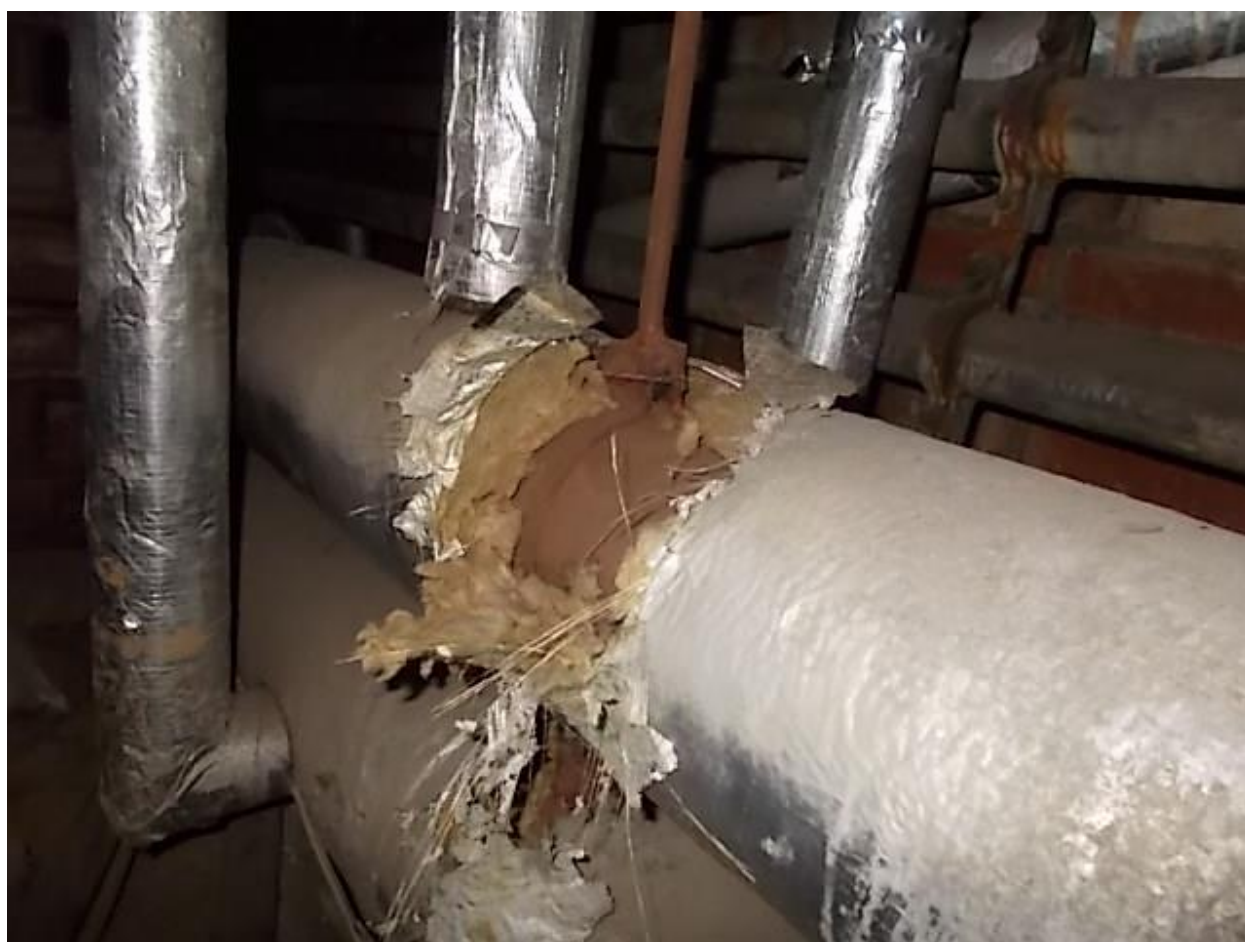
Sample Ref	Description	Location & Extent	Asbestos Type
KA052	Boiler Room - Pipe Insulation Residues	Boiler room Full length of pipework	Chrysotile Amosite
Material Assessment Score	Priority Assessment Score	Recommendation	
10	2	Remove under fully controlled conditions by a licenced contractor prior to demolition works

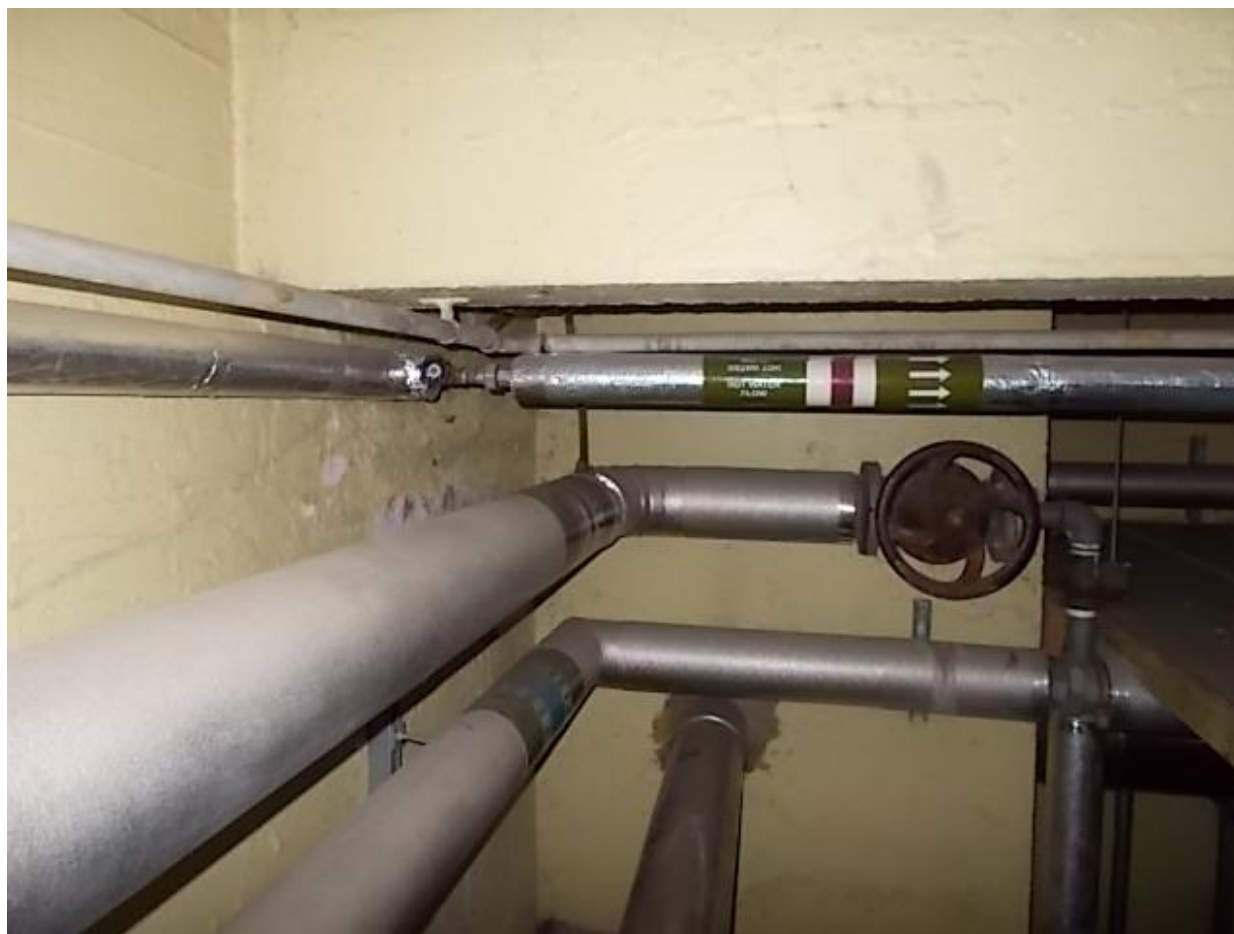
Sample Ref	Description	Location & Extent	Asbestos Type
KA054	Boiler Room - High Level Pipe Residues	Boiler room Full length of pipework	Amosite
Material Assessment Score	Priority Assessment Score	Recommendation	
10	2	Remove under fully controlled conditions by a licenced contractor prior to demolition works

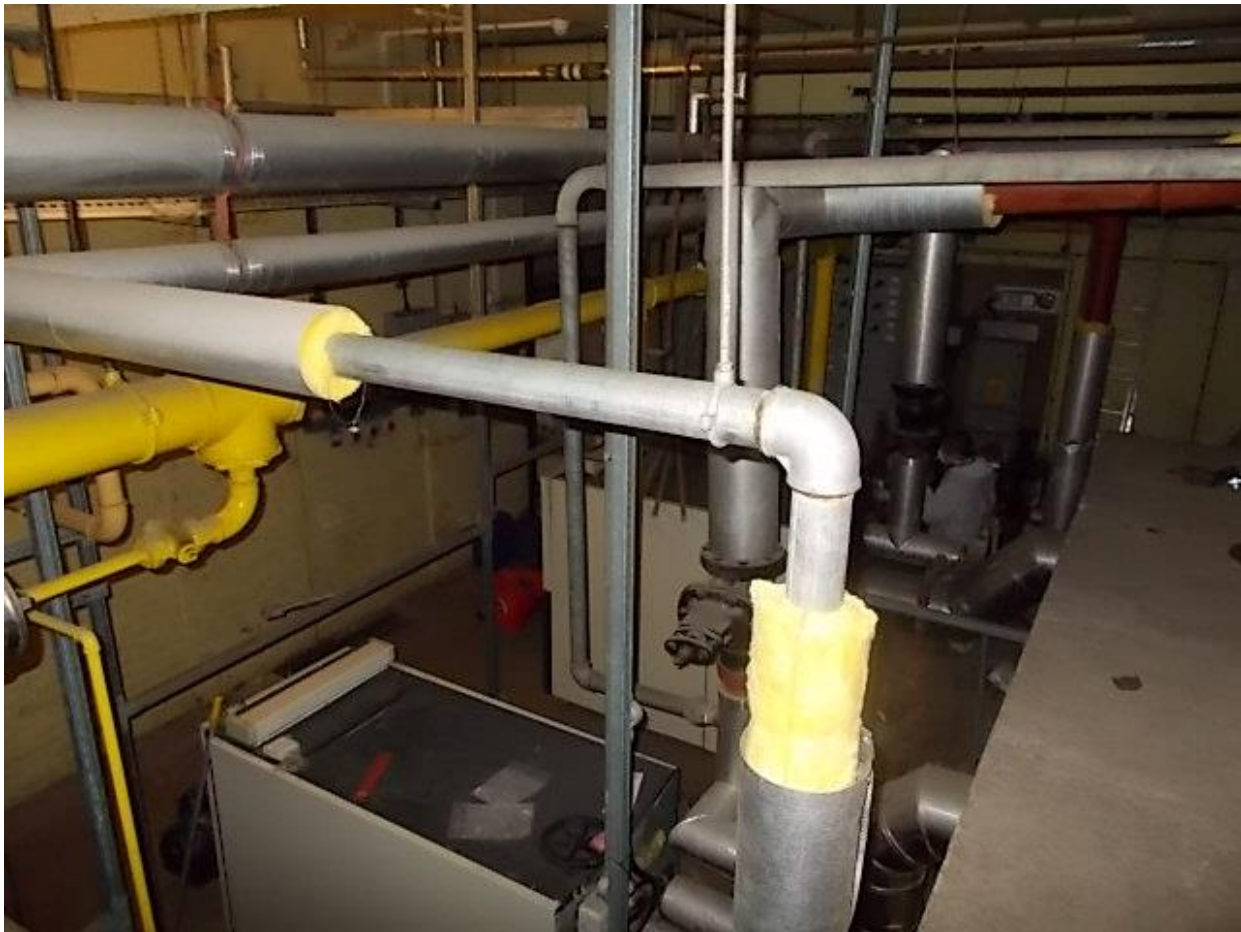
Sample Ref	Description	Location & Extent	Asbestos Type
KA056	Boiler Room - High Level Pipe Residues	Boiler room Full length of pipework	Amosite
Material Assessment Score	Priority Assessment Score	Recommendation	
10	2	Remove under fully controlled conditions by a licenced contractor prior to demolition works

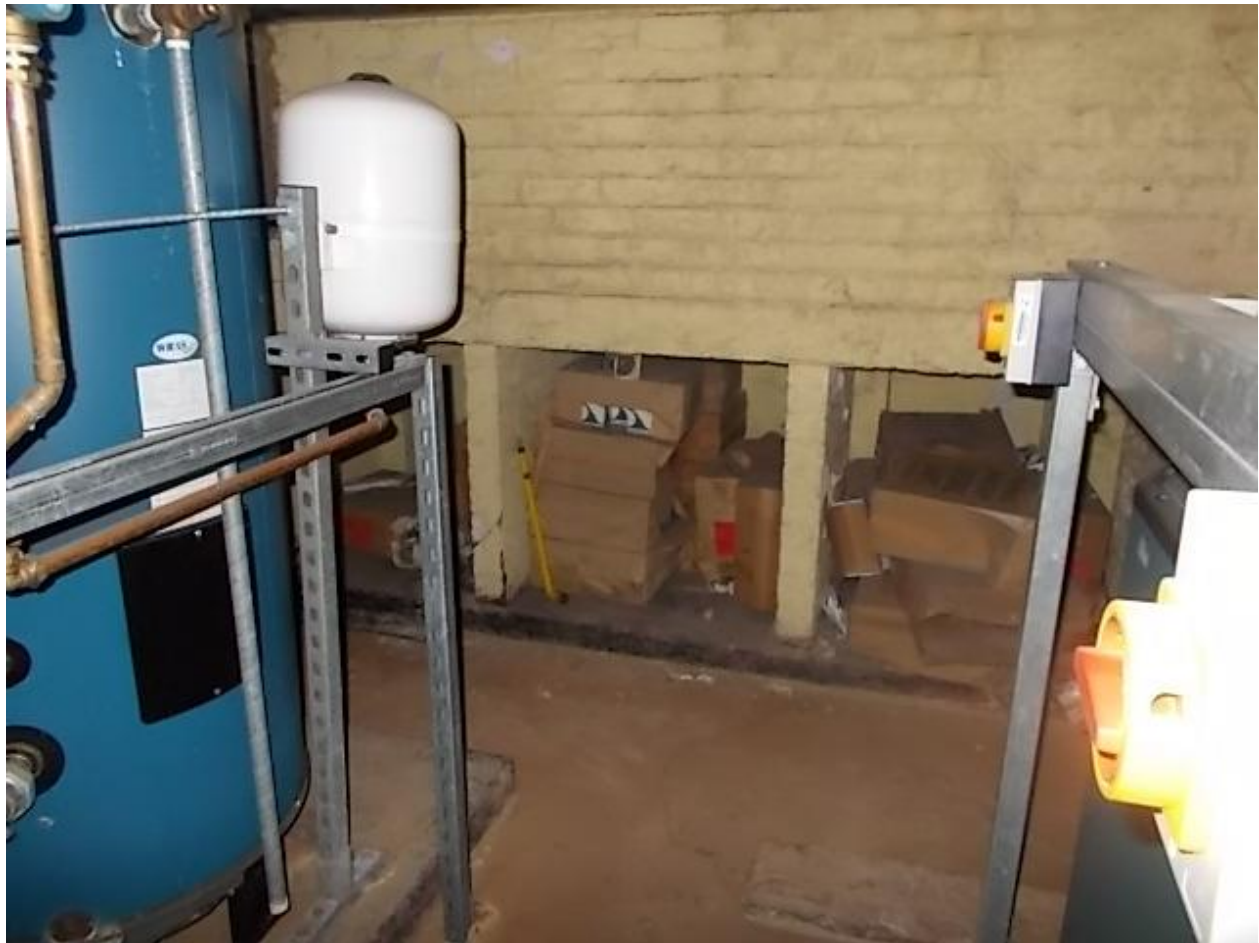
Sample Ref	Description	Location & Extent	Asbestos Type
KA060	Boiler Room - Dust & Debris From Floor	Boiler room Throughout boiler room	Amosite
Material Assessment Score	Priority Assessment Score	Recommendation	
10	2	Remove under fully controlled conditions by a licenced contractor prior to demolition works

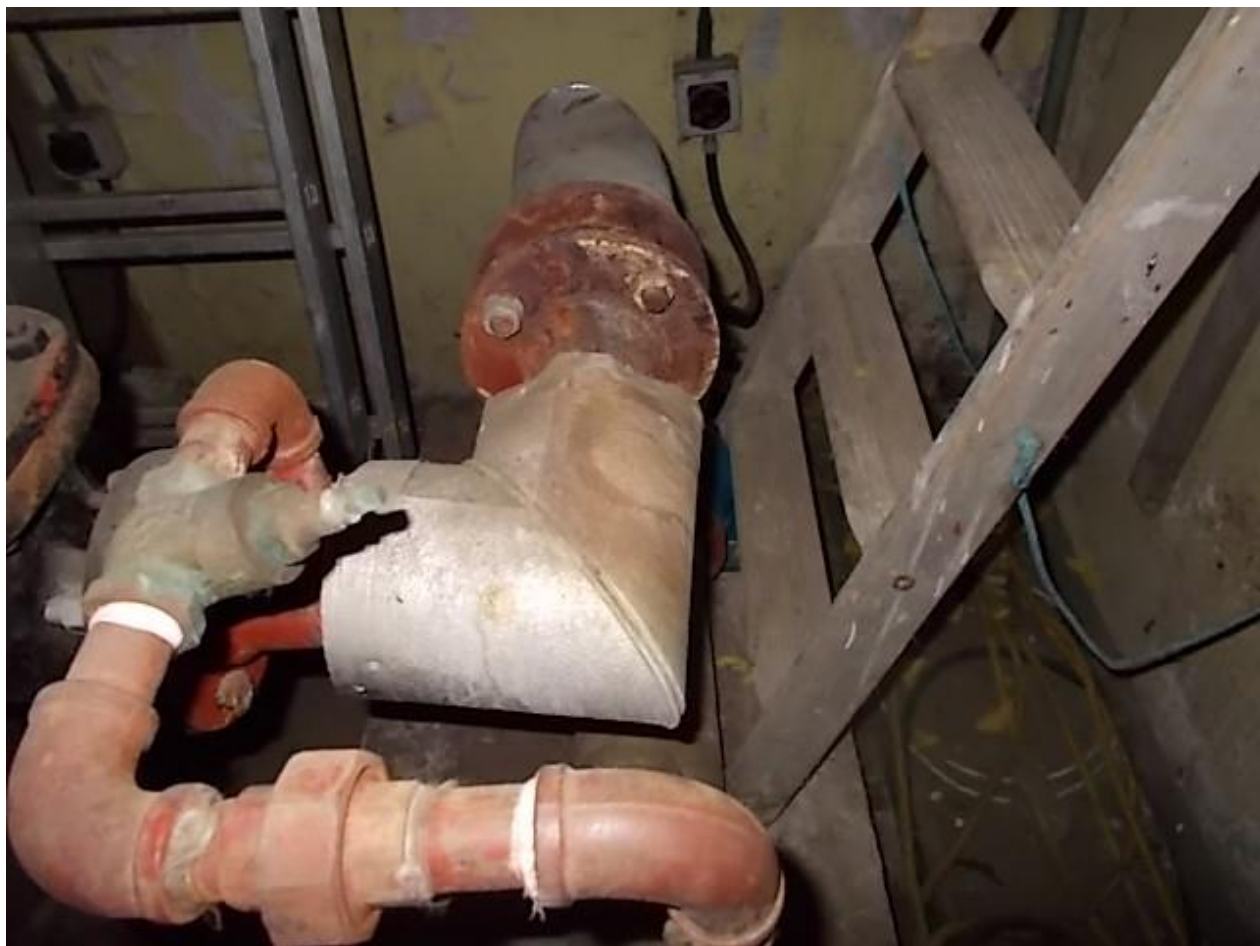
Sample Ref	Description	Location & Extent	Asbestos Type
KA063	Boiler Room - Low Level Pipe Residue	Boiler room Full length of pipework	Chrysotile Amosite
Material Assessment Score	Priority Assessment Score	Recommendation	
10	2	Remove under fully controlled conditions by a licenced contractor prior to demolition works

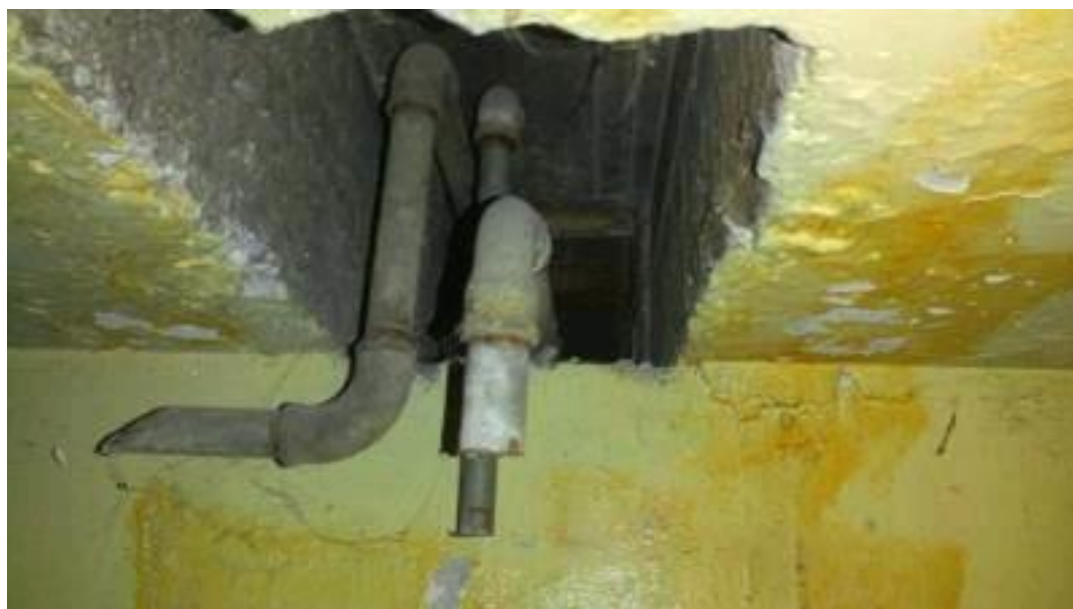
Sample Ref	Description	Location & Extent	Asbestos Type
Strongly Presumed	Presumed asbestos containing materials within cement shuttering within solid pipe run from ceiling - unable to gain access to sample	Full extent to be identified during demolition works	Strongly Presumed Chrysotile
Material Assessment Score	Priority Assessment Score	Recommendation	
10	2	<b>Remove under controlled conditions during demolition works</b> <b>** Further investigation will be required during the demolition work to establish the exact extent of the cement materials within the duct.</b>

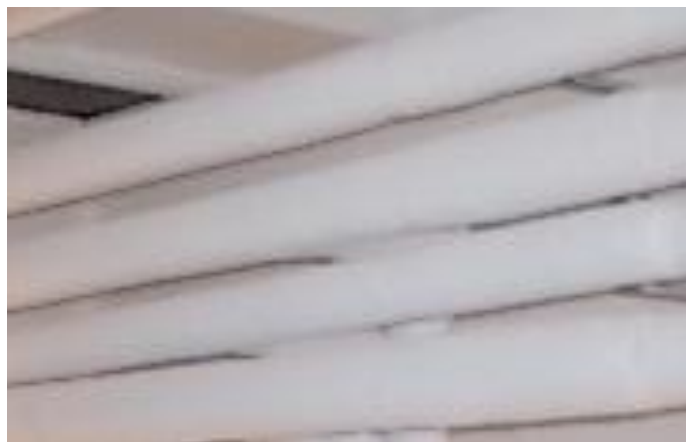
Sample Ref	Description	Location & Extent	Asbestos Type
KA080	Lower Ground Changing rooms Men's W/C - Residues To Pipes	Internal Small amount	Chrysotile
Material Assessment Score	Priority Assessment Score	Recommendation	
10	2	Remove under fully controlled conditions by a licenced contractor prior to demolition works

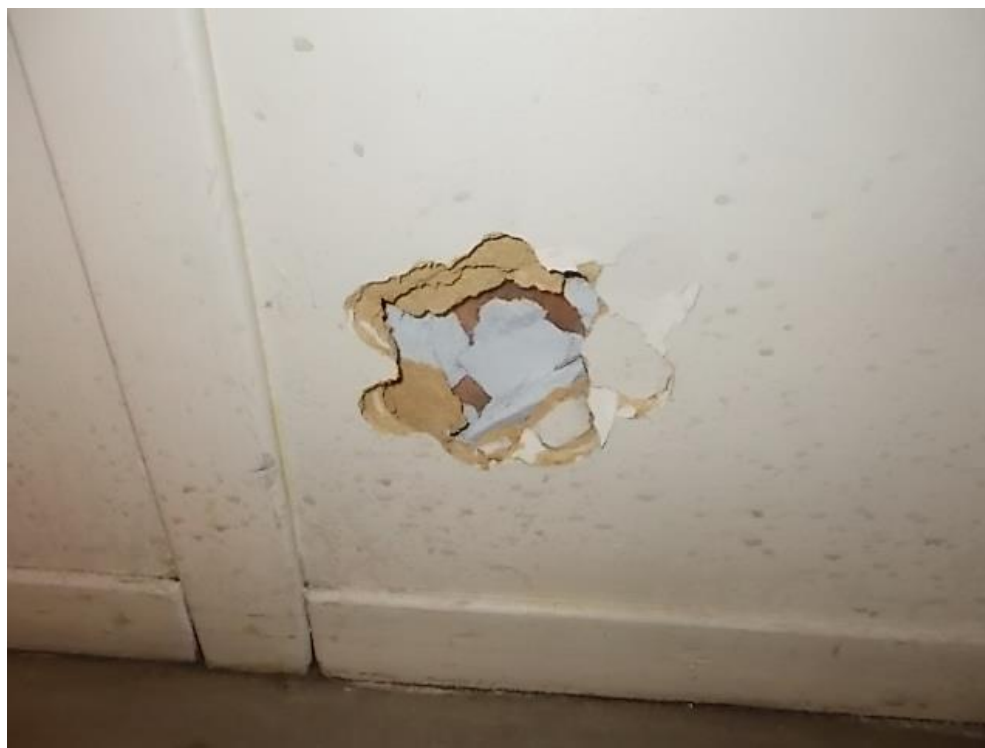
Sample Ref	Description	Location & Extent	Asbestos Type
KA068	Insulating board lining within cavity of fibreboard walls - Insulation Board	Internal Approx. 22 m <sup>2</sup>	Chrysotile Amosite

Material Assessment Score	Priority Assessment Score	Recommendation
10	2	Remove under fully controlled conditions by a licenced contractor prior to demolition works

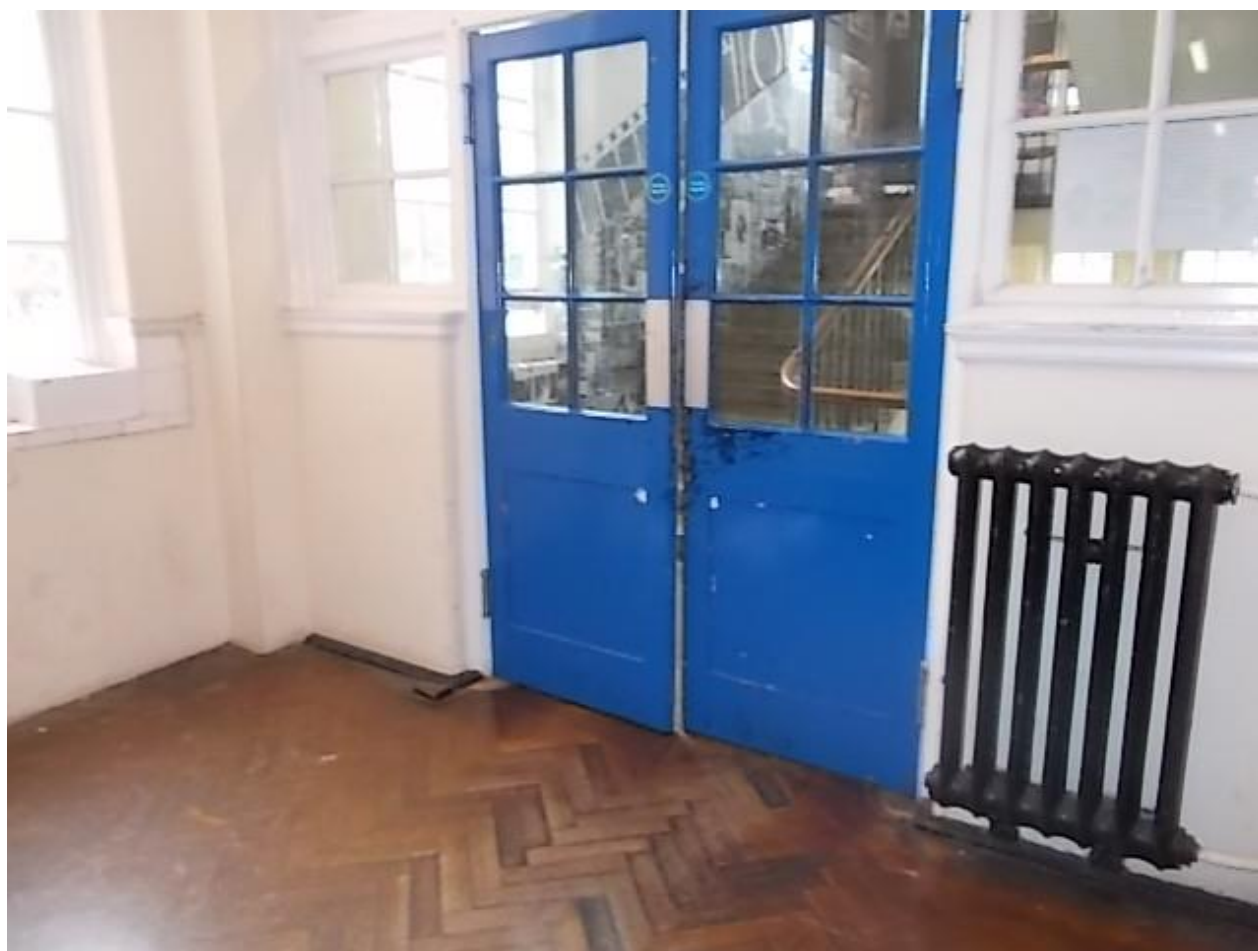
Sample Ref	Description	Location & Extent	Asbestos Type
KA084	First Floor Corridor To Stairs – Door Panel	Internal Approx. 2 m <sup>2</sup>	Chrysotile Amosite

Material Assessment Score	Priority Assessment Score	Recommendation
10	2	Remove under fully controlled conditions by a licenced contractor prior to demolition works

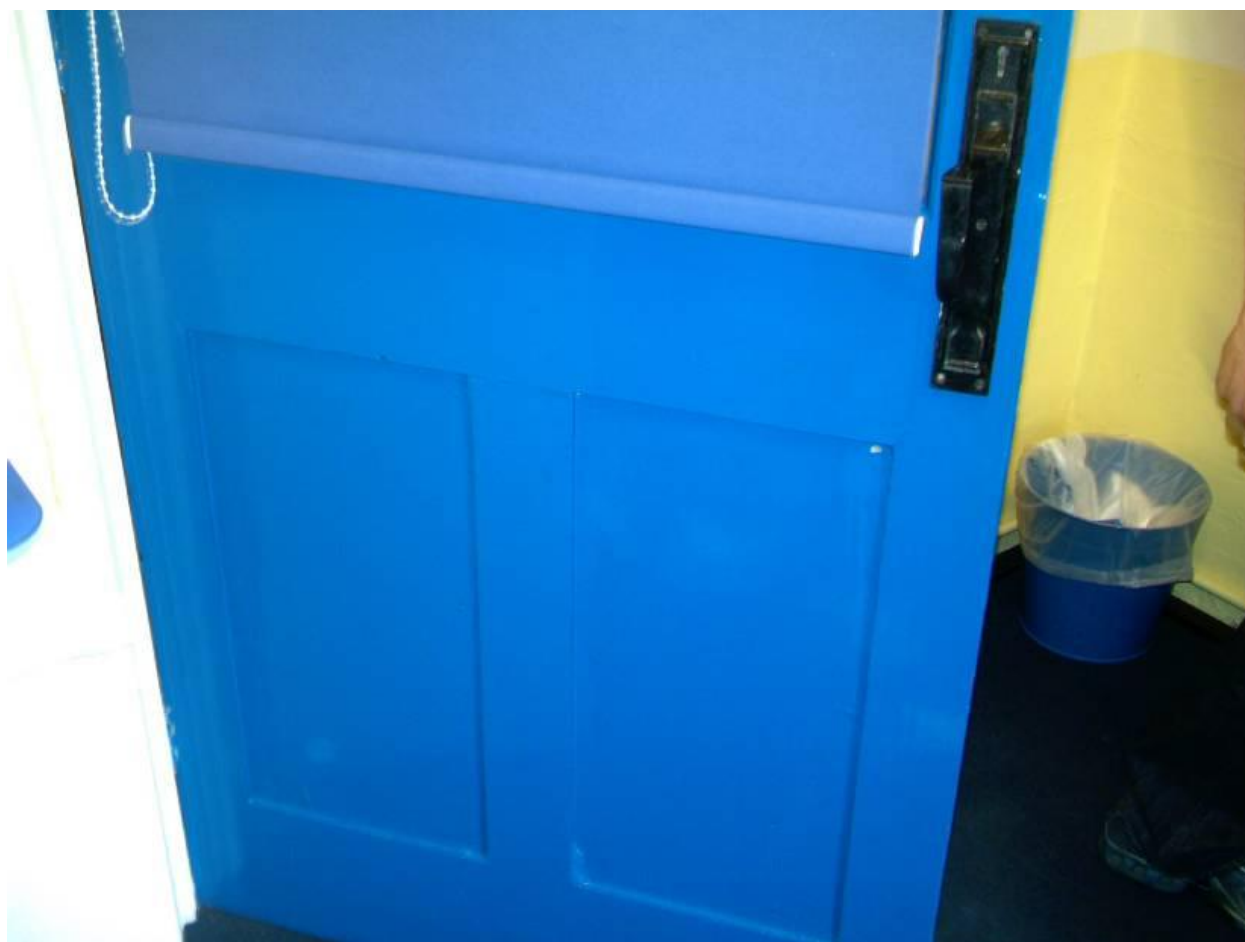
Sample Ref	Description	Location & Extent	Asbestos Type
KA086	First Floor - Modern Languages, Door Panel	Internal Approx. 1 m <sup>2</sup>	Chrysotile Amosite
Material Assessment Score	Priority Assessment Score	Recommendation	
10	2	Remove under controlled conditions prior to demolition/refurbishment works

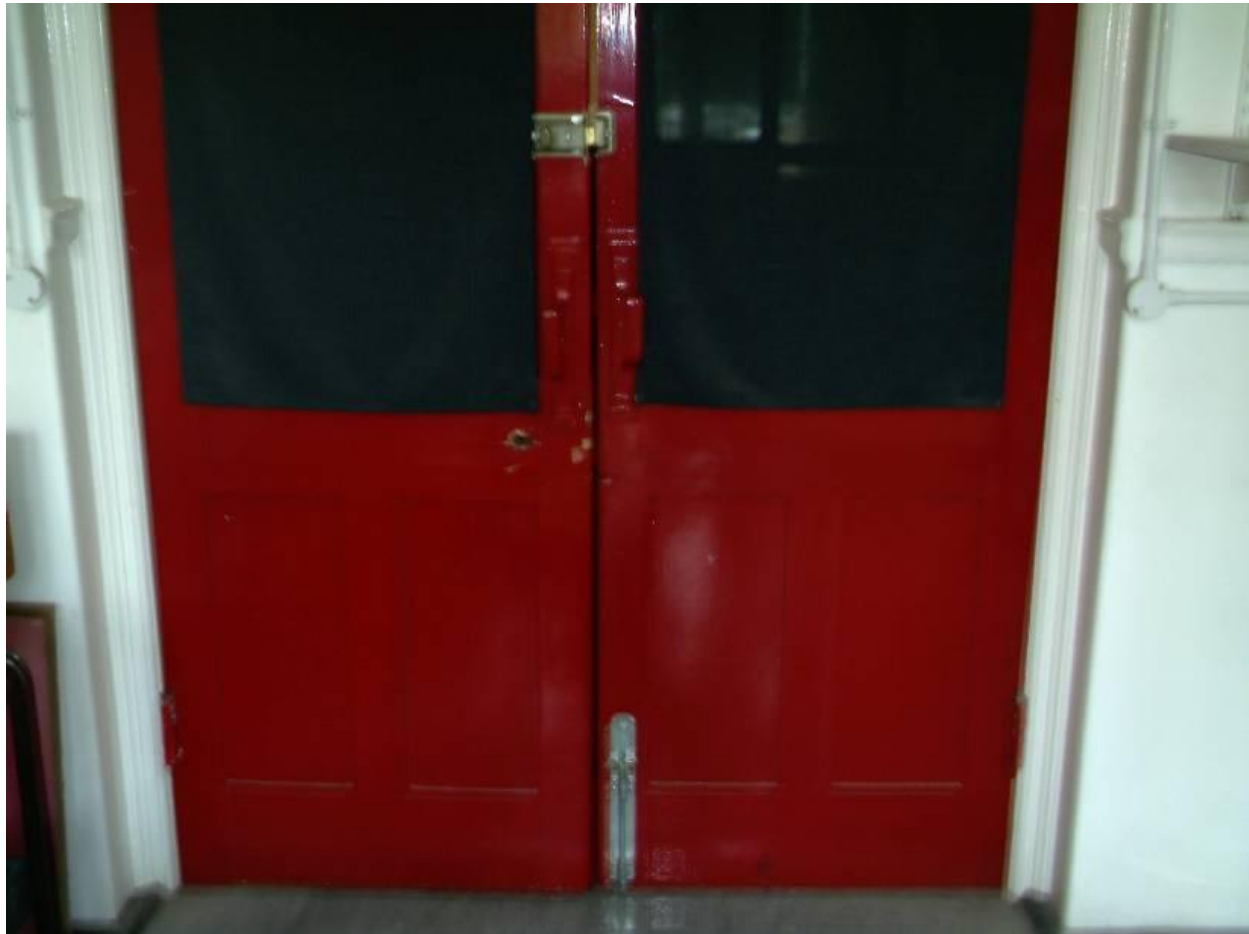
Sample Ref	Description	Location & Extent	Asbestos Type
KA088	First Floor - Morant Studio, Door Panels	Internal Approx. 2 m <sup>2</sup>	Chrysotile Amosite
Material Assessment Score	Priority Assessment Score	Recommendation	
10	2	Remove under controlled conditions prior to demolition/refurbishment works

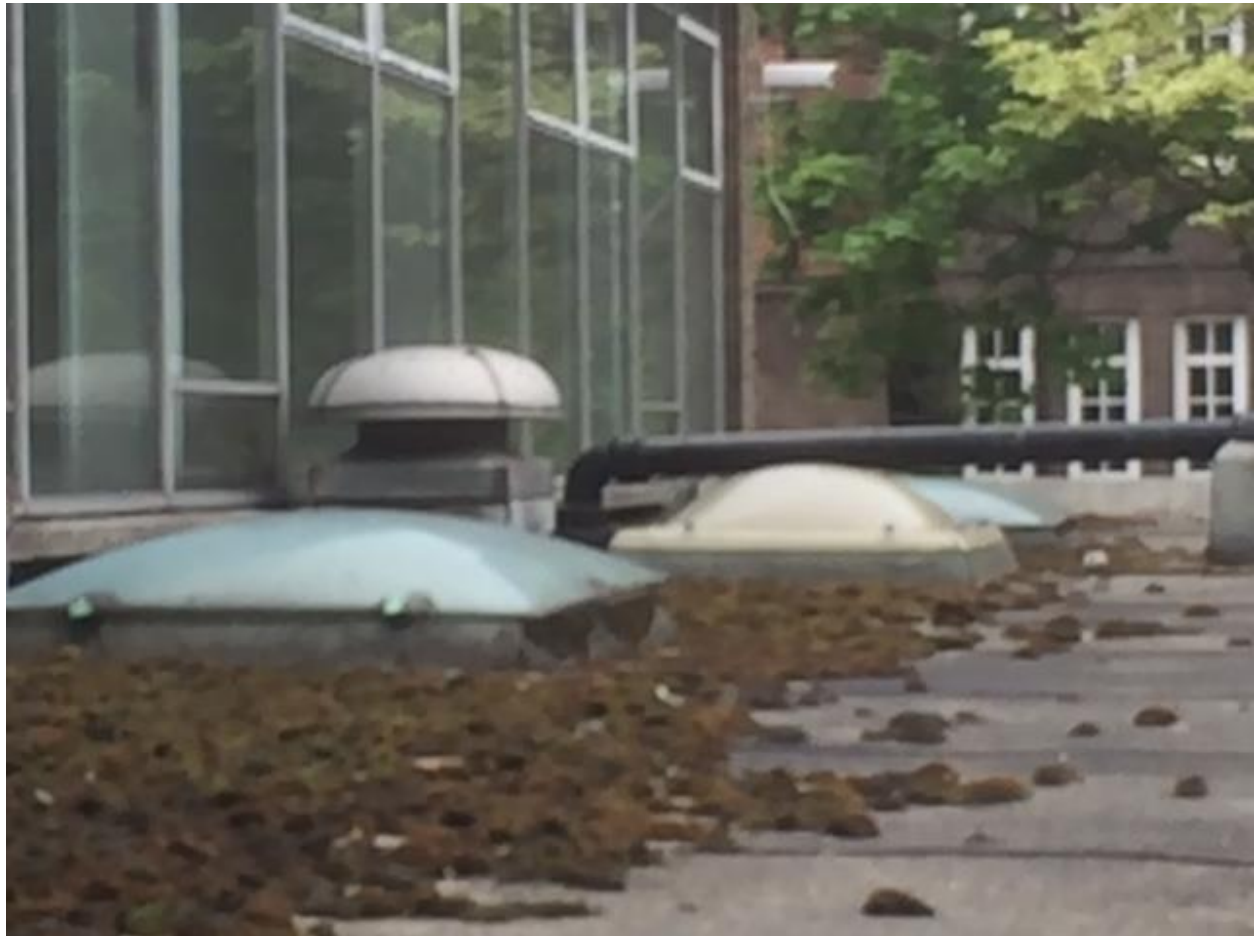
Sample Ref	Description	Location & Extent	Asbestos Type
KA403	Gym - Seals To Skylights	External Approx. 8lm	Chrysotile

Material Assessment Score	Priority Assessment Score	Recommendation
10	2	Remove under controlled conditions by a licenced asbestos removal contractor prior to demolition works

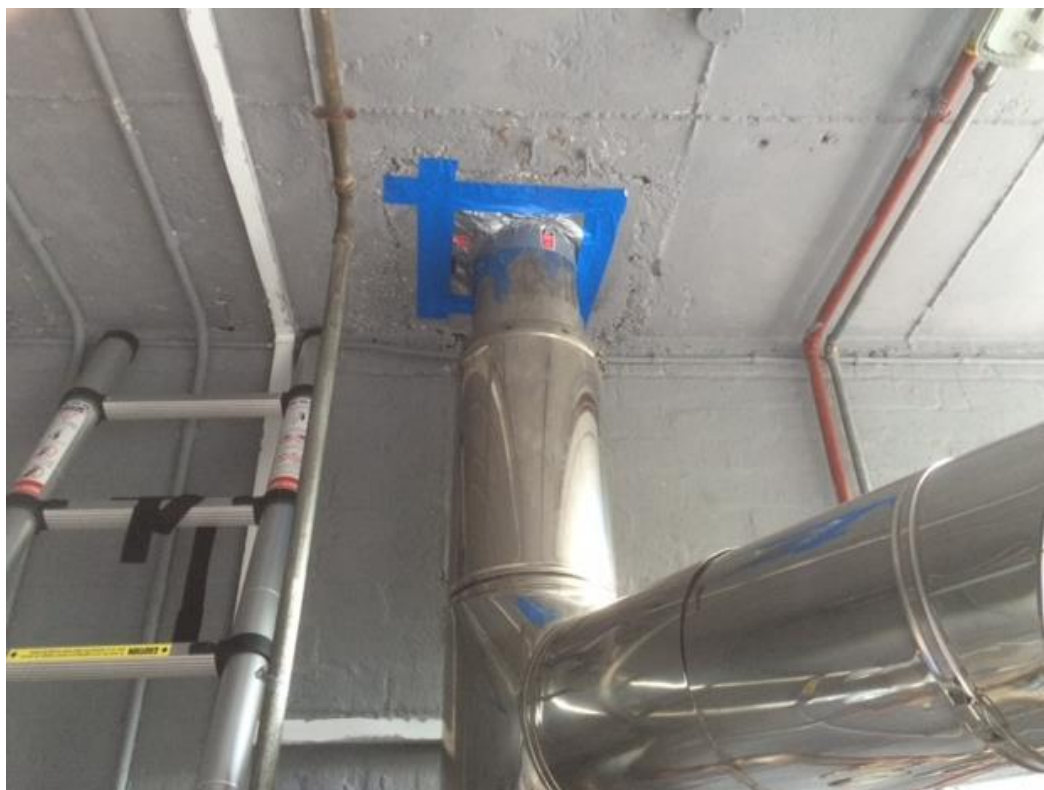
Sample Ref	Description	Location & Extent	Asbestos Type
KA407	Gym Boiler Room - Residues To Flue Penetration Point	Internal Small amounts	Chrysotile Amosite
Material Assessment Score	Priority Assessment Score	Recommendation	
10	2	Remove under fully controlled conditions by a licenced asbestos removal contractor prior to demolition works

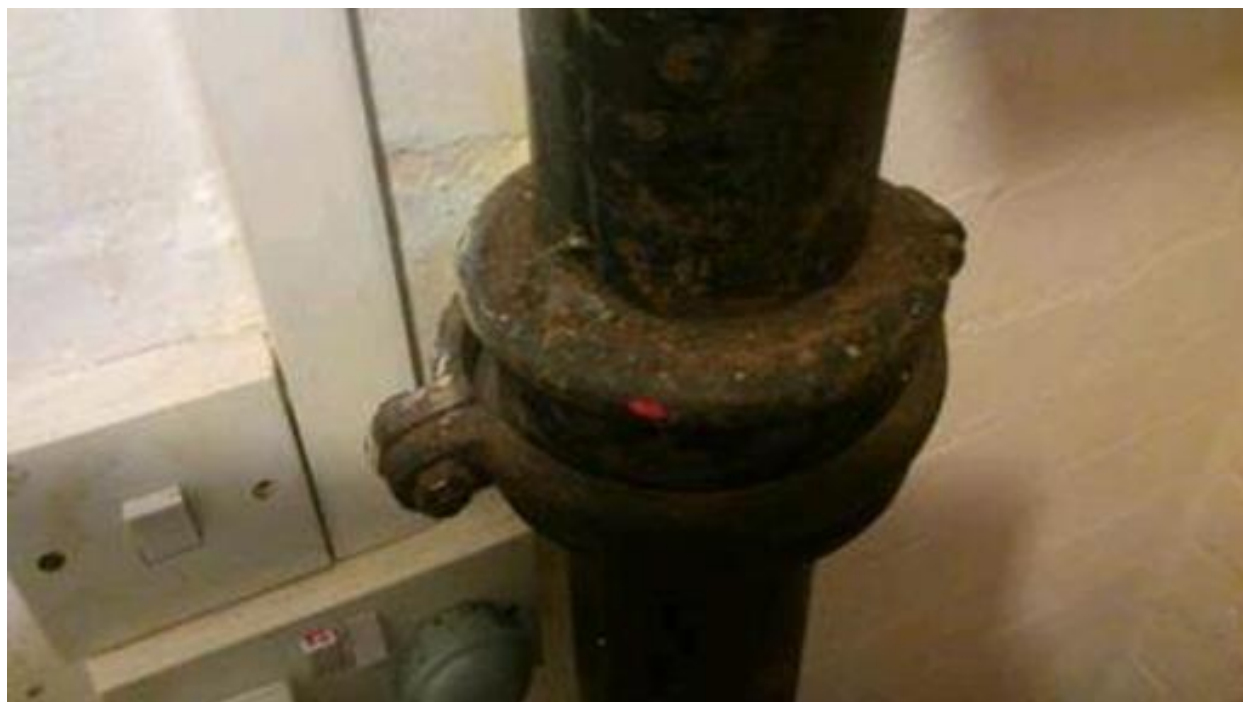
Sample Ref	Description	Location & Extent	Asbestos Type
KA501	Caretakers House - Soil Pipe Packing	Internal Small amounts	Chrysotile
Material Assessment Score	Priority Assessment Score	Recommendation	
10	2	Remove under controlled conditions prior to demolition works

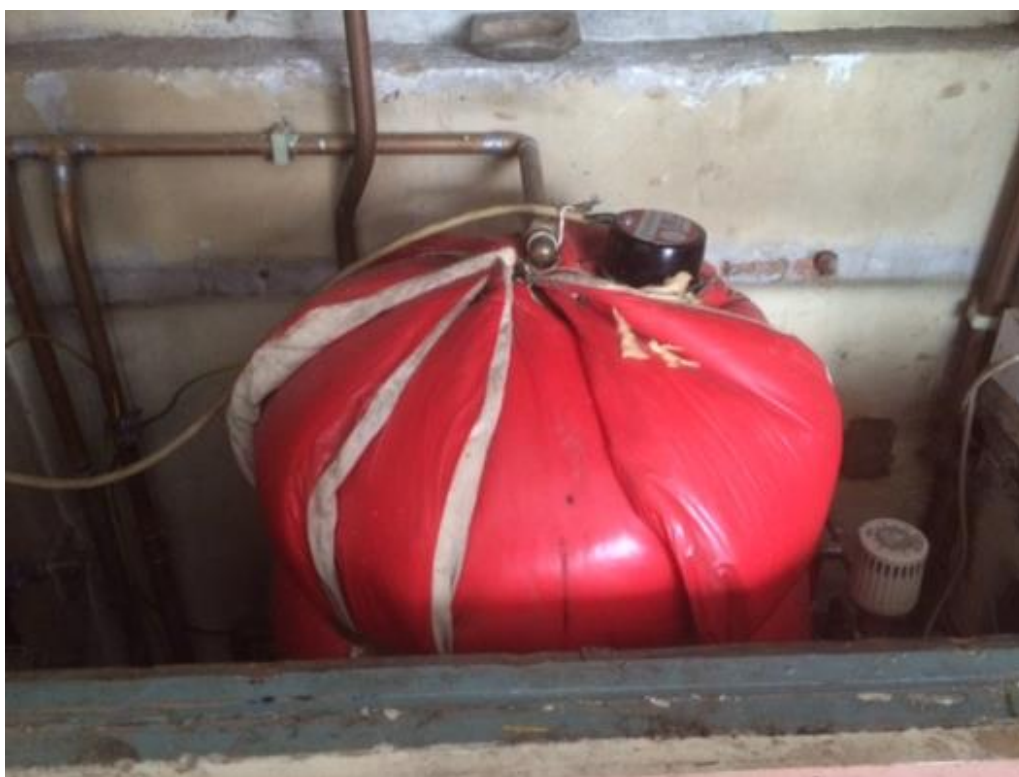
Sample Ref	Description	Location & Extent	Asbestos Type
KA508	Caretakers House - Gasket To Immersion Tank	Internal Small amount	Chrysotile
Material Assessment Score	Priority Assessment Score	Recommendation	
10	2	Remove under controlled conditions prior to demolition works
