# Appendix H

Intrusive investigations and site visit reports

## Arthur Stanley House – Site Visit Report No.01

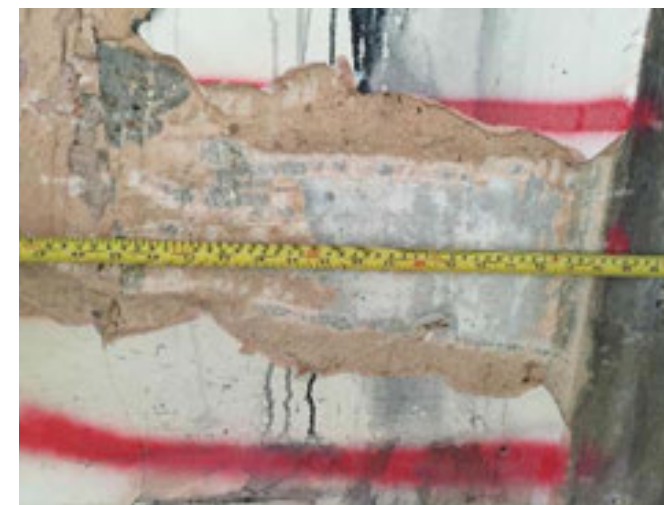
2.1 The column located at the end of the front façade that rises all the way up the building was identified as reinforced concrete. It was also measured from the inside to determine its overall width (see picture below).

2.2 The overall column width was measured to be 1150mm. Reinforcement bars and links are to be exposed and measured by HTS.

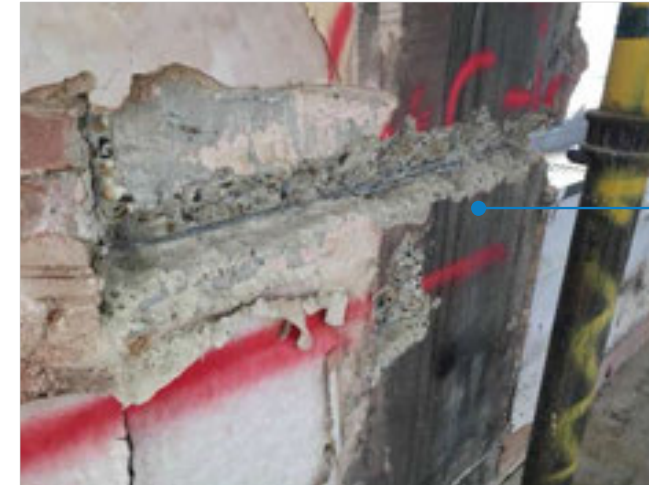
1.1 Reinforcement was exposed on the sixth floor end of façade column. Cover to reinforcement looked very consistent with six longitudinal bars on the inner face.

Confinement of concrete is well achieved with groups of links between main bars

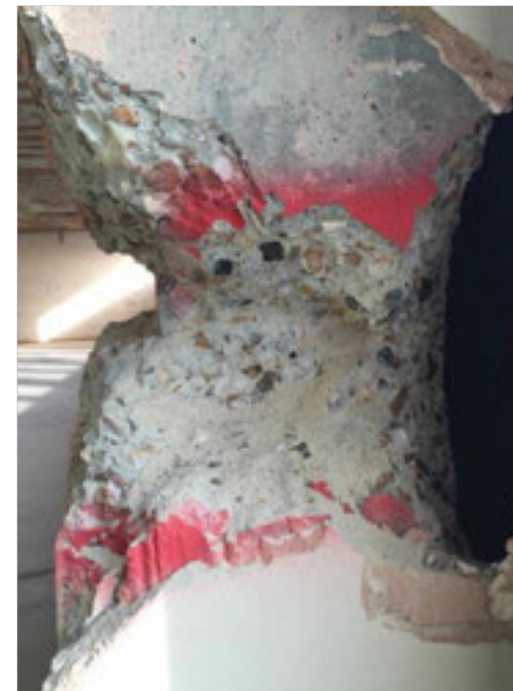
2.3 Column's strength capacity has been highly affected by material removal of most of its sectional area near mid height.

Column is to be repaired following HTS's column repair sequence. See sketch SK009-01.

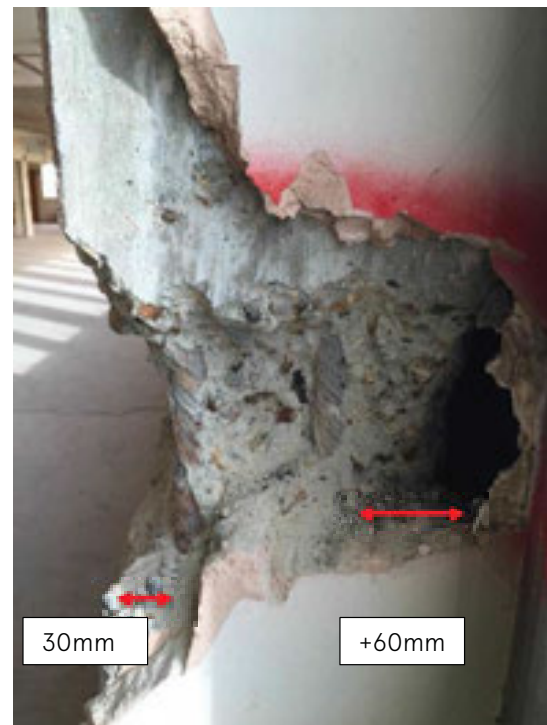
Cover to reinforcement varies significantly on column sides.  
This is due to poor workmanship during construction.

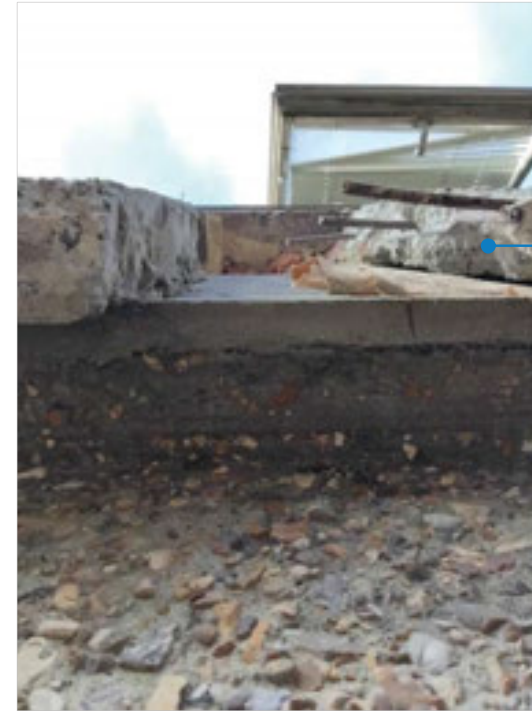
1.4 Rebars within fascia were identified as diameter 6mm plain bars in the downstand and ribbed diameter 6mm within the toe.  
Concrete upstand behind front face.

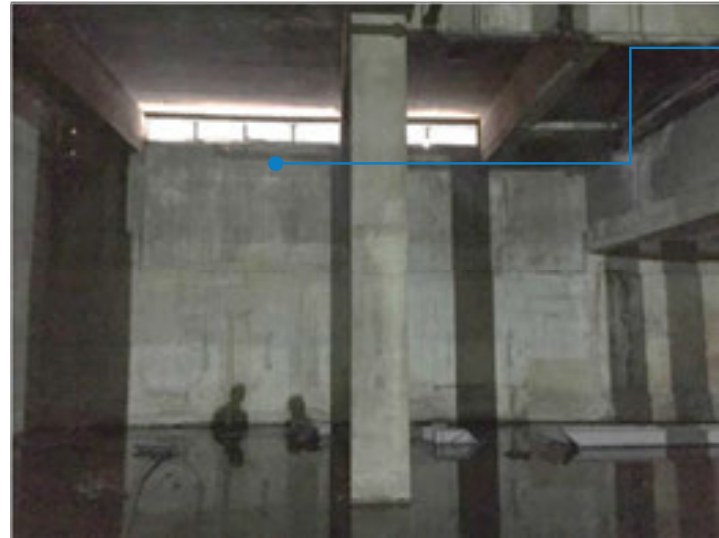
- 1.1 The existing light well is to be lowered down from its current basement level.  
The extent of retention of the existing RC wall at basement level will be determined by the proposed facade line of the residential building.

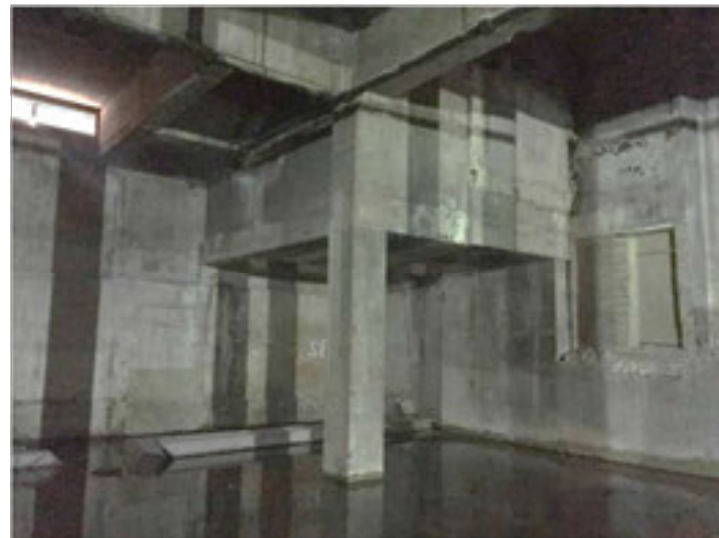
- 1.2 The interface between the residential and office building to be studied in further detail.

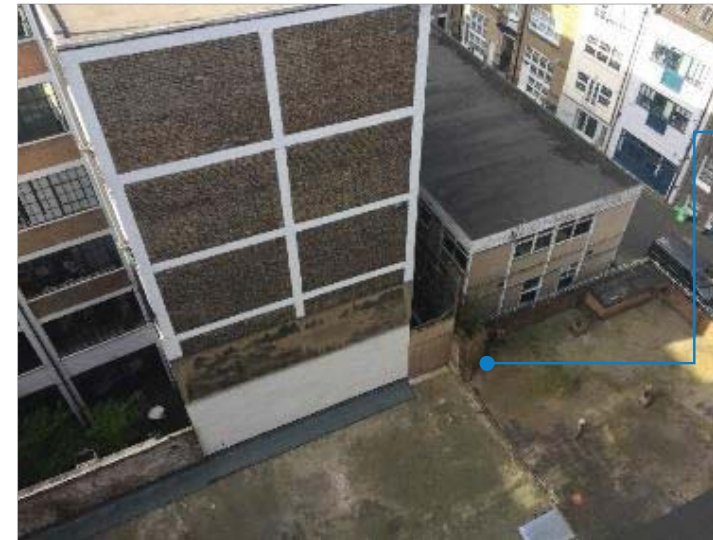
- 2.1 Party wall crossing the site boundary constructed of 440mm thick brick pier.  
Intersection with boundary walls and tying to be studied in further detail to understand demolition sequencing.

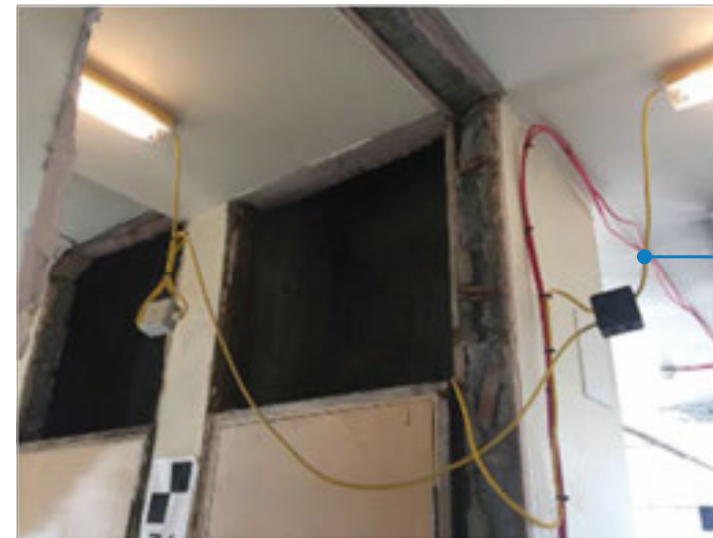
- 3.1 Design team to review the stair core and service riser space requirement for demolition extent coordination.  
There is an existing band beam adjacent to the existing riser that might require full demolition

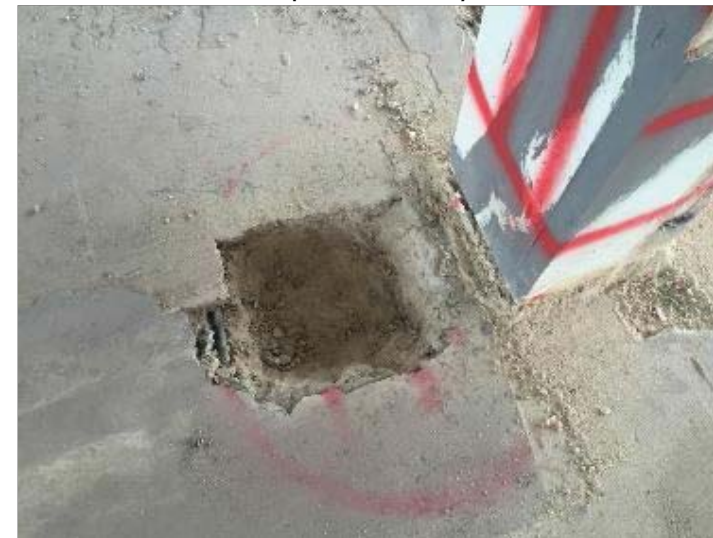
- 4.1 It is recommended that a spot level survey is carried out throughout the building to determine existing slab SSL.  
The screed is bonded to the slab which would make its removal labour intensive and requiring repairs to the structural slab post demo.

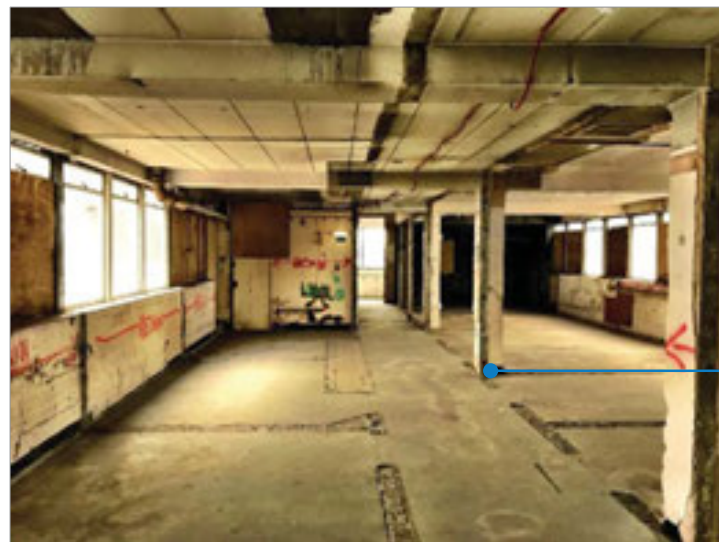
2.01 Existing 7th Floor.

All existing structure is currently proposed to be demolished above 7th Floor. New roof structure – at a higher level than the existing – is proposed to be a concrete filled profile metal deck slab supported on steel beams, which span between steel columns.

On the north elevation and above the central line of the building, steel columns supporting the new roof structure will be in the line of the concrete columns below the 7th Floor slab. Horizontal transfer structures at 7th Floor will therefore not be required.

HTS to update load rundown to take into account new roof structure and accommodation and analyse capacity of existing columns to support new loads.

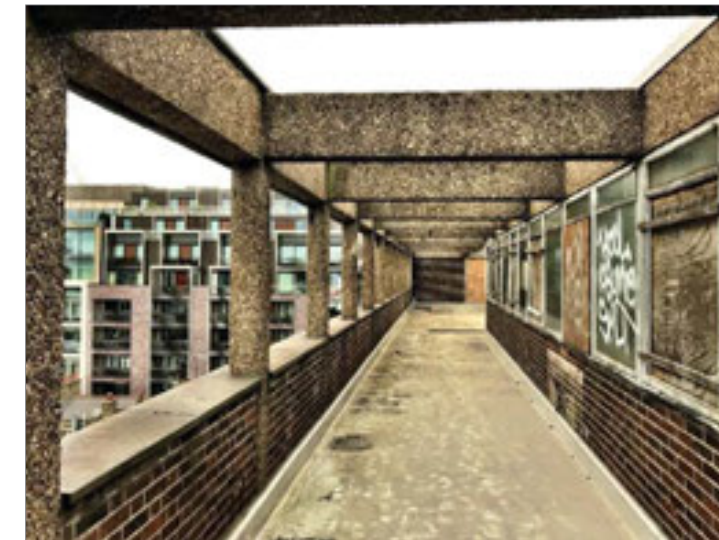
2.02 On the south elevation, the new column line above 7th Floor is proposed to be inboard of the existing facade line below. The steel columns supporting the new roof structure will therefore not be in the line of the concrete columns below the 7th Floor slab.

A horizontal transfer structure at 7th Floor will therefore be required.

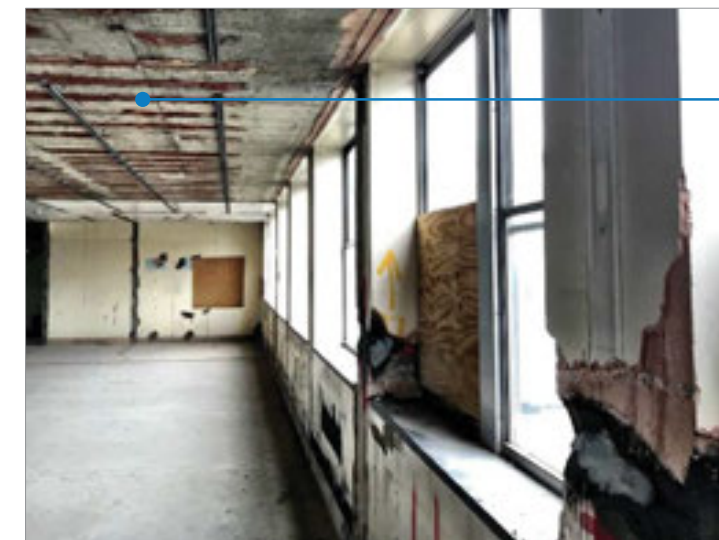
2.03 The existing beam and pot slab at 7th Floor are unlikely to have the capacity to transfer vertical forces from the new column line to the existing column lines.

HTS to investigate capacity of existing beam and pot slab. If the slab does not have capacity to transfer loads, HTS to develop options for a proposed transfer structure.

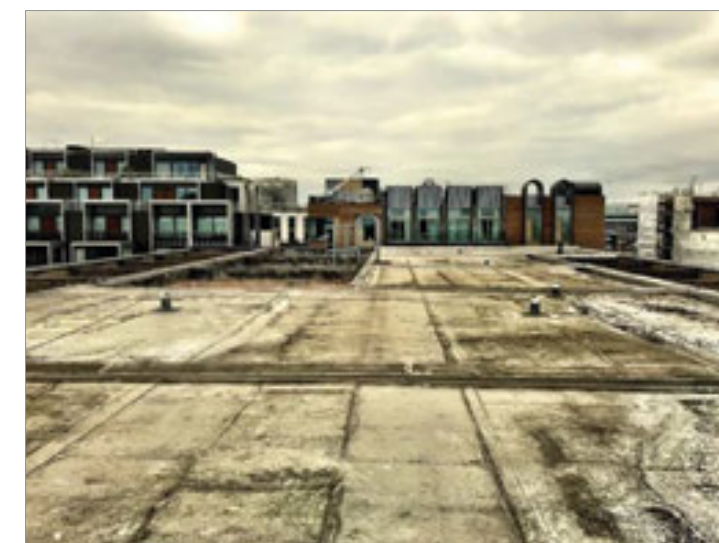
2.04 Existing roof slab. This appears to be precast concrete floor slab units supported on in situ concrete beams.

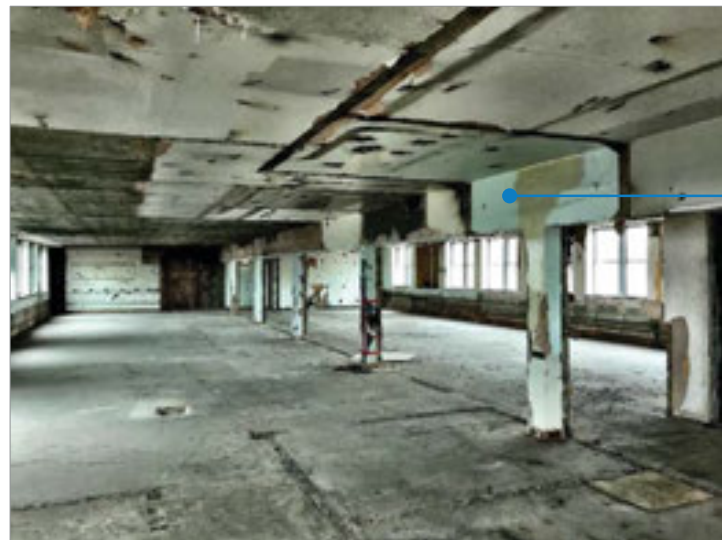
2.06 Central line of columns and downstand beams - 650mm below slab soffit - on a typical floor.

It is currently proposed to demolish the existing downstand beams and replace these with steel downstand beams either side of the existing concrete beam line. It is currently envisaged that the steel beams will be installed prior to the demolished of the concrete beam to avoid temporary works.

The steel beams are currently proposed to be 203UC sections. Based on typical rules-of-thumb, it should be possible to form service penetrations up to 100mm deep through the webs of these beams.

HTS to discuss the feasibility of this demolition methodology with demolition contractor.

HTS to develop beam support detail.

GBuild to provide typical maximum dimensions of required services passing across the central column line. HTS to investigate whether these can pass through the currently proposed beam webs or whether a deeper beam will be required.

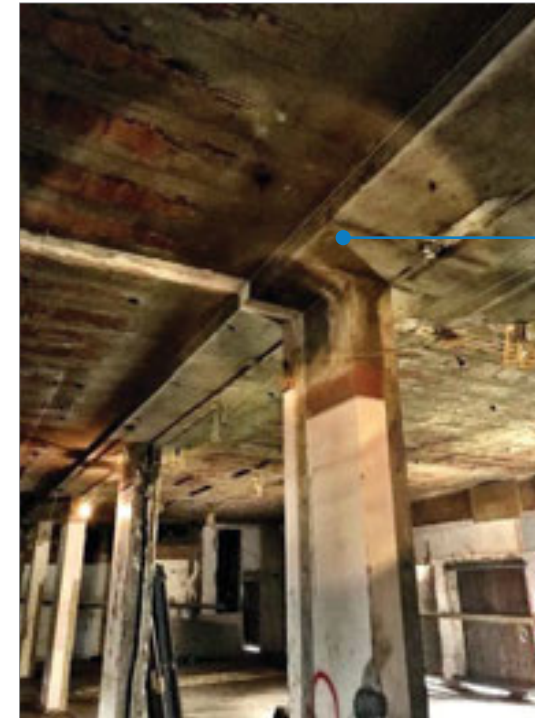
2.07 At high level Ground Floor, the down stand beam is approx. 200mm below the slab soffit. The distance between the Ground Floor SSL and the beam soffit is therefore approx. 3.65m. It may therefore not be necessary to remove this beam and replace with steel beams.

AHMM to confirm.

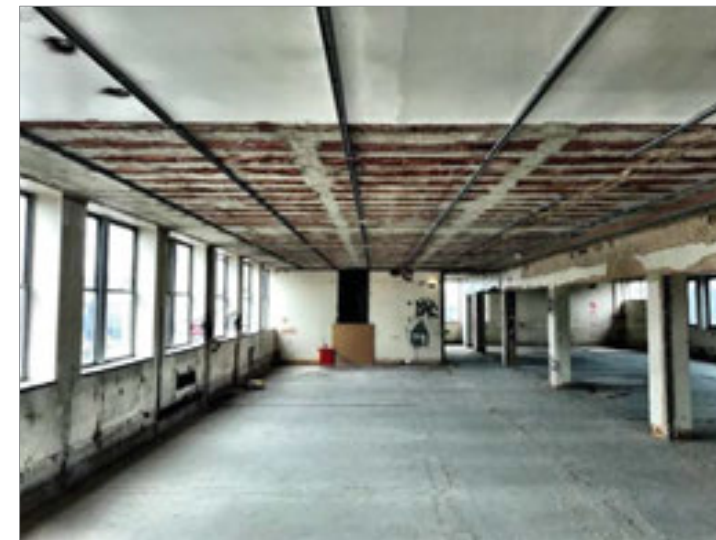
2.08 Existing concrete structure on typical floor.

Based on advice from Fire Risk Solutions, the required fire resistance period for the existing structural elements is 90mins.

Based on guidelines set out within BRE Report 128 *Guidelines for the construction of fire-resisting structural elements*, the existing structural elements have the following fire resistance periods:

- Slabs - 90mins
- Beams - 60mins
- Columns - 60mins

To attempt to increase the above figures HTS to research the fire design approach in the concrete design code that was current when the building was constructed and confirm the fire resistance periods for which the structure would appear to have been designed.

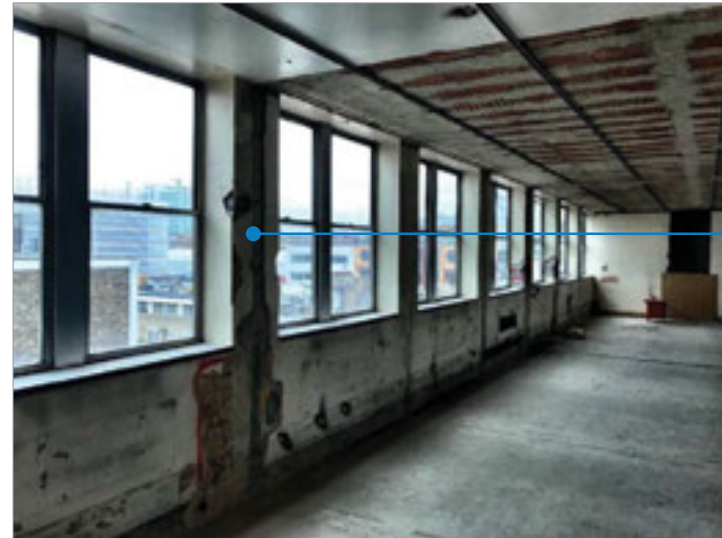
2.09 Existing column line on north elevation of building.

Every second existing concrete column is proposed to be removed. The upstand spandrel beams within the masonry façade will also be removed.

Downstand steel beam will be installed under the concrete slabs at every level to transfer slab loads back to the retained columns.

Downstand beams are currently proposed to be installed within the existing column line. This would require temporary works to prop the slab between the demolition of the columns and the installation of the beams.

Strengthening is currently proposed to column on the north elevation up to 4th Floor.

HTS to investigate fixing downstand steel beams into the southern faces of the columns to avoid temporary propping.

As per Item 2.01, HTS to update load rundown to take into account new roof structure and accommodation and analyse capacity of existing columns to support new loads and confirm extent of column strengthening.

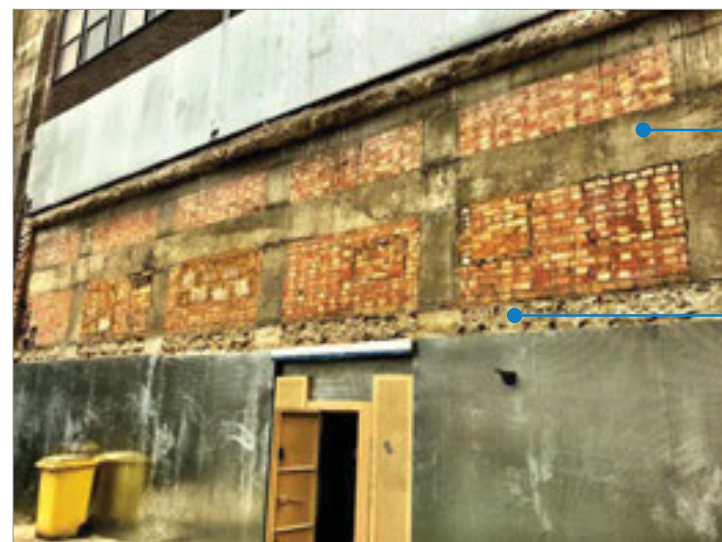
2.10 External face of north elevation of the building above Ground Floor.

It is possible that the existing Ground to 1st Floor columns have been designed as restrained by the slab embedded in the wall at the level of the roof of the previous structure on the Ground Floor slab.

HTS to scope additional intrusive investigations arrangement of reinforcement in columns at the previous roof level.

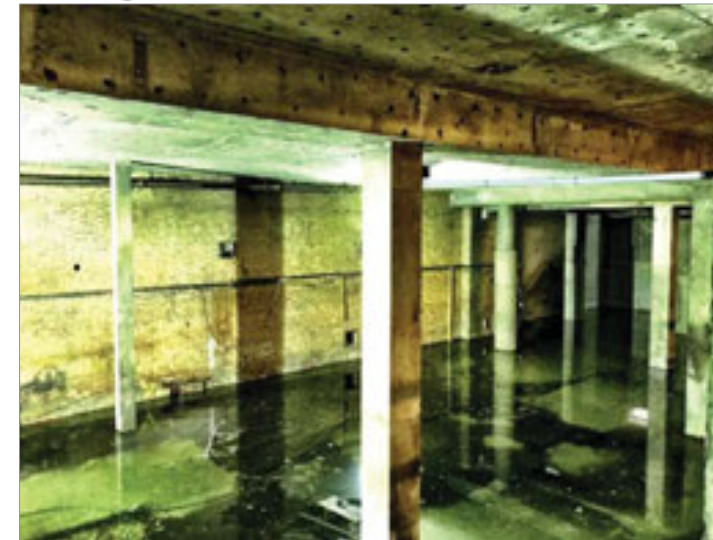
3.01 Retained Ground Floor slab and supporting beams and columns at the north of the site at high level basement.

It is currently proposed to demolish all existing structure to the inner face of basement walls and slab.

HTS to circulate concept sketch of proposed structure if slab, beams and columns are retained to Ground Floor. Loads from columns in office grid above Ground Floor will need to be transferred to existing columns below Ground Floor.

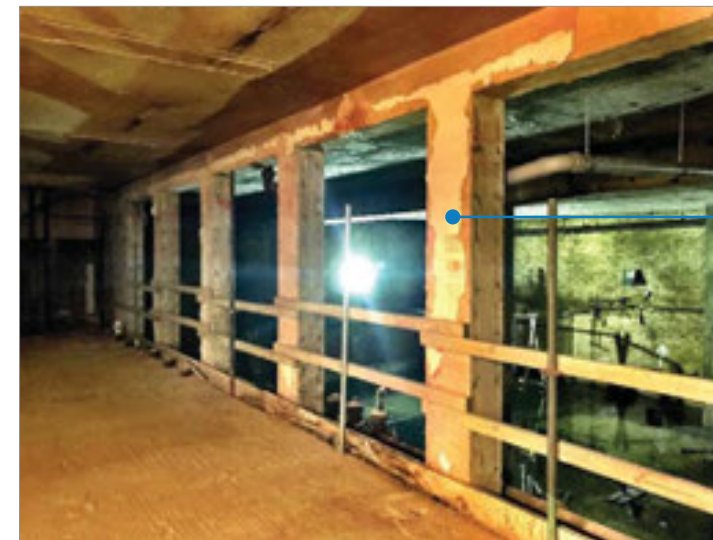
3.02 Existing columns below Ground Floor at northern elevation of existing building.

It is proposed for diagonal struts between Ground Floor and Basement 2 to transfer forces from columns above to existing foundations at Basement 2.

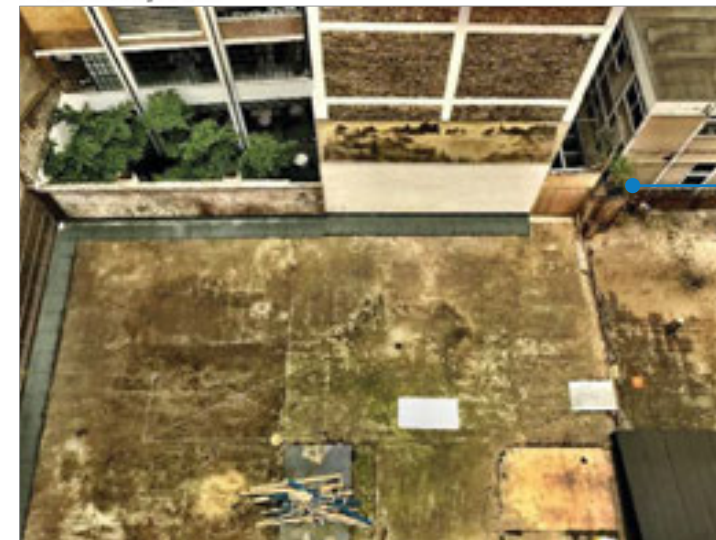
4.01 Top of Ground Floor slab to the north of the site.

Boundary wall with UCLH day hospital on Tottenham Mews.

Dog leg in wall above Ground Floor slab.

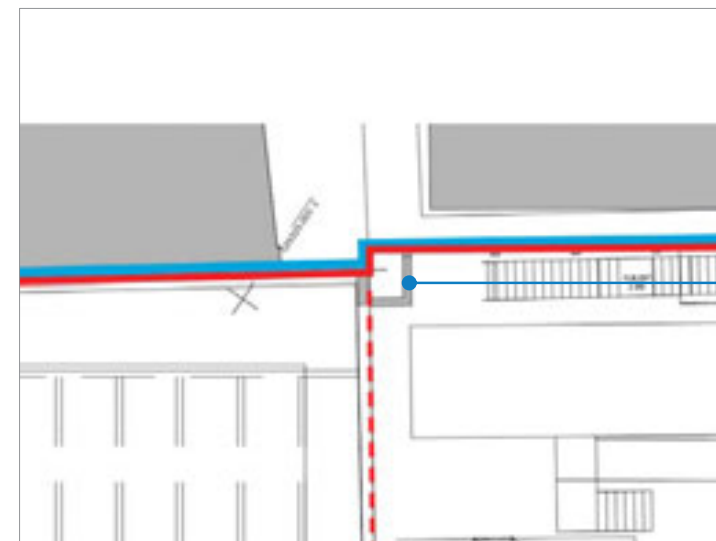
4.02 Red line boundary for development.

Dog leg in wall is within site boundary.

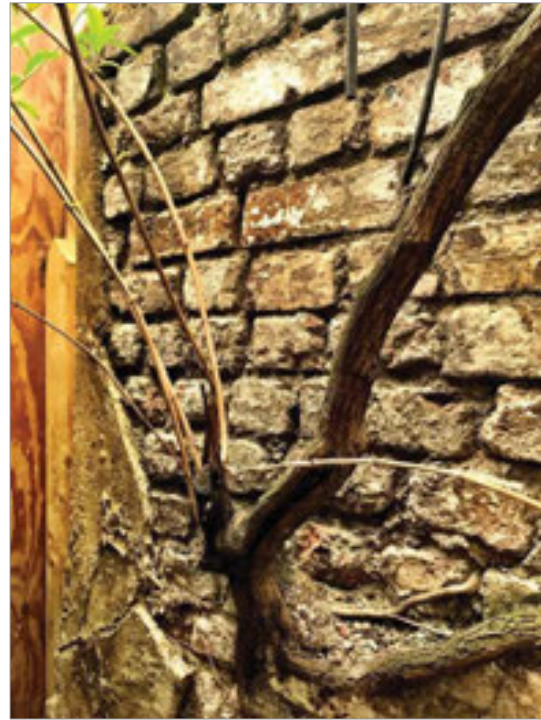
4.03 Face wall above Ground Floor slab. Wall appears to be constructed of solid masonry in an English bond.

The masonry wall is supported on what appears to be an RC upstand beam that lines up with a step in the Basement wall below.

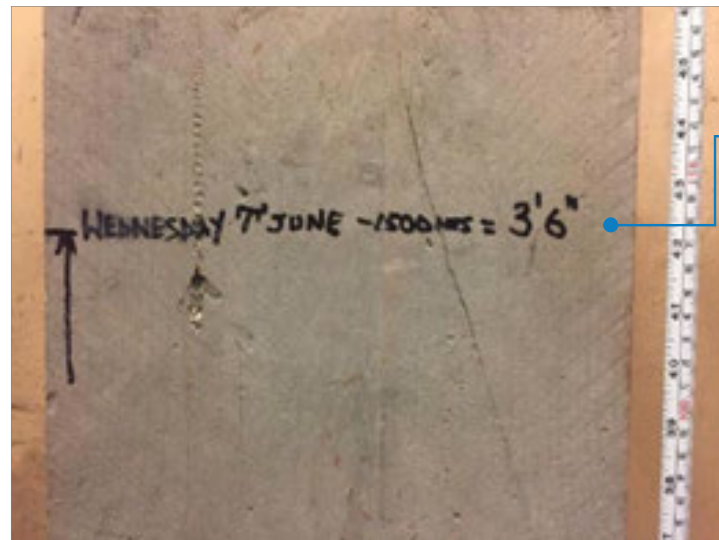
2.1 The maximum groundwater level was measured on the 7<sup>th</sup> of June just before dewatering started.

The level of water was recorded at 1065mm above basement slab level.

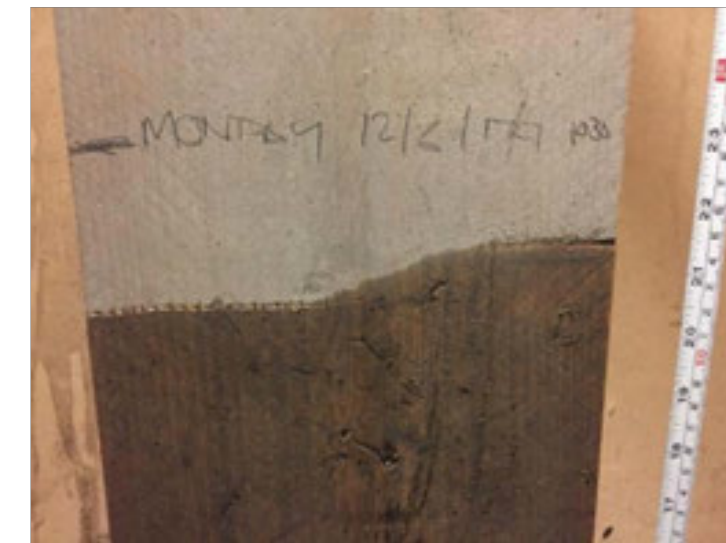
2.2 Measurements were undertaken on Wednesday the 14<sup>th</sup> of June and the approximate water level was recorded at 520mm from basement SSL level.

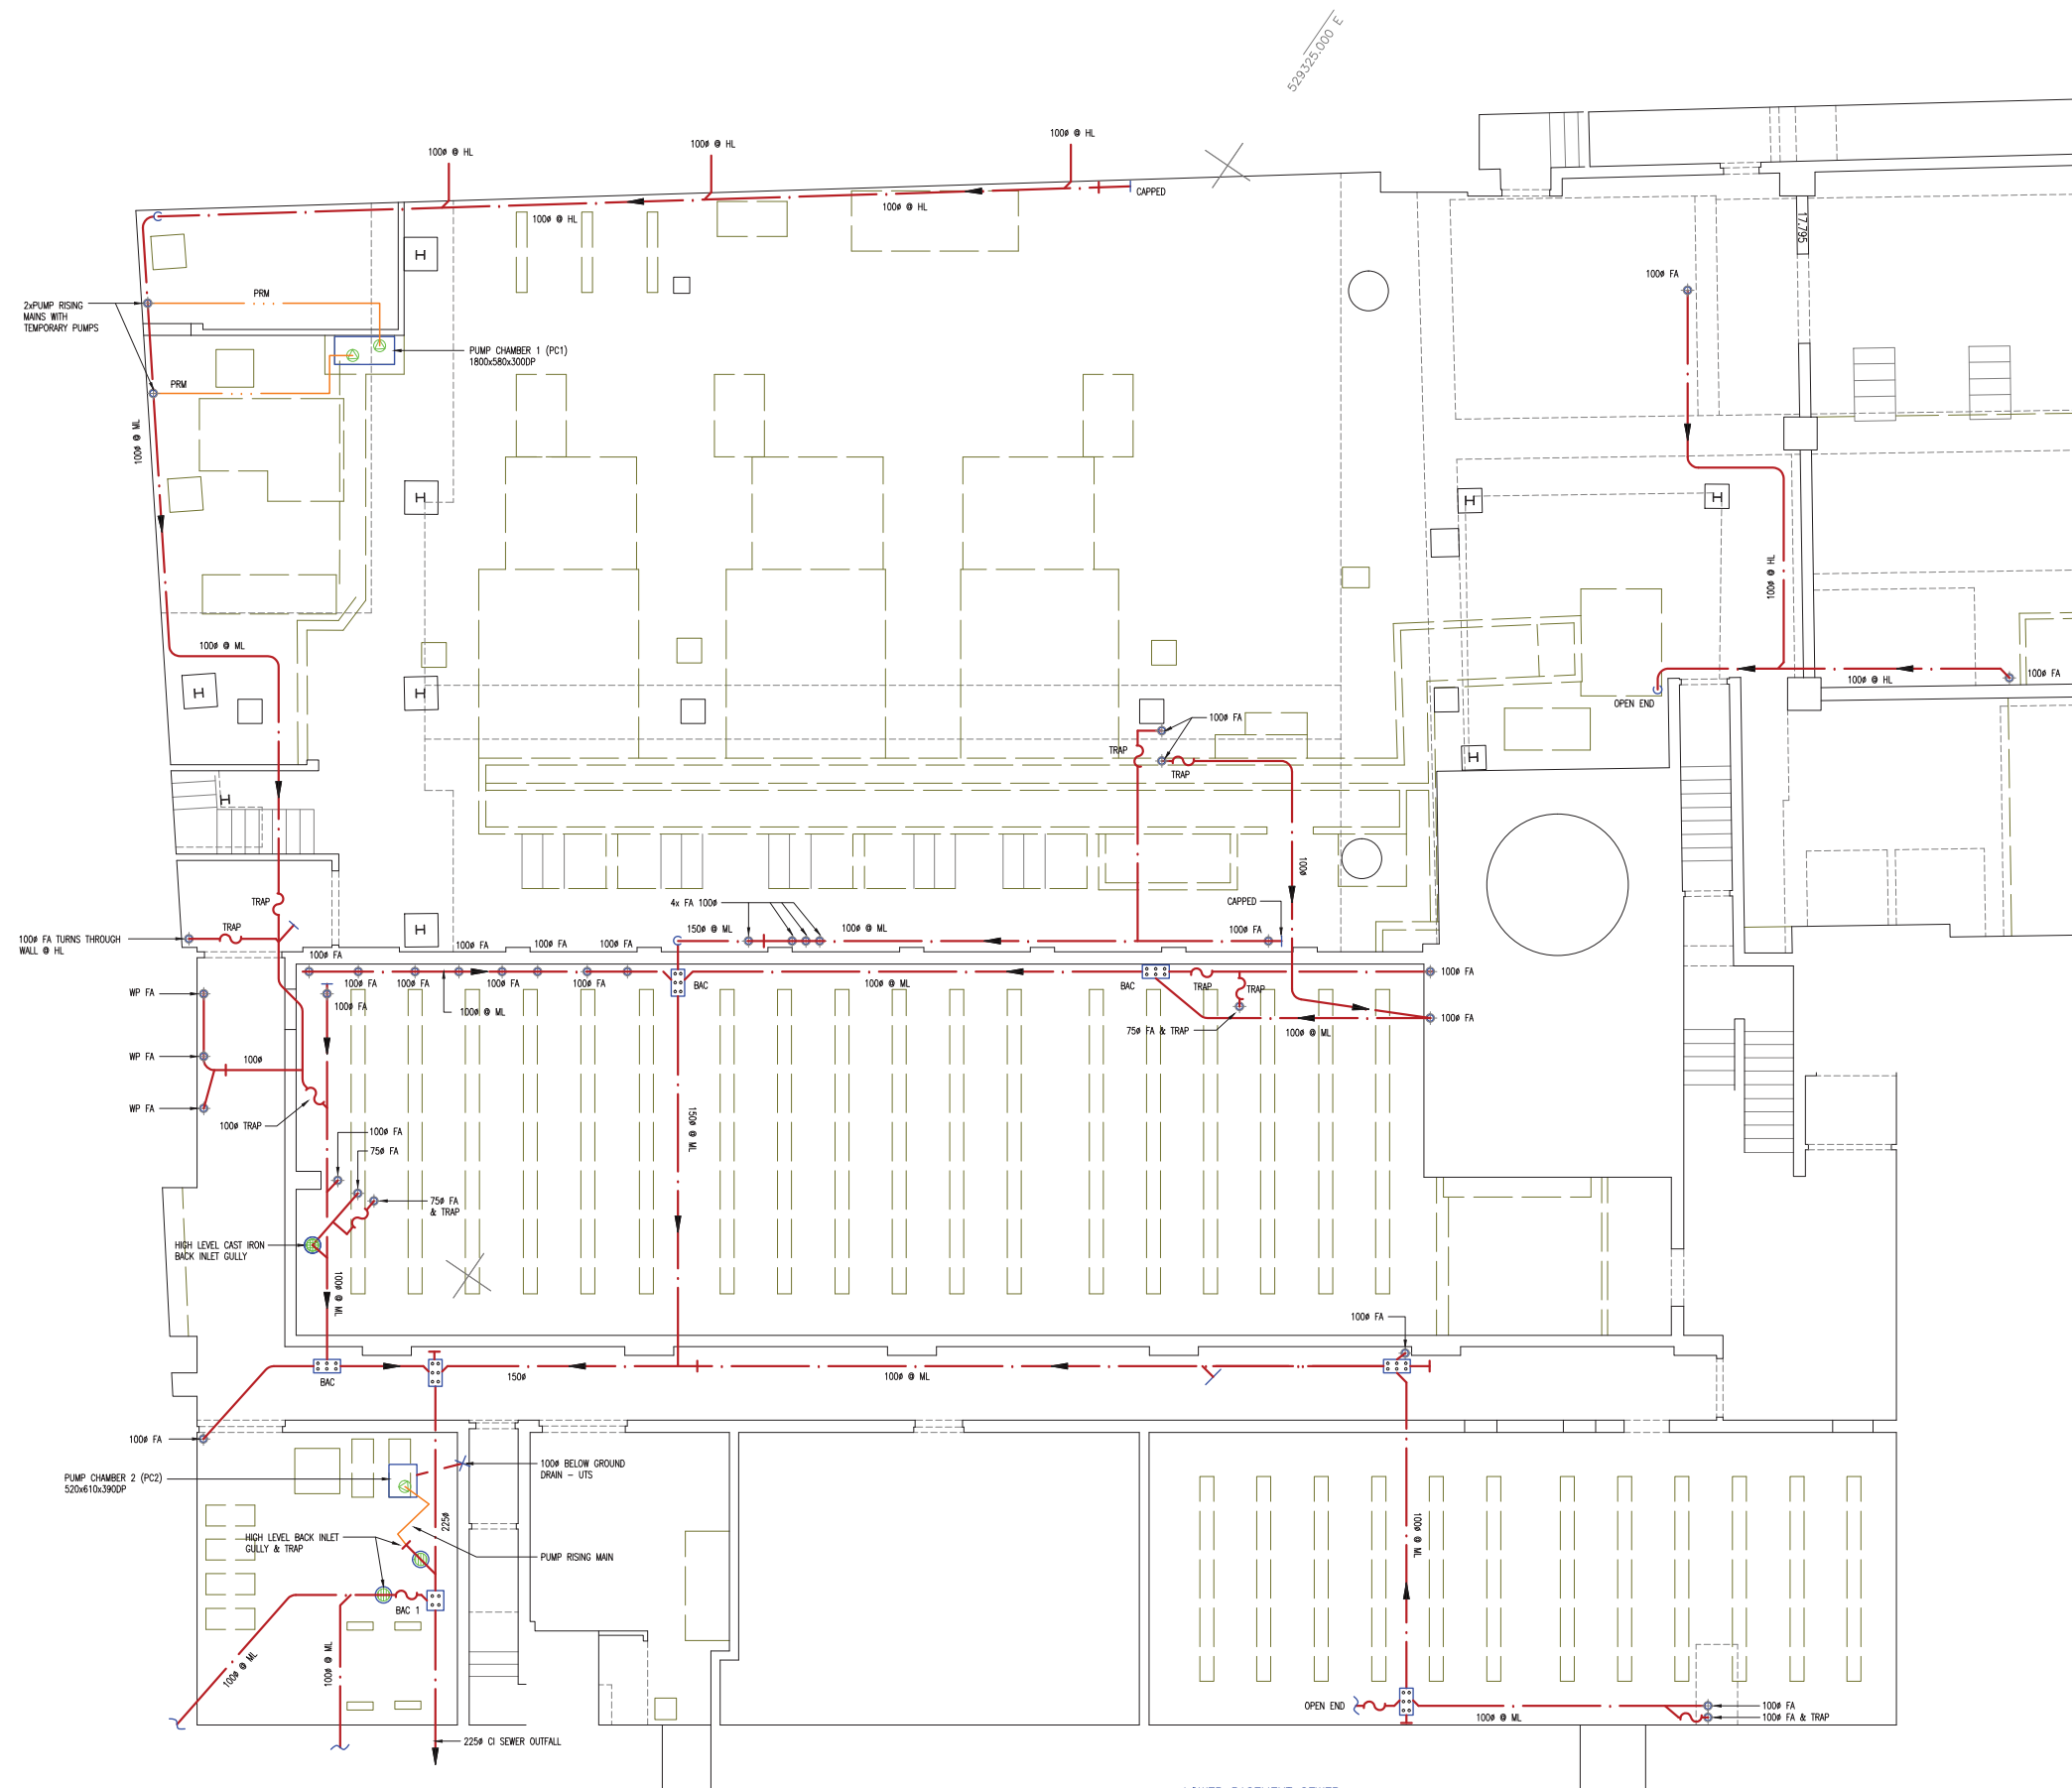
LOWER BASEMENT SEWER  
OUTFALL DETAIL

The 225dia cast iron sewer outfall was the only section of pipework CCTV surveyed and is in a fair condition, free flowing and with no structural defects noted.
