**Project**  
Goodenough College  
47, Mecklenburgh Square, London  
WC1N 2AD

**Drawing Title**  
Existing Balcony Details

Drawing number 17023-CBP-XX-XX-DR-A-0002 P04  
Revision

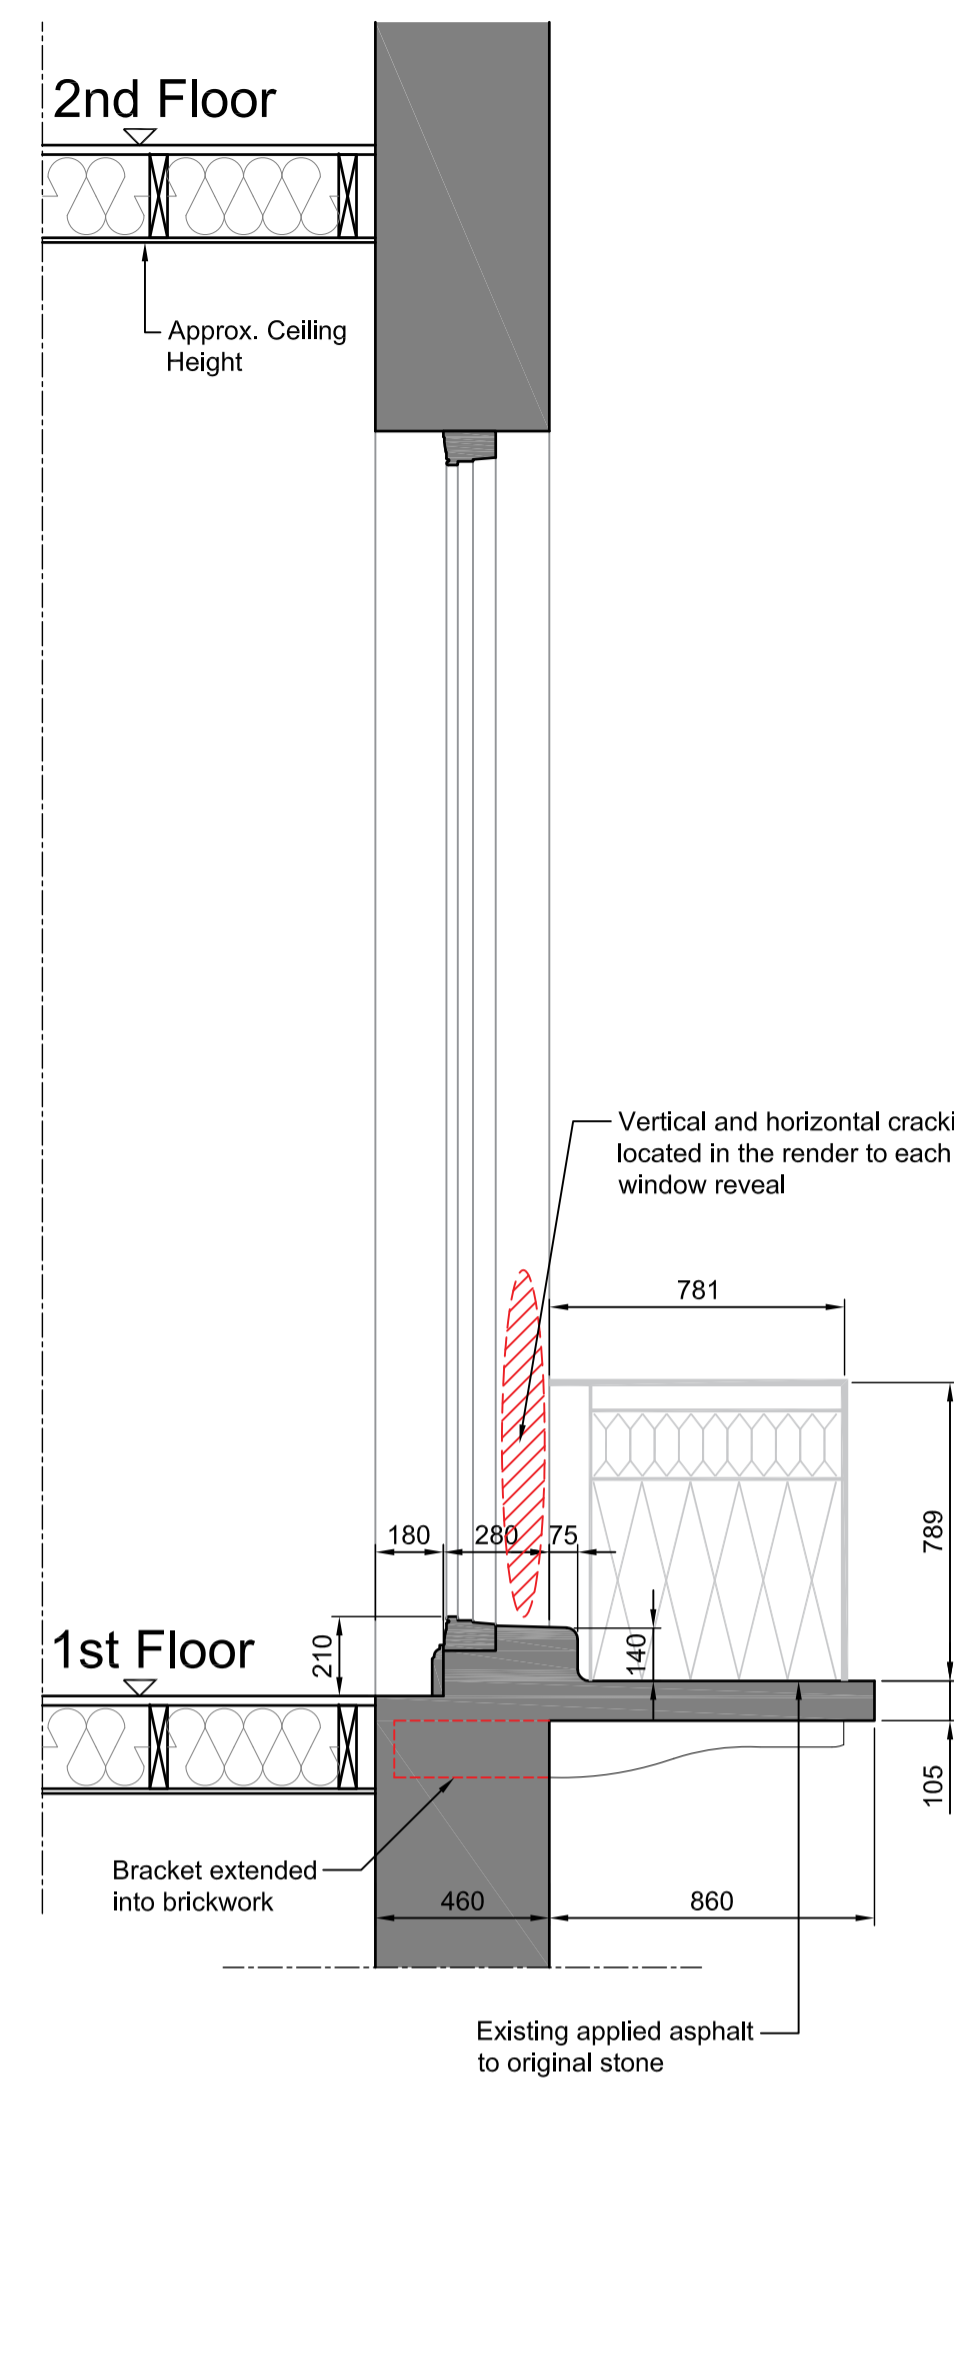
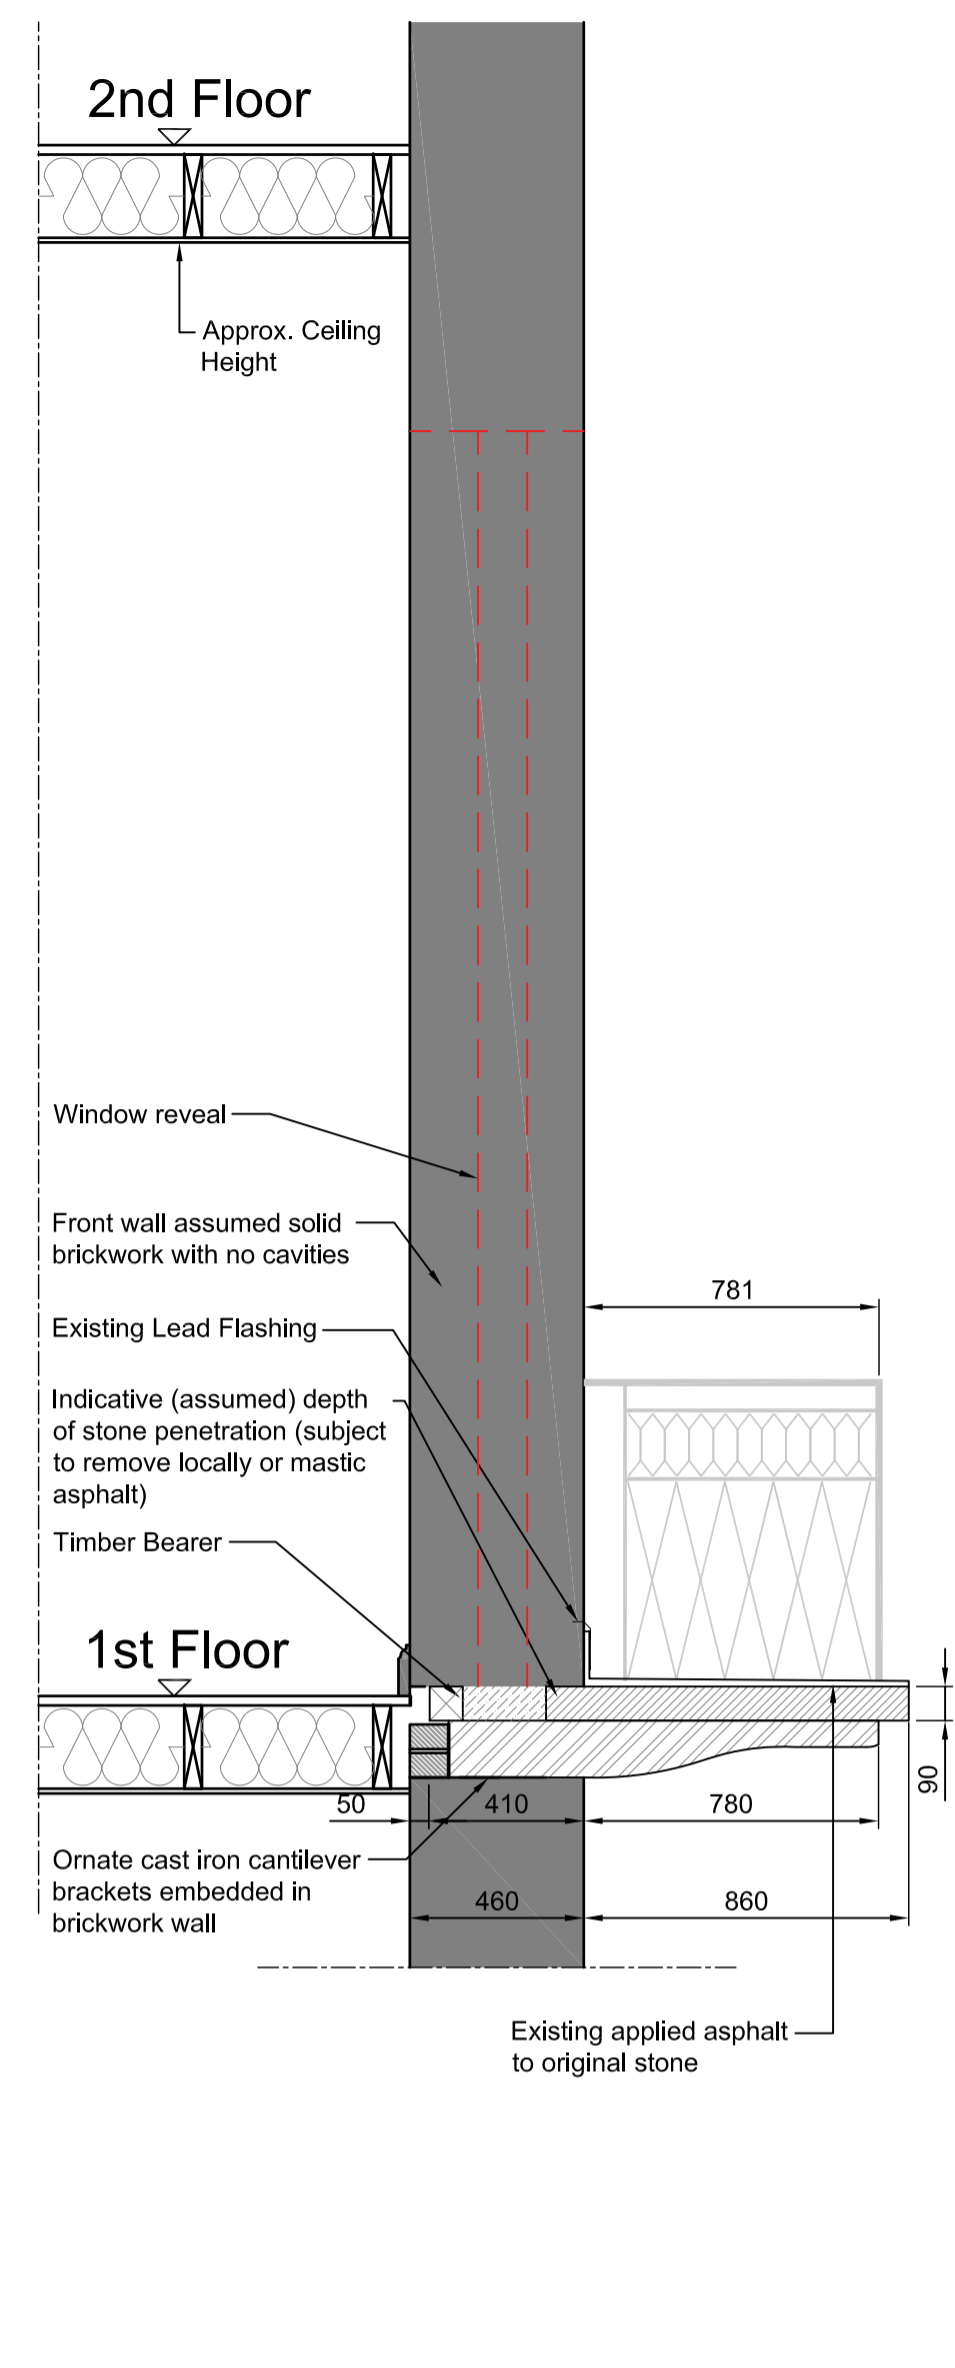
**Cast Iron Brackets**  
6no. ornate cast iron cantilever brackets solidly built into the front wall. The brackets project approximately 780mm out from the wall and are built up to 50-60 mm back from the inner face of the brick wall. The inner face and outer face of the brackets have surface corrosion and sitting directly above the cast iron brackets internally is a timber bearer.

**Stone Slab**  
The brackets are arranged so that two brackets support a stone slab which spans between them and cantilever 385 - 440mm at each end, giving three stone slabs with two butt joints along the length of the balcony. The slabs are 90mm (approx.) thick. It is not clear how far they are embedded into the front wall of the property, but it could be up to 225mm.

**Balcony Finish**  
The slabs are currently finished with mastic asphalt although this is considered to be a later addition and not original. It presents minor cracking which may be allowing water penetration. Vegetation is growing around the edge of the stone slabs and the underside of the stone slabs have flaking and missing paintwork.

**Front Wall**  
Is constructed using London common brick from first floor upwards, it is assumed to be formed by solid brickwork with no cavities, with ashlar stone facings at basement and ground floor levels. A prominent stone string course is located just below 3rd floor window level. There are existing historic windows repairs above the lintel head to the brickwork panel.

**Windows**  
Tall sash windows have an outer reveal in the facing brickwork which 280mm deep and an inner reveal that is approximately 200mm deep and set 160-175mm inside the outer reveal. The junction between the asphalt and the window frames presents a gap which will allow water penetration. Also the render to each window reveal has horizontal and vertical cracking.
