# GRENVILLE STREET

EXISTING OFFICES MARKETING STATEMENT  
FOR PLANNING APPLICATION

**STRUCTURAL SURVEY**

**11-12 GRENVILLE STREET  
LONDON  
WC1N 1LZ**

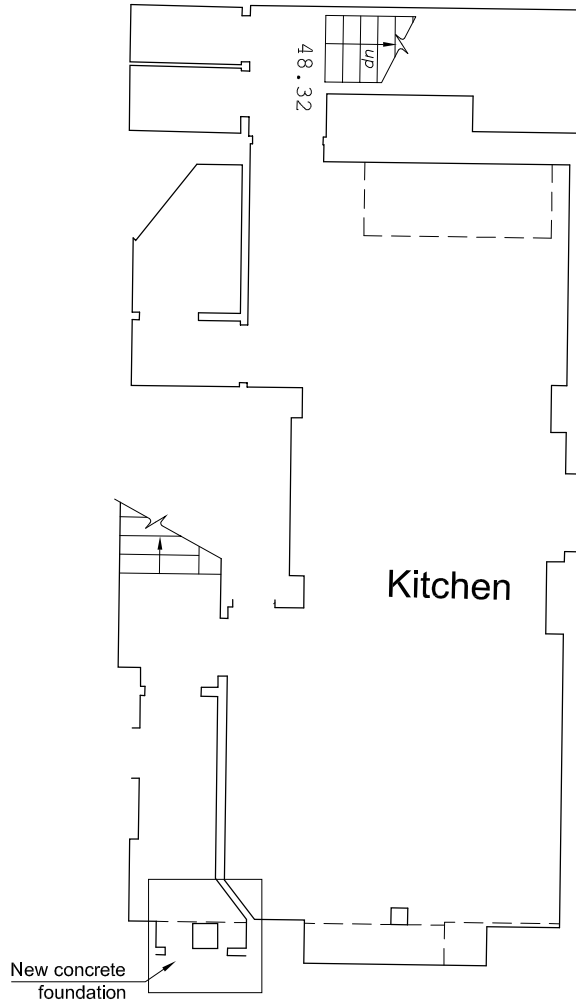
**Basement Floor  
Plan**

TYPICAL STRENGTHENING TO IMPROVE RESISTANCE TO  
DISPROPORTIONATE PROGRESSIVE COLLAPSE, IMPROVE INHERENT  
INSTABILITY DUE TO OPEN GROUND FLOOR AND PROVIDE  
ADDITIONAL LATERAL AND LONGITUDINAL STABILITY
