Summary Of Structural Assessment And Strengthening Works Required

project name		9 Denmark Street	
sketch title		Proposed Structural Details	
date		15.09.2017	
project no	sketch no	rev	by
879	Z3-S-100.0	-	RK

project name		9 Denmark Street	
sketch title		Proposed Structural Details	
project no		879	
sketch no		Z3-S-100.1	
date		25.08.2017	
rev		-	
by		RK

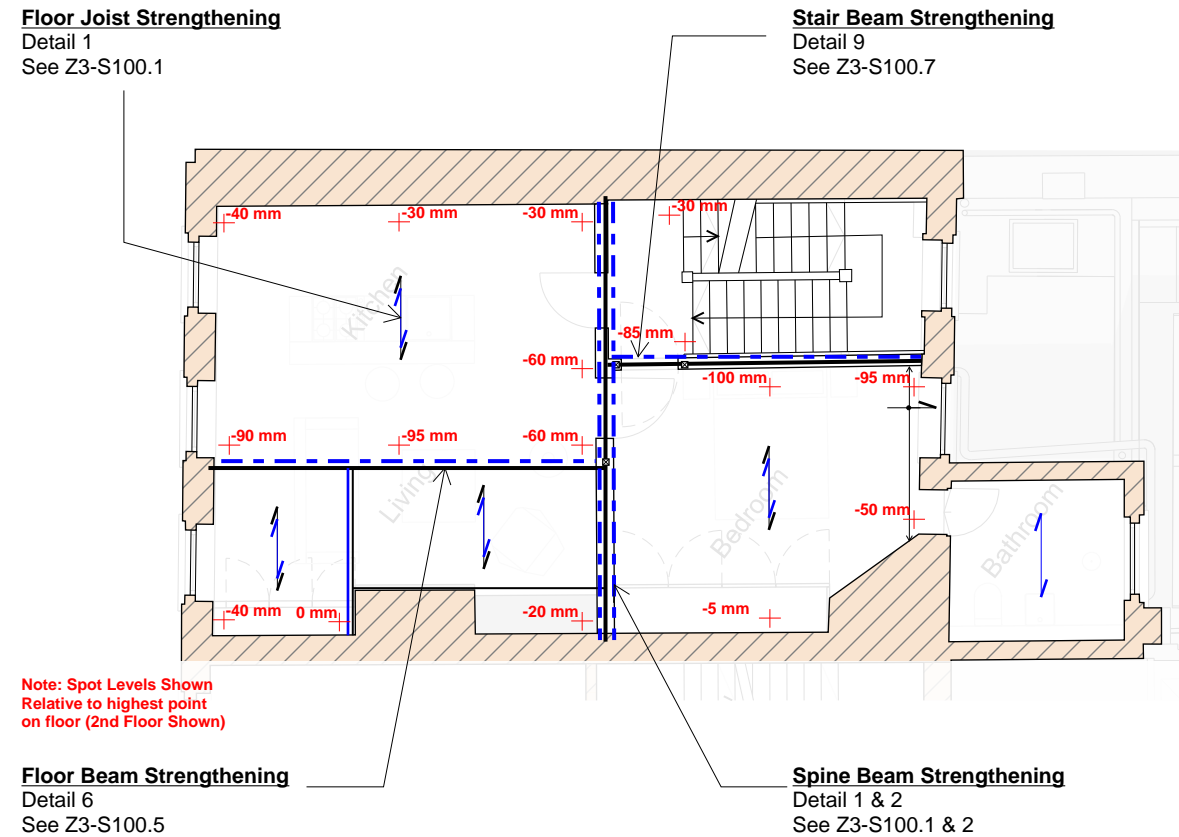
The spine wall has been re-supported at 1st floor level on a 203UC steel beam, from analysis this beam is insufficient to support the full height of spine wall and floor beams above so the existing timber floor beams at each level have been assessed.

Bending Stresses @ 230% capacity => strengthening required
 Deflection @ 200% limit => strengthening required

The existing floor joists vary in both depth and width, typically they are 160x60 at 380 c/c. They have been assessed for their maximum span.

Bending Stresses @ 98% capacity
 Deflection @ 160% limit => strengthening required

From survey spot levels the existing floor structure has settled/deflected by up to 100mm at each floor level. Strengthening Works are required to ensure to further settlement occurs

Existing timber spine wall beams to be strengthened with pairs of PFC steel beams - through bolted to spine beam with pairs of bolts at 600mm c/c

Existing joists to be strengthened with 200x50 C24 timber joists - bolted together at 400mm staggered c/c

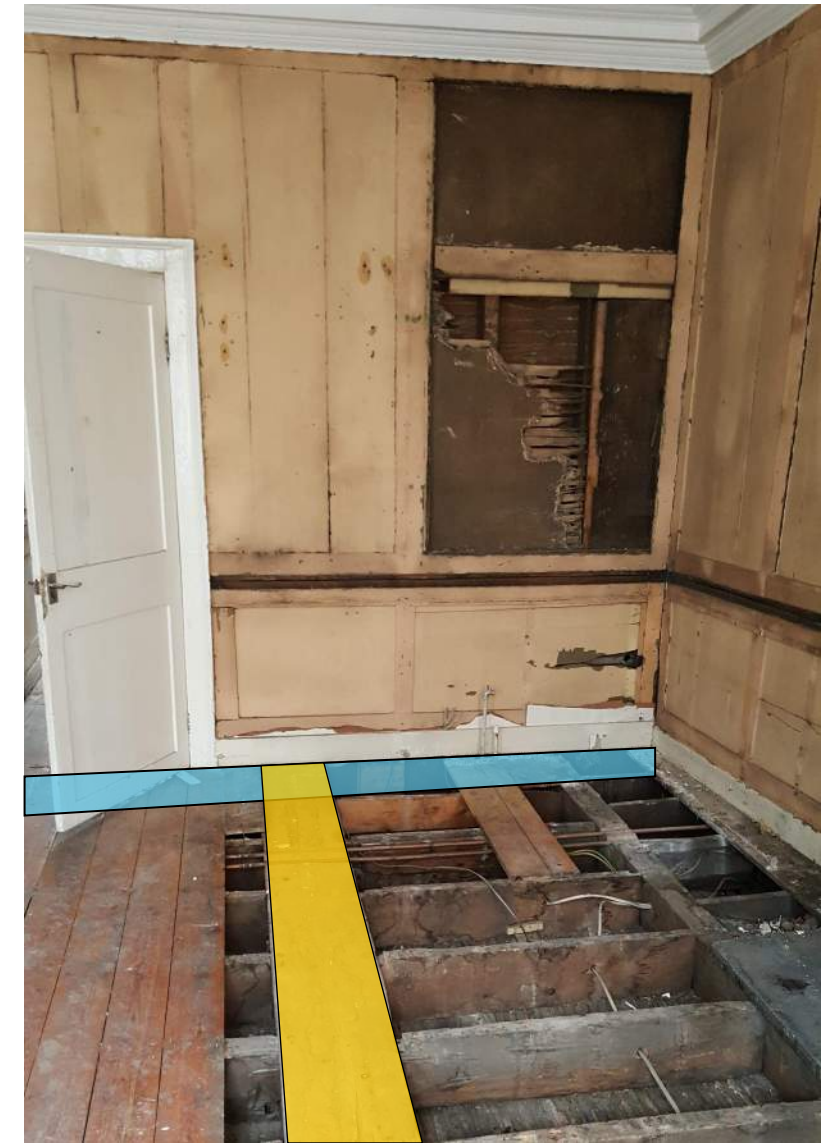
Figure 4, Floor Beam To Be Re-supported

- The strengthening is required to the bearing of the floor beams to justify the connection for required residential loadings to current standards
