CCTV REPORT

CLIENT	RANDALL SURVEYS LLP
LOCATION	CAMLEY STREET
DATE	26/05/2017
REF	071082
DVD No	001

071082 CAMLEY STREET LONDON - CCTV Survey Report : 28/05/17

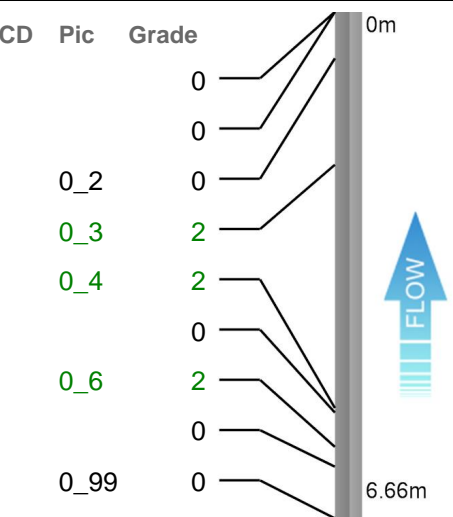
Position	Code	Description	CD	Pic	Grade
00.00m	MH	Start node type, manhole			0
00.00m	WL	Water level 0%			0
00.61m	JN	Junction 6 : 150mm Diameter	0_2		0
02.01m	OJM	Open joint medium	0_3		2
05.21m	OJM	Open joint medium	0_4		2
05.27m	LRQ	Line of drain/sewer deviates right [quarter]			0
05.72m	OJM	Open joint medium	0_6		2
05.98m	LLQ	Line of drain/sewer deviates left [quarter]			0
06.66m	SA	Survey abandoned	0_99		0

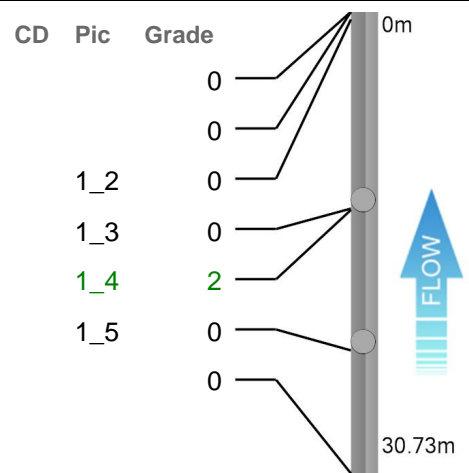
Position	Code	Description	CD	Pic	Grade
00.00m	MH	Start node type, manhole			0
00.00m	WL	Water level 5%			0
00.50m	JN	Junction 6 : 150mm Diameter	1_2		0
13.10m	CN	Connection other than junction 12 : 100mm Diameter	1_3		0
13.19m	CC	Crack, circumferential 1-5	1_4		2
22.54m	CN	Connection other than junction 12 : 100mm Diameter	1_5		0
30.73m	MHF	Finish node type, manhole			0

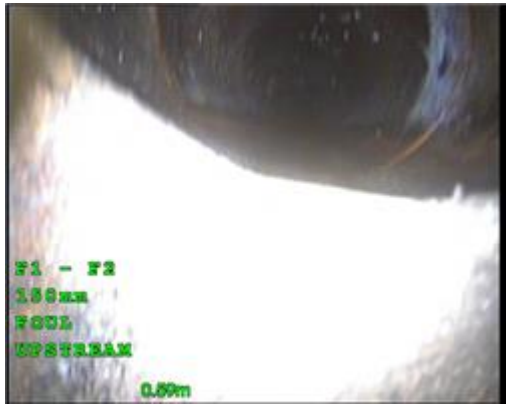
Pos	Code	Description	Image
00.00m	MH	Start node type, manhole F1	
00.00m	WL	Water level: 5% Height/Diameter	
00.50m	JN	Junction at 6 o'clock: 150mm Diameter BACKDROP	<p>Image Provided - Ref: 1_2</p>

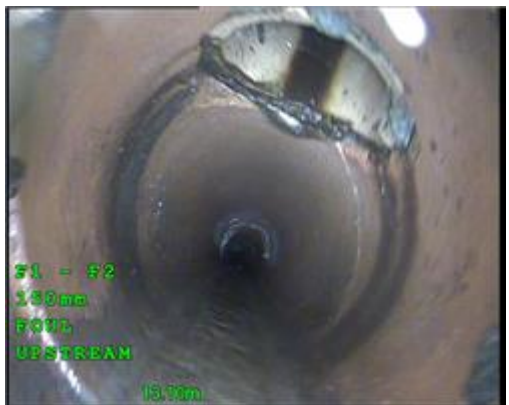
13.10m	CN	Connection other than junction at 12 o'clock: 100mm Diameter	<p>Image Provided - Ref: 1_3</p>

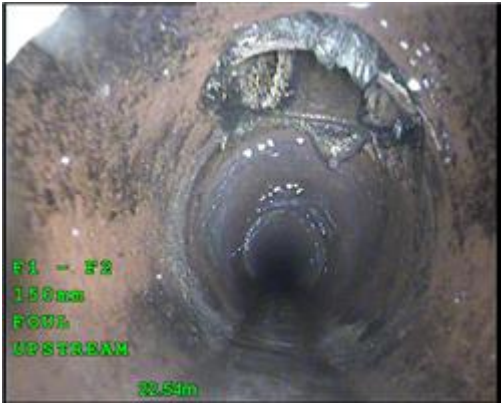
Pos	Code	Description	Image
22.54m	CN	Connection other than junction at 12 o'clock: 100mm Diameter	<p>Image Provided - Ref: 1_5</p>

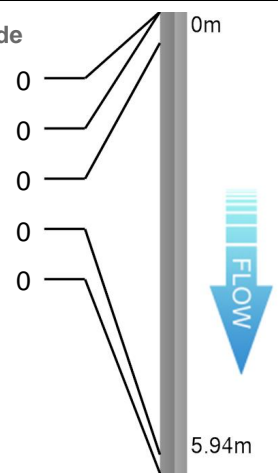
Position	Code	Description	CD	Pic	Grade
00.00m	MH	Start node type, manhole			0
00.00m	WL	Water level 5%			0
00.40m	REM	General remark	2_2		0
05.70m	REM	General remark	2_3		0
05.94m	WRF	Finish node type, major connection without manhole			0

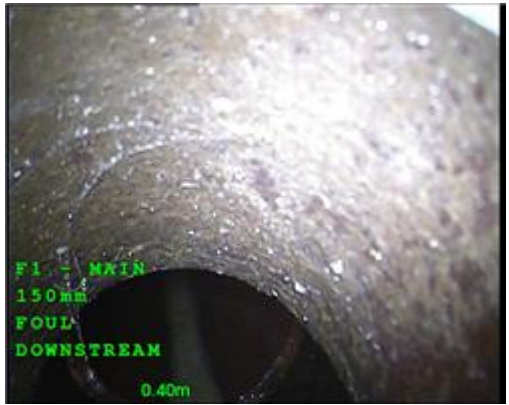
Pos	Code	Description	Image
00.00m	MH	Start node type, manhole F1	
00.00m	WL	Water level: 5% Height/Diameter	
00.40m	REM	General remark ENTER VIA 100mm RODDING EYE	<p>Image Provided - Ref: 2_2</p>

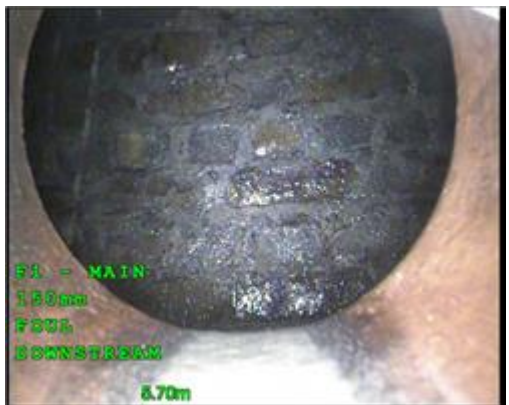
05.70m	REM	General remark JOIN MAIN	<p>Image Provided - Ref: 2_3</p>

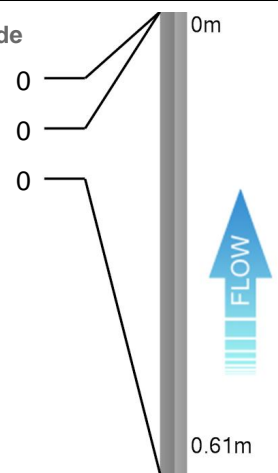
Position	Code	Description	CD	Pic	Grade
00.00m	MH	Start node type, manhole			0
00.00m	WL	Water level 0%			0
00.61m	SA	Survey abandoned			0

Pos	Code	Description	Image
00.00m	MH	Start node type, manhole F2	
00.00m	WL	Water level: 0% Height/Diameter	
00.61m	SA	Survey abandoned SHARP BEND LEFT

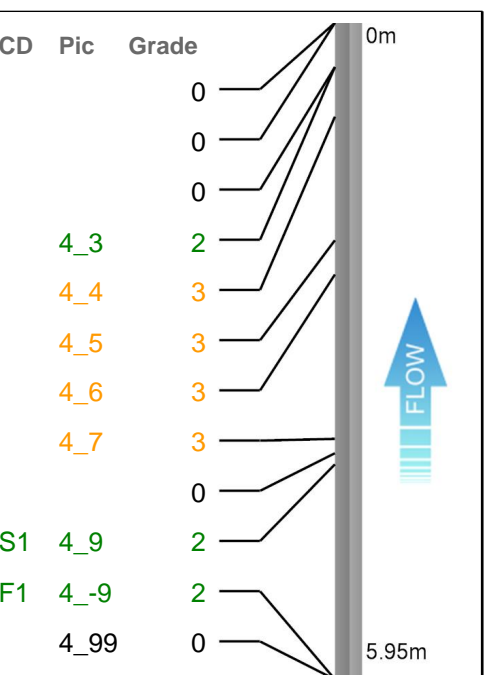
Position	Code	Description	CD	Pic	Grade
00.00m	MH	Start node type, manhole			0
00.00m	WL	Water level 0%			0
00.40m	LLH	Line of drain/sewer deviates left [half]			0
00.40m	R	Roots		4_3	2
00.85m	JDL	Joint displaced large		4_4	3
01.97m	FC	Fracture circumferential 6-12		4_5	3
02.28m	JDL	Joint displaced large		4_6	3
03.77m	JDL	Joint displaced large		4_7	3
03.90m	LLQ	Line of drain/sewer deviates left [quarter]			0
04.00m	R	S1 Roots	S1	4_9	2
05.95m	R	F1 Roots	F1	4_-9	2
05.95m	SA	Survey abandoned		4_99	0

Pos	Code	Description	Image
00.00m	MH	Start node type, manhole F2	
00.00m	WL	Water level: 0% Height/Diameter	
00.40m	LLH	Line of drain/sewer deviates left [half]	
00.40m	R	Roots - Grade 2 MASS ROOTS AT JOINT 30%	<p>Image Provided - Ref: 4_3</p>

01.97m	FC	Fracture circumferential from 6 o'clock to 12 o'clock - Grade 3	<p>Image Provided - Ref: 4_5</p>

05.95m	F1 R	RootsDefect End - Grade 2 MASS ROOTS 40%

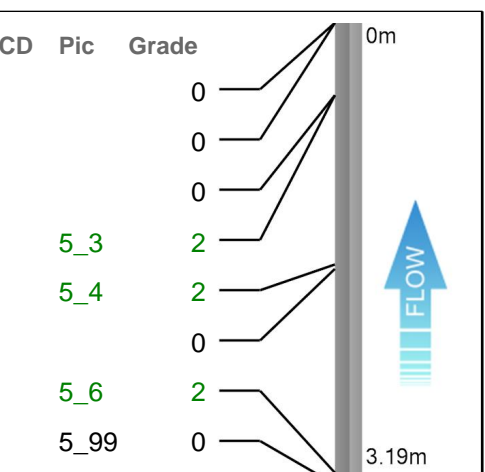
Position	Code	Description	CD	Pic	Grade
00.00m	MH	Start node type, manhole			0
00.00m	WL	Water level 0%			0
00.50m	LRQ	Line of drain/sewer deviates right [quarter]			0
00.50m	JDM	Joint displaced medium	5_3		2
01.67m	JDM	Joint displaced medium	5_4		2
01.70m	LRQ	Line of drain/sewer deviates right [quarter]			0
03.11m	R	Roots	5_6		2
03.19m	SA	Survey abandoned	5_99		0

Pos	Code	Description	Image
00.00m	MH	Start node type, manhole F2	
00.00m	WL	Water level: 0% Height/Diameter	
00.50m	LRQ	Line of drain/sewer deviates right [quarter]	
00.50m	JDM	Joint displaced medium - Grade 2	<p>Image Provided - Ref: 5_3</p>

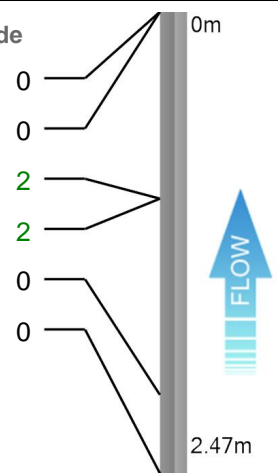
Position	Code	Description	CD	Pic	Grade
00.00m	MH	Start node type, manhole			0
00.00m	WL	Water level 5%			0
01.00m	CL	Crack, longitudinal 11	6_2		2
01.00m	CL	Crack, longitudinal 2			2
02.05m	LUF	Line of drain/sewer deviates up [full]			0
02.47m	SA	Survey abandoned			0

Pos	Code	Description	Image
00.00m	MH	Start node type, manhole F2	
00.00m	WL	Water level: 5% Height/Diameter	
01.00m	CL	Crack, longitudinal at 11 o'clock - Grade 2	<p>Image Provided - Ref: 6_2</p>

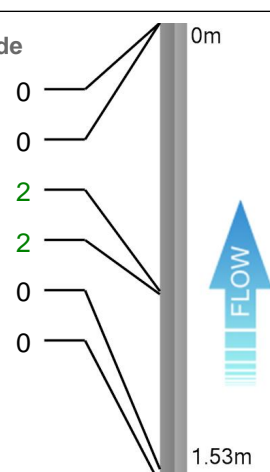
Position	Code	Description	CD	Pic	Grade
00.00m	MH	Start node type, manhole			0
00.00m	WL	Water level 0%			0
00.89m	JDM	Joint displaced medium	7_2		2
00.90m	DES	Settled deposits fine 10%			2
01.48m	LUF	Line of drain/sewer deviates up [full]			0
01.53m	SA	Survey abandoned			0

Pos	Code	Description	Image
00.00m	MH	Start node type, manhole F2	
00.00m	WL	Water level: 0% Height/Diameter	
00.89m	JDM	Joint displaced medium - Grade 2	<p>Image Provided - Ref: 7_2</p>  
00.90m	DES	Settled deposits fine: 10% Cross sectional area loss - Grade 2	
01.48m	LUF	Line of drain/sewer deviates up [full]	
01.53m	SA	Survey abandoned SHARP BEND UP

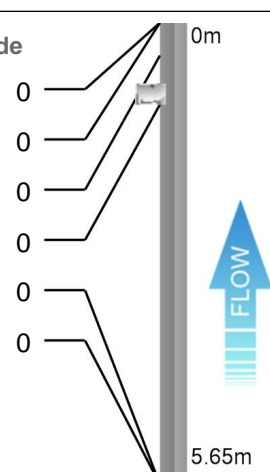
Position	Code	Description	CD	Pic	Grade
00.00m	MH	Start node type, manhole			0
00.00m	WL	Water level 40%			0
00.40m	CUW	S1 Loss of vision, camera under water	S1		0
01.00m	JN	Junction 2 : 100mm Diameter			0
05.65m	CUW	F1 Loss of vision, camera under water	F1		0
05.65m	SA	Survey abandoned			0

Pos	Code	Description	Image
00.00m	MH	Start node type, manhole S1	
00.00m	WL	Water level: 40% Height/Diameter	
00.40m	S1 CUW	Loss of vision, camera under water 0.4m - 5.65m	
01.00m	JN	Junction at 2 o'clock: 100mm Diameter	
05.65m	F1 CUW	Loss of vision, camera under water Defect End	
05.65m	SA	Survey abandoned BLANKED OFF

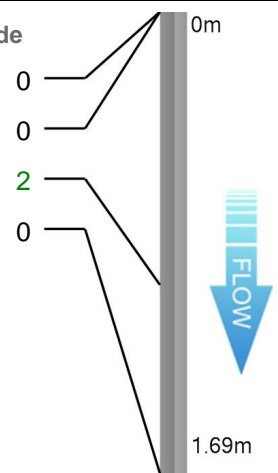
Position	Code	Description	CD	Pic	Grade
00.00m	MH	Start node type, manhole			0
00.00m	WL	Water level 30%			0
01.00m	DES	Settled deposits fine 30%			2
01.69m	SA	Survey abandoned			0

Pos	Code	Description	Image
00.00m	MH	Start node type, manhole S1	
00.00m	WL	Water level: 30% Height/Diameter	
01.00m	DES	Settled deposits fine: 30% Cross sectional area loss - Grade 2	
01.69m	SA	Survey abandoned UNABLE TO PASS DEBRIS
