Appendix H6 - CCTV Drainage Survey

Site Details
THE HOPE PROJECT
CAMDEN HIGH STREET
LONDON
NW1 7JE

CCTV SURVEY REPORT

Project name: 45059 Project Number: Contact: Date: 06/07/2016

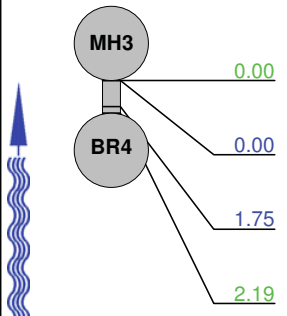
MH	Start node type, manhole, reference number : MH3	(Constr) 0
		WL	Water level, 5% of the vertical dimension	(Serv) 0
		LU	Line deviates up Remarks: SHARP	(Serv) 0
		OCF	Finish node type, other special chamber reference number: BR4 Remarks: BASE OF STACK	(Constr) 0

Structural Defects					Constructional Features				
Service Defects					Miscellaneous Features				
STR no def	STR peak	STR mean	STR total	STR grade	SER no def	SER peak	SER mean	SER total	SER grade
0	0	0	0	1	0	0	0	0	1

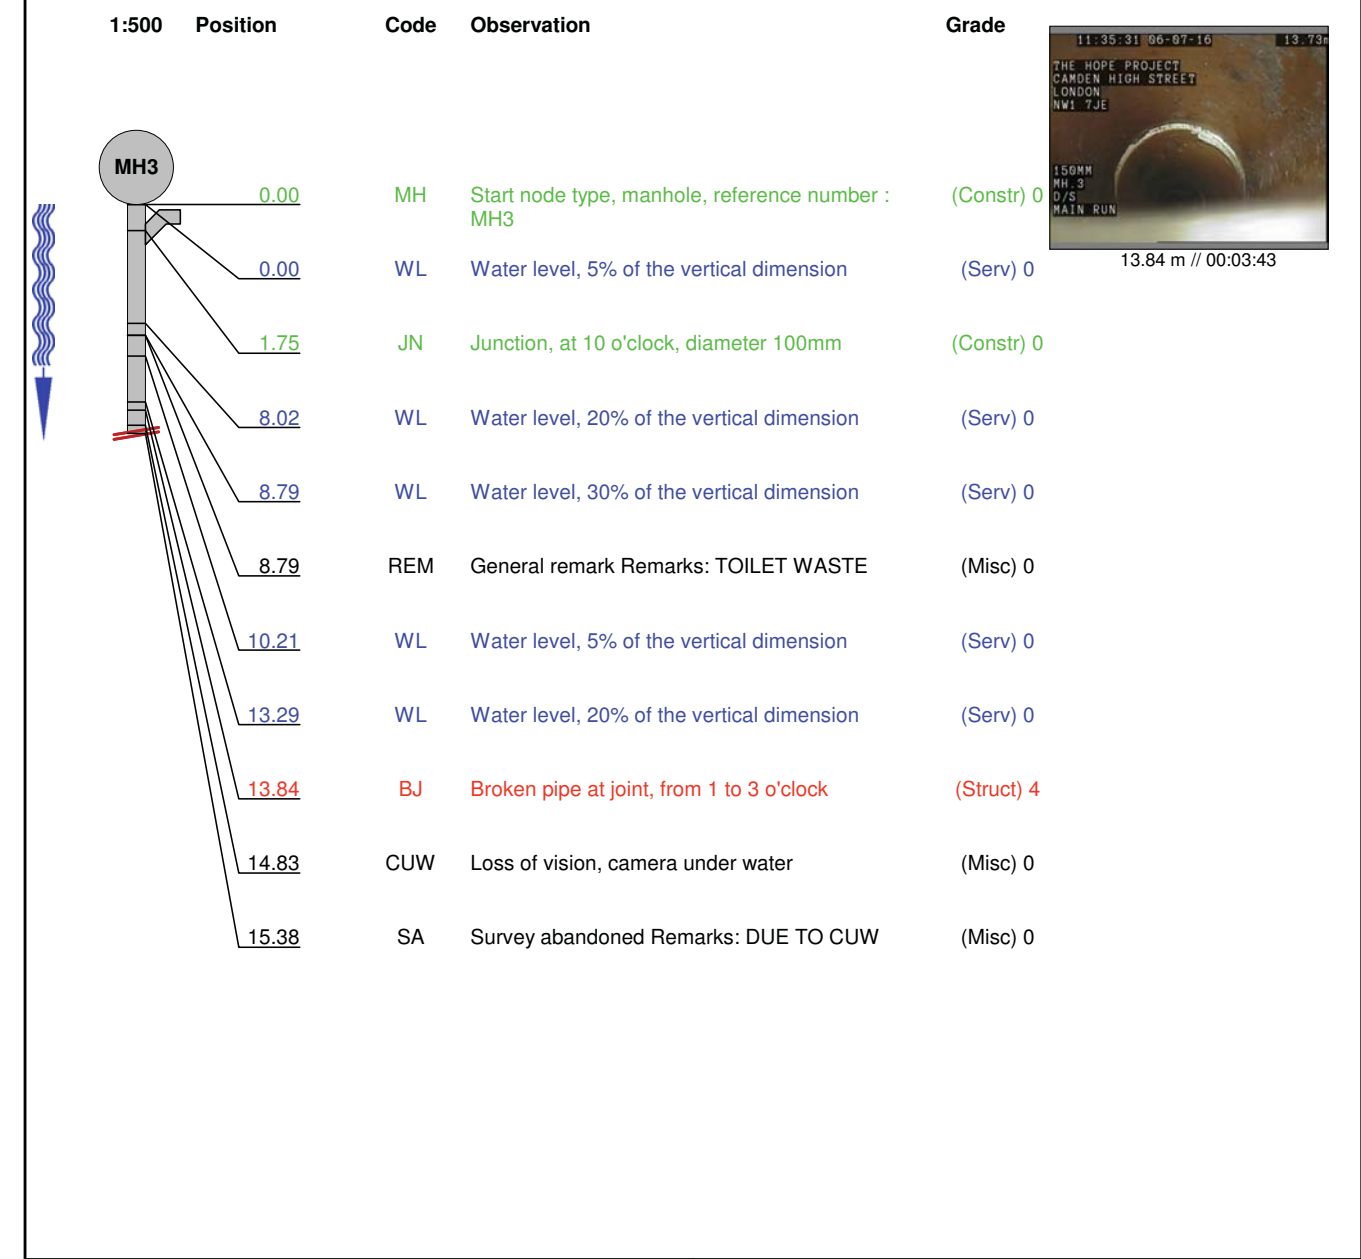
Place : LONDON	Location details: Catchment: Tape number : 1 Pipe Length 1.00 m	U/S MH : MH3 U/S Depth : D/S MH : MAIN RUN D/S Depth :
Road : CAMDEN HIGH STREET	Direction Use: Combined	Pipe shape : Circular
Location Difficult access	Year laid : Z	Pipe size : 150 mm
Inspection MH3 (D/S) MAIN RUN	Purpose : Sample survey to determine asset condition	Pipe material : Vitrified clay
	Total length : 15.38 m	Lining :

Structural Defects					Constructional Features				
Service Defects					Miscellaneous Features				
STR no def	STR peak	STR mean	STR total	STR grade	SER no def	SER peak	SER mean	SER total	SER grade
1	80	5.2	80	4	0	0	0	0	1
