Place :	LONDON	Location details:	U/S MH :	BR1
Road :	CAMDEN HIGH STREET	Catchment:	U/S Depth :	
Location	Difficult access	Tape number : 1	D/S MH :	MH7
Inspection	MH7 (U/S) BR1	Pipe Length 1.00 m	D/S Depth :	0.52
Direction Use:	Combined	Pipe shape :	Circular	
Year laid :	Z	Pipe size :	150 mm	
Purpose :	Sample survey to determine asset condition	Pipe material :	Vitrified clay	
Total length :	2.41 m	Lining :

THE HOPE PROJECT
CAMDEN HIGH STREET
LONDON
NW1 7JE

STRUCTURAL ENGINEER'S REPORT**ON:****DATING OF TRUSSES OVER MAIN AUDITORIUM****OF:****KOKO (NEE CAMDEN PALACE THEATRE), CAMDEN****FOR:****JASMEER PATTI**

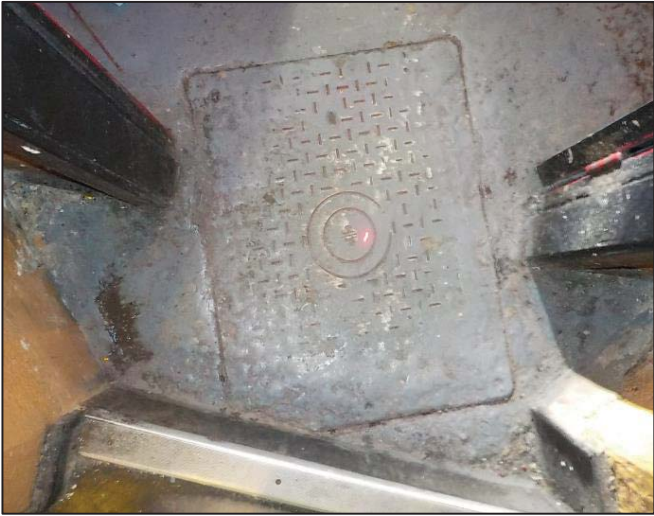
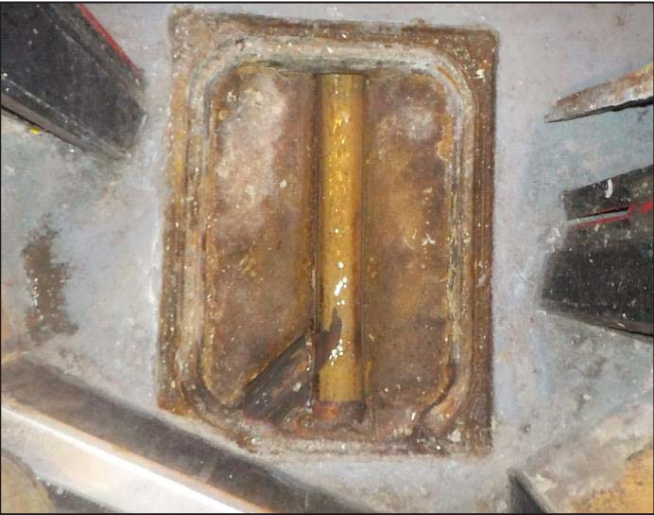
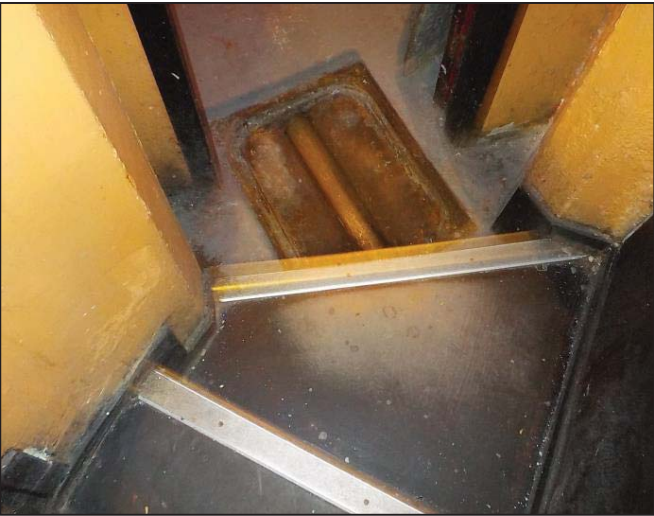
Location		Other Gents underground toilets		Date		6-Jul-2016	
Manhole number		MH5					
Type		MH					
Cover shape		RE		Material		CI	
Cover Duty		M					
Cover Size		590x750		Clear opening		460x660	
Cover Condition		Good					
Shaft type		NA		Size of Shaft			
Access		No step irons		Access ok		Y	
Entry type		Manhole		Chamber size		460x660	
Chamber material		PC		Other material			
Chamber condition		2					
Silt		N		Surcharged		N	
Infiltration		N		Toxic		N	
Rats		N					
Benching Condition		2					
Channel Condition		2					
Step irons/ladder		N/A		Cover Level			
Sewer type		CO

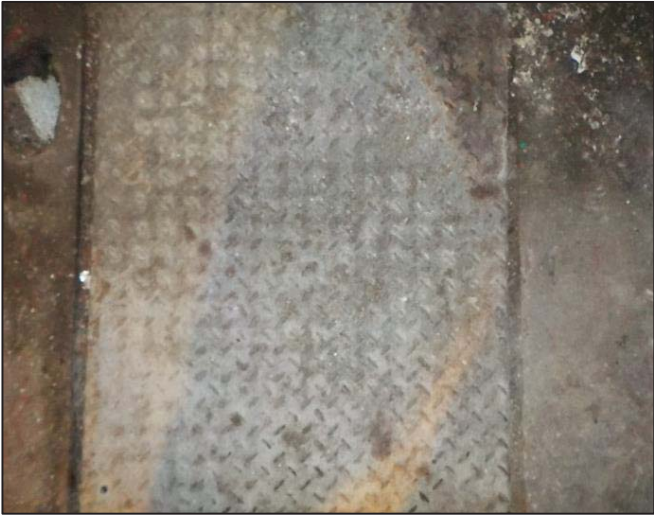
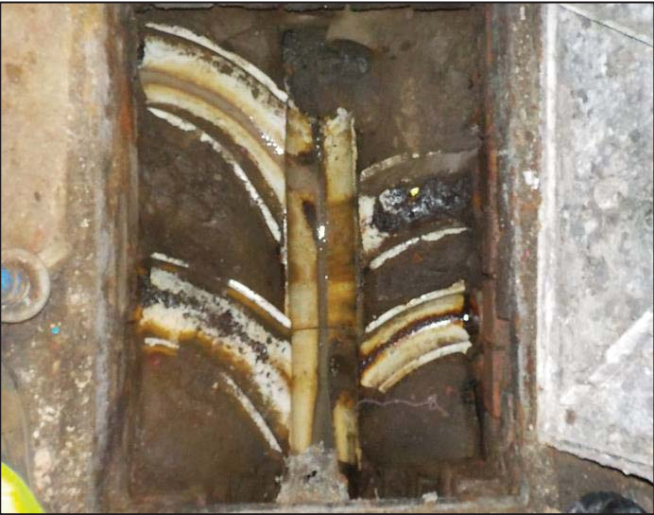
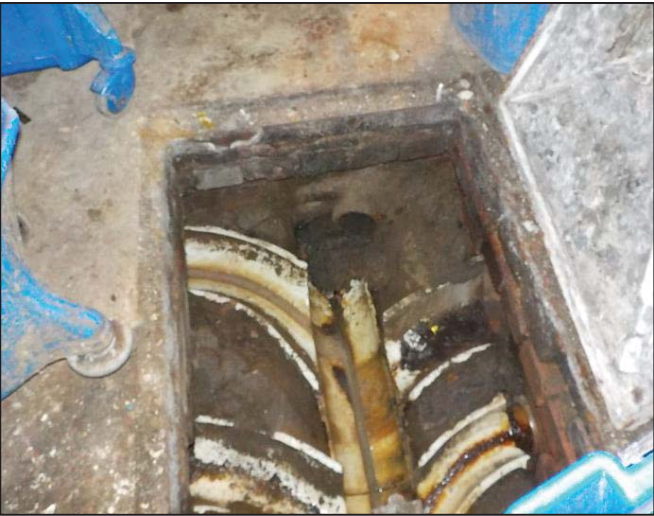
Location		Cleaners Cubord underground		Date		6-Jul-2016	
Manhole number		MH7					
Type		MH					
Cover shape		RE		Material		CI	
Cover Duty		M					
Cover Size		650x790		Clear opening		640x780	
Cover Condition		Good					
Shaft type		BR		Size of Shaft		640x780	
Access		No step irons		Access ok		Y	
Entry type		Manhole		Chamber size		650x800	
Chamber material		BR		Other material			
Chamber condition		2					
Silt		N		Surcharged		N	
Infiltration		N		Toxic		N	
Rats		N					
Benching Condition		2					
Channel Condition		2					
Step irons/ladder		N/A		Cover Level			
Sewer type		CO

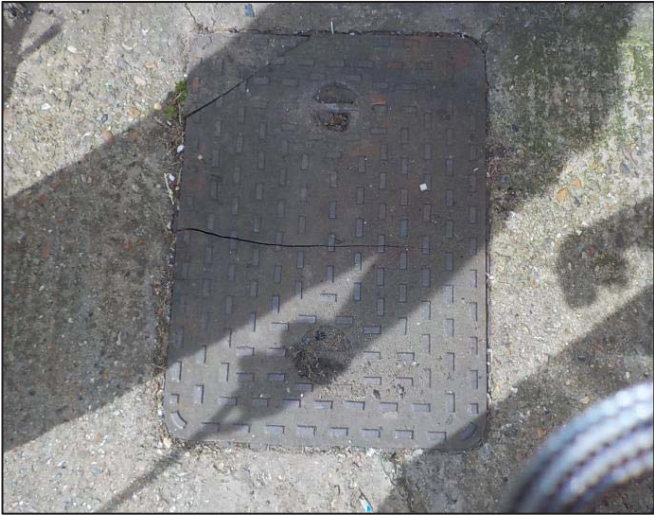
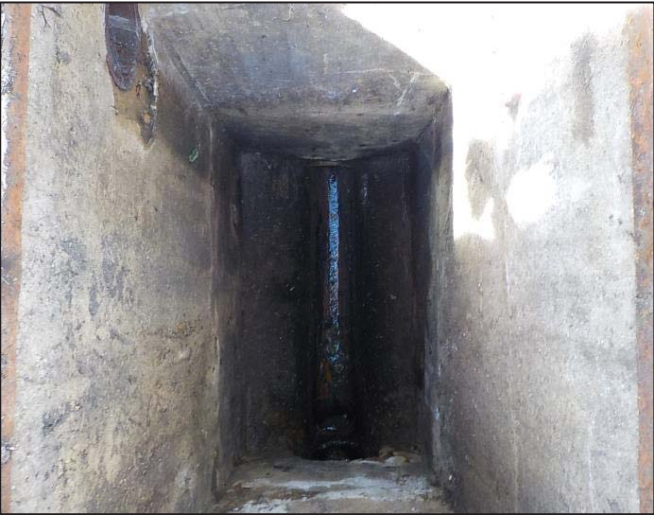
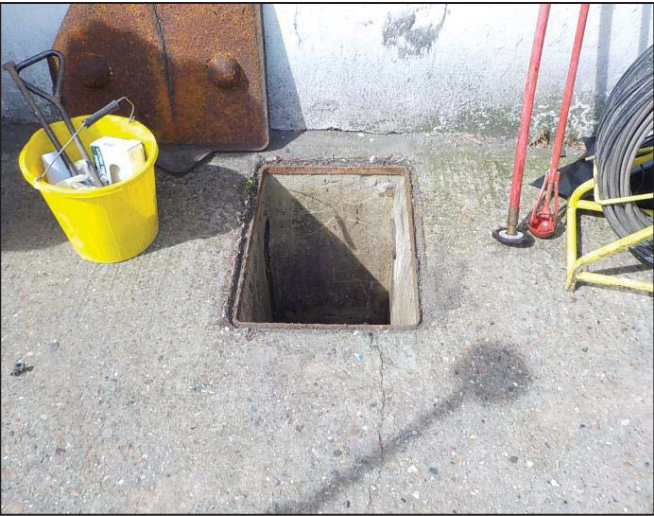
LocationPublic path		Date6-Jul-2016
Manhole numberMH1		
TypeMH		
Cover shapeRE	MaterialCI	
Cover DutyM		
Cover Size500x660	Clear opening460x600	
Cover ConditionPoor/broken		
Shaft typeConcrete	Size of Shaft460x600	
AccessNo step irons	Access okY	
Entry typeManhole	Chamber size460x710	
Chamber materialPC	Other material	
Chamber condition2		
SiltN	SurchargedN	InfiltrationN
ToxicN	RatsN	
Benching Condition2		
Channel Condition2		
Step irons/ladderN/A	Cover Level22.551	
Sewer typeCO

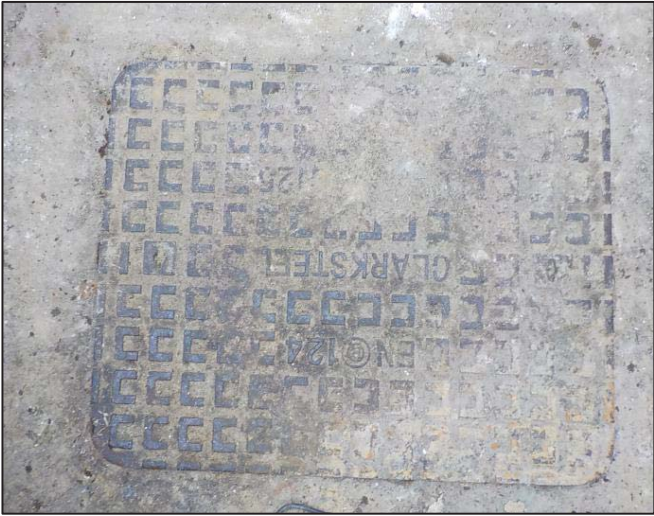
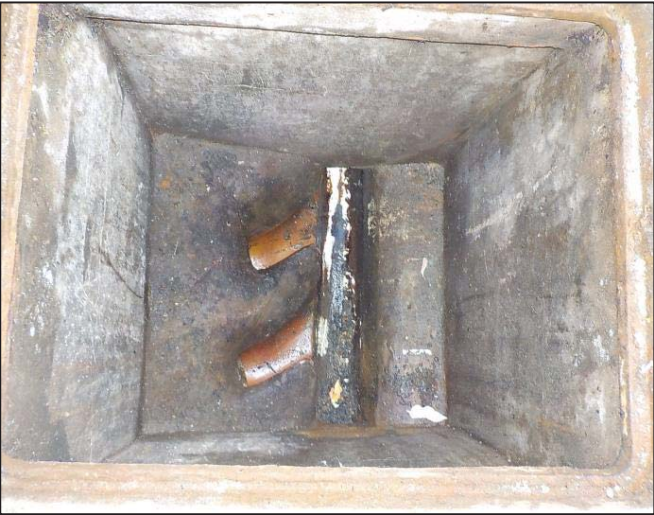
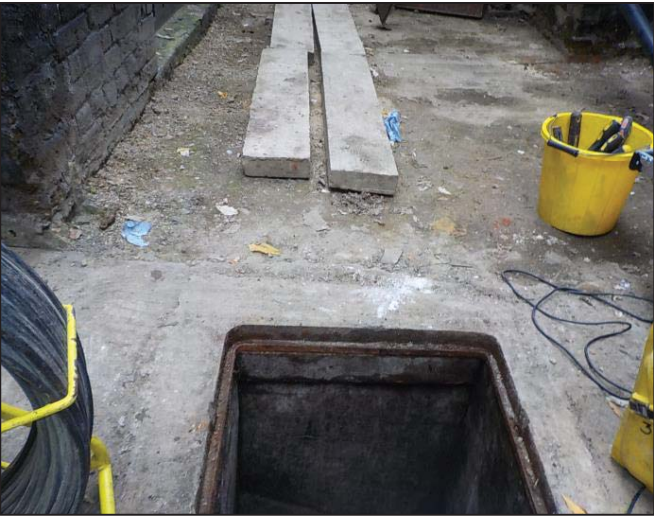
Location		Pub area		Date		8-Jul-2016	
Manhole number		MH11					
Type		MH					
Cover shape		RE		Material		CI	
Cover Duty		M					
Cover Size		500x640		Clear opening		460x600	
Cover Condition		Good					
Shaft type		CO		Size of Shaft		462X602	
Access		No step irons		Access ok		Y	
Entry type		Manhole		Chamber size		630x620	
Chamber material		PC		Other material			
Chamber condition		2					
Silt		N		Surcharged		N	
Infiltration		N		Toxic		N	
Rats		N					
Benching Condition		2					
Channel Condition		2					
Step irons/ladder		N/A		Cover Level			
Sewer type		CO

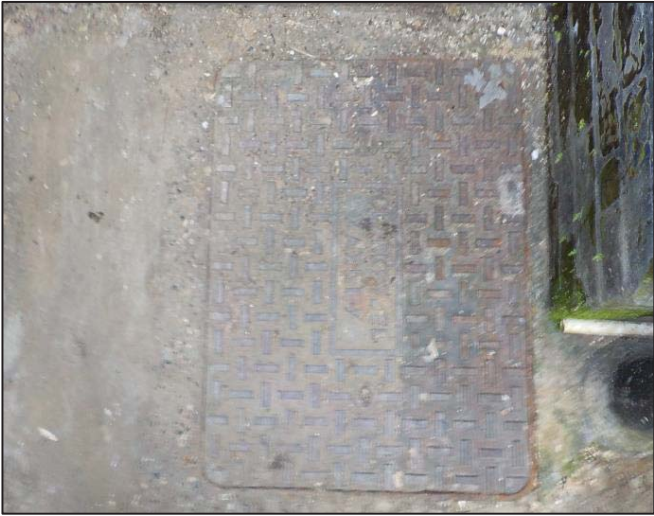
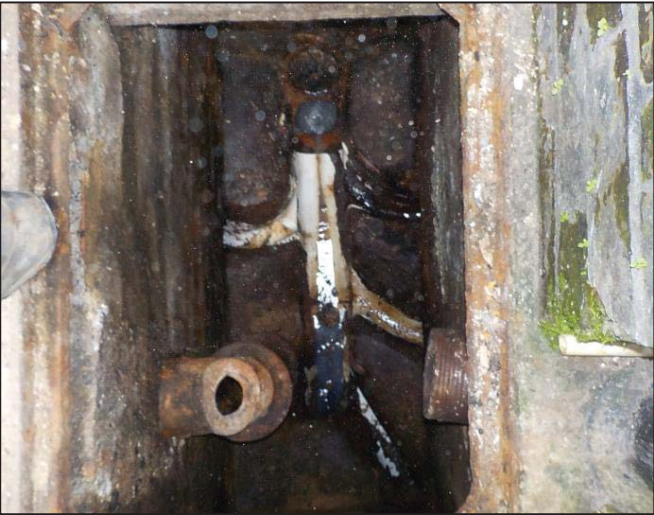
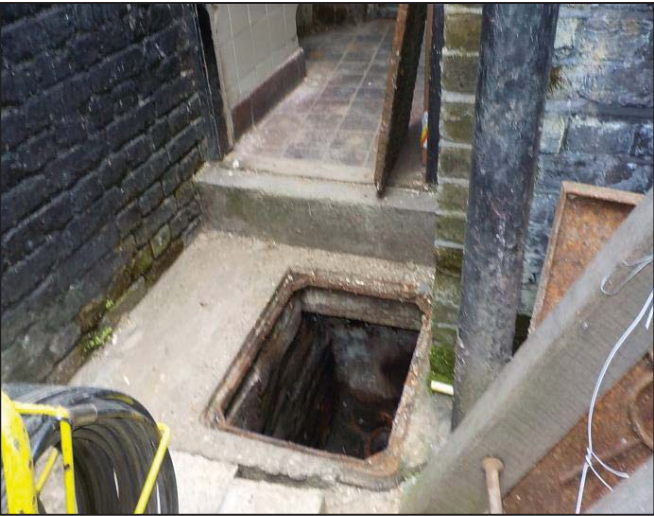
Location		Pub area		Date		8-Jul-2016			
Manhole number		MH13							
Type		MH							
Cover shape		RE		Material		CI			
Cover Duty		M							
Cover Size		520x650		Clear opening		460x600			
Cover Condition		Good							
Shaft type		Concrete		Size of Shaft		480x630			
Access		No step irons		Access ok		Y			
Entry type		Manhole		Chamber size		500x1200			
Chamber material		PC		Other material					
Chamber condition		4							
Silt	N	Surcharged	N	Infiltration	N	Toxic	N	Rats	N
Benching Condition		3							
Channel Condition		3							
Step irons/ladder		N/A		Cover Level					
Sewer type		CO

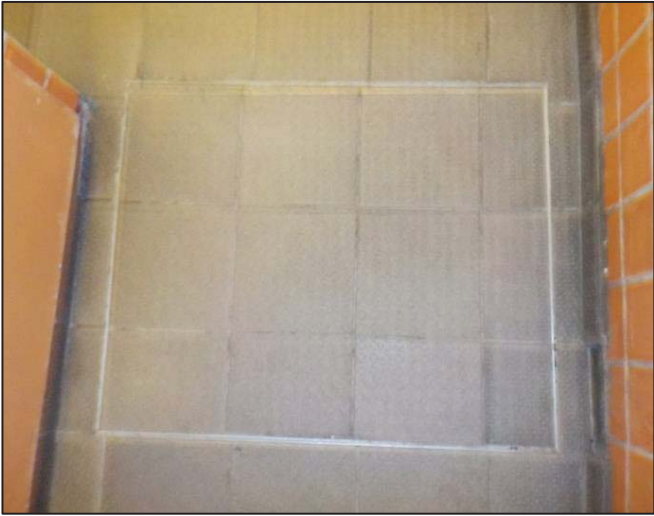
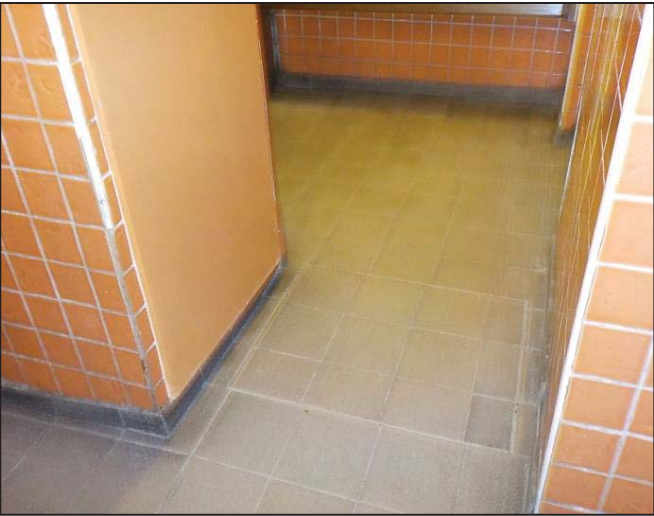
Location		Gents underground toilets		Date		6-Jul-2016	
Manhole number		MH4					
Type		OC					
Cover shape		RE		Material		Ceramic	
Cover Duty		H					
Cover Size		550x690		Clear opening			
Cover Condition		Good					
Shaft type		Size of Shaft					
Access				Access ok		N	
Entry type		Chamber size					
Chamber material		Other material					
Chamber condition		9					
Silt		N		Surcharged		N	
				Infiltration		N	
				Toxic		N	
				Rats		N	
Benching Condition		9					
Channel Condition		9					
Step irons/ladder		9		Cover Level			
Sewer type		CO

Comments	Unable to raise
Drawing	
<div></div>

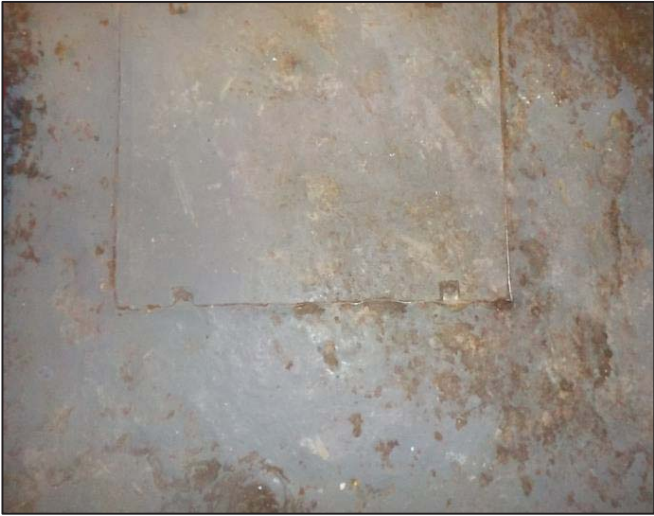
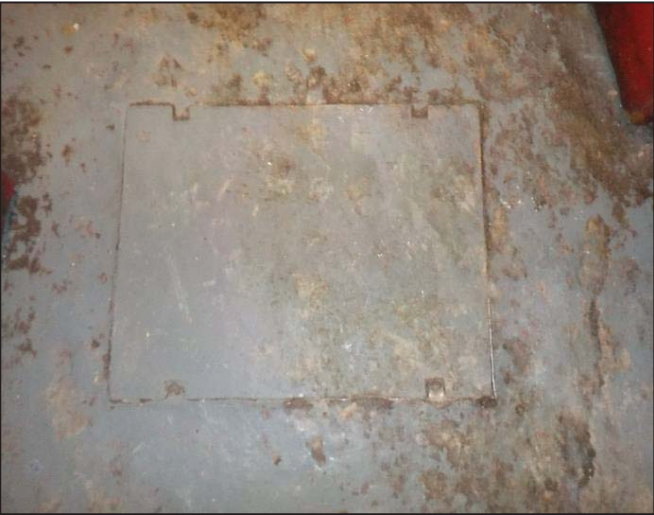
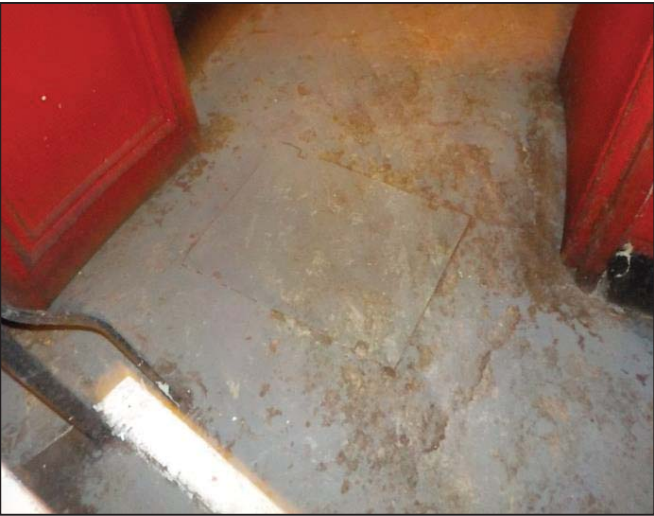
Location		Stair way		Date		6-Jul-2016	
Manhole number		MH6					
Type		OC					
Cover shape		RE		Material		CI	
Cover Duty		M					
Cover Size		540x690		Clear opening			
Cover Condition		Warn					
Shaft type		Size of Shaft					
Access		N/A		Access ok		N	
Entry type		Chamber size					
Chamber material		Other material					
Chamber condition		9					
Silt		N		Surcharged		N	
Infiltration		N		Toxic		N	
Rats		N					
Benching Condition		9					
Channel Condition		9					
Step irons/ladder		9		Cover Level			
Sewer type

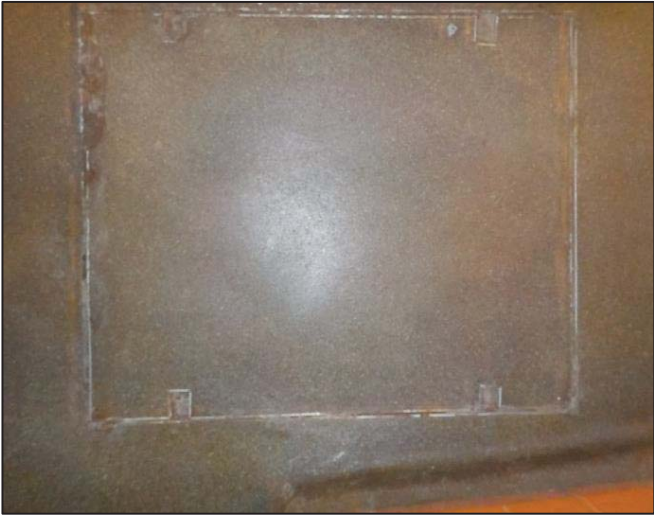
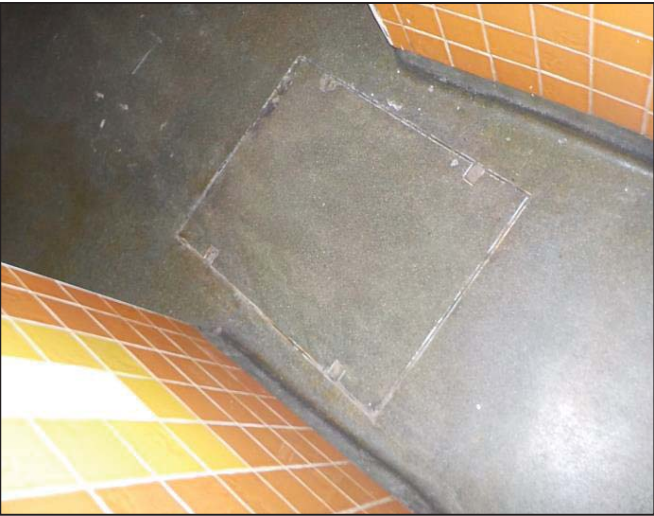
Location		Ladies Underground toilets		Date		6-Jul-2016	
Manhole number		MH8					
Type		OC					
Cover shape		RE		Material		CI	
Cover Duty		M					
Cover Size		530x690		Clear opening			
Cover Condition		Poor					
Shaft type		Size of Shaft					
Access		N/A		Access ok		N	
Entry type		Chamber size					
Chamber material		Other material					
Chamber condition		9					
Silt		N		Surcharged		N	
Infiltration		N		Toxic		N	
Rats		N					
Benching Condition		9					
Channel Condition		9					
Step irons/ladder		9		Cover Level			
Sewer type		CO

Comments	Unable to raise
Drawing	
<div></div>

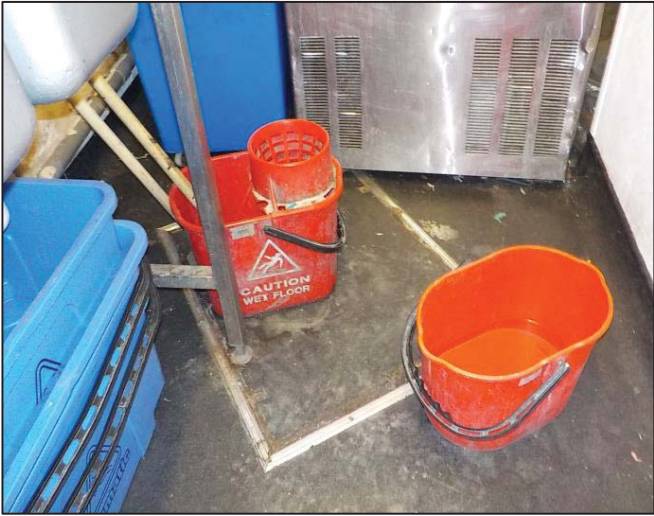
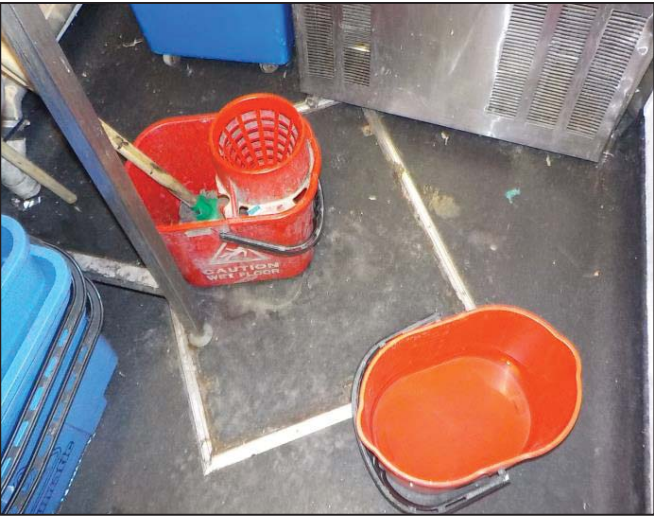
Location		Workshop Underground toilets		Date		7-Jul-2016	
Manhole number		MH9					
Type		OC					
Cover shape		RE		Material		CI	
Cover Duty		M					
Cover Size		570x740		Clear opening			
Cover Condition		Good					
Shaft type		Size of Shaft					
Access		N/A		Access ok		N	
Entry type		Chamber size					
Chamber material		Other material					
Chamber condition		9					
Silt		N		Surcharged		N	
Infiltration		N		Toxic		N	
Rats		N					
Benching Condition		9					
Channel Condition		9					
Step irons/ladder		9		Cover Level			
Sewer type		CO

Comments	Unable to raise
Drawing	
<div></div>

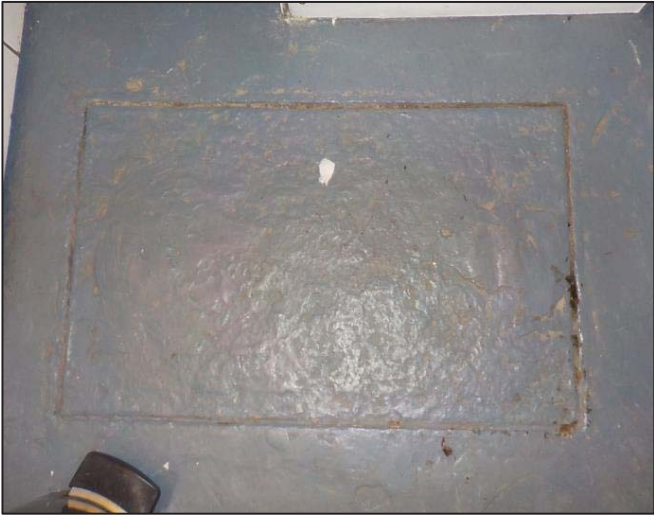
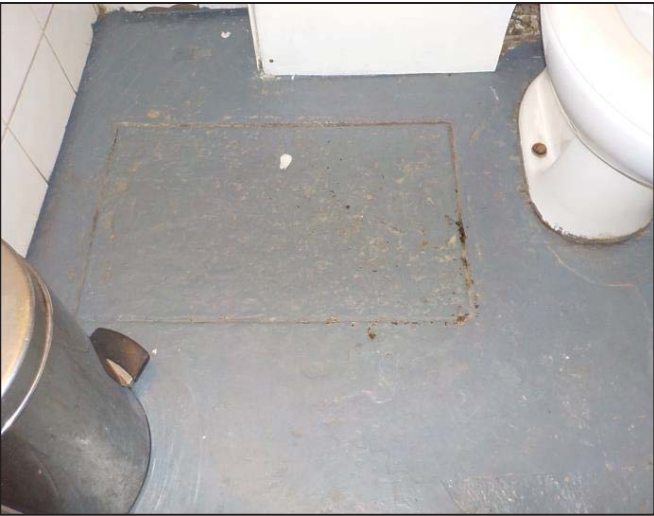
Location		Toilet Stairway		Date		7-Jul-2016	
Manhole number		MH10					
Type		OC					
Cover shape		RE		Material		CO	
Cover Duty		H					
Cover Size		380x610		Clear opening			
Cover Condition		Poor					
Shaft type		Size of Shaft					
Access		N/A		Access ok		N	
Entry type		Chamber size					
Chamber material		Other material					
Chamber condition		9					
Silt		N		Surcharged		N	
Infiltration		N		Toxic		N	
Rats		N					
Benching Condition		9					
Channel Condition		9					
Step irons/ladder		9		Cover Level			
Sewer type		CO

Comments	Unable to raise
Drawing	<div></div>

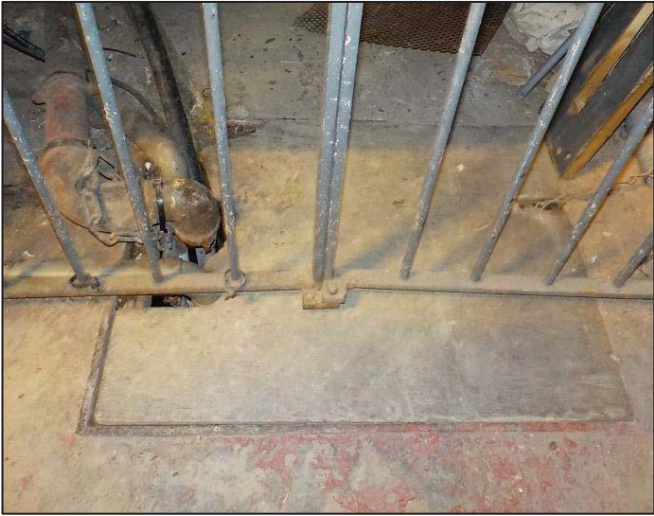
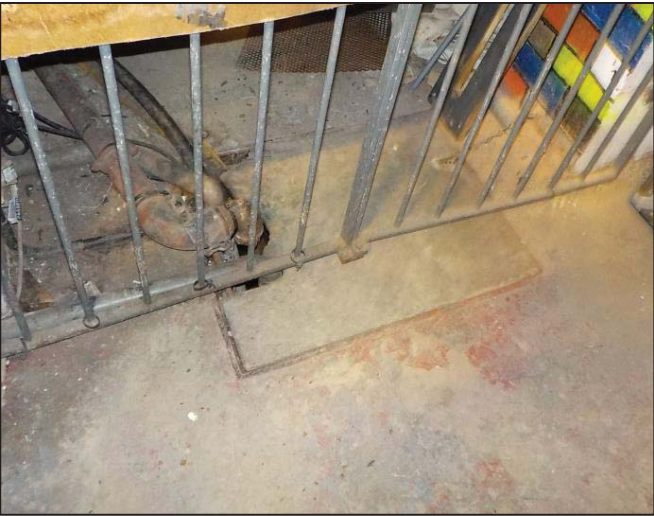
Location		Underground		Date		8-Jul-2016	
Manhole number		MH / 2					
Type		OC					
Cover shape		RE		Material		CI	
Cover Duty		M					
Cover Size		550x770		Clear opening			
Cover Condition		Good					
Shaft type		Size of Shaft					
Access				Access ok		N	
Entry type		Chamber size					
Chamber material		Other material					
Chamber condition		9					
Silt		N		Surcharged		N	
Infiltration		N		Toxic		N	
Rats		N					
Benching Condition		9					
Channel Condition		9					
Step irons/ladder		9		Cover Level			
Sewer type

Comments	Unable to raise	
Drawing	<div></div>
